the **play inspection** company

Annual Inspection

Broadbridge Heath Parish Council

Charrington Way Play Area

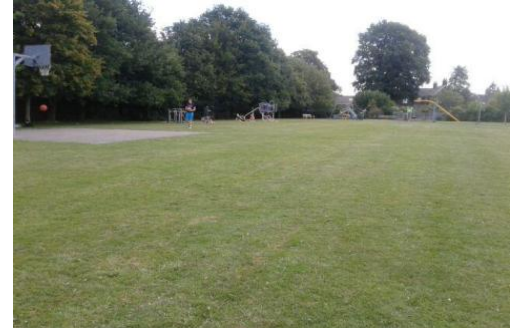
There are trip hazards present in the play area - Reinstate surrounding surfaces to level to remove the trip points area

It is recommended that Adult Outdoor Fitness equipment is installed a minimum of 25m away from a childrens playground or separated and screened to discourage access by younger children - Monitor use and review risk assessment regularly

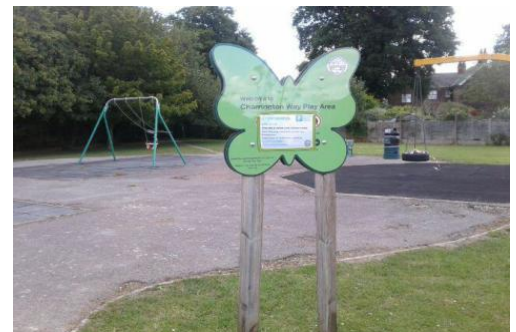
BS EN 1176 Part 7 recommends that signage shall include the site name / address - Provide additional information

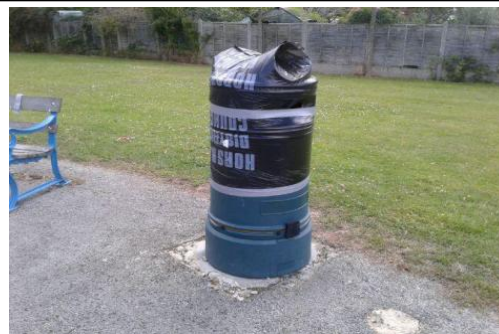
Bins were cordoned off at the time of inspection and the inspector was unable to make a full assessment - Ensure the bin is inspected/emptied as required

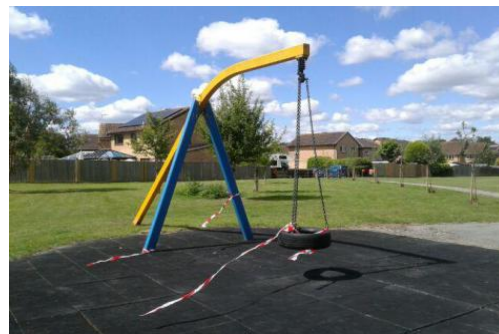
The surfacing dimensions are short and do not meet with the requirements of the current applicable standard - Monitor - no remedial action recommended

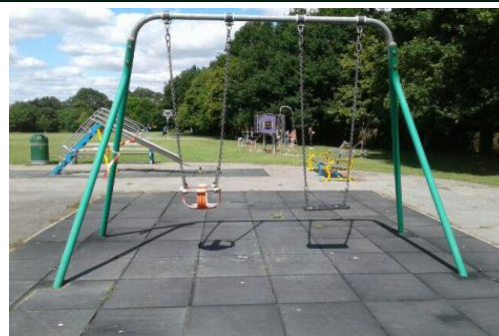
Bird muck is present on the seats - Clear the muck and maintain

There are caps missing from the underside of the seats - Replace missing caps under the seats

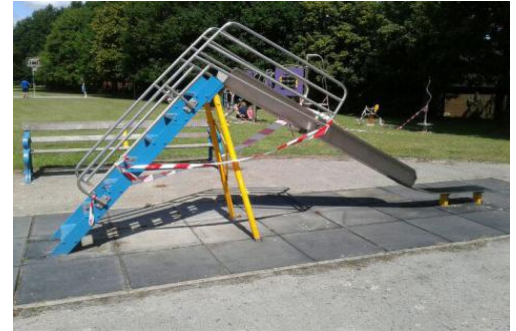
The item fails to meet the requirements of BS EN 1176 Part 1 4.2.7.2 head and neck entrapment in the barriers and/or steps - Monitor - No remedial work recommended

The height of the barrier(s) is insufficient and fails to meet the recommendations of BS EN 1176 Part 1 - Monitor - No remedial work recommended

The surfacing dimensions are significantly short and do not meet with the requirements of the current applicable standard (1500mm required / 700mm provided) - Extend surface area to comply

There is surface corrosion present on the item - Consider treating the item

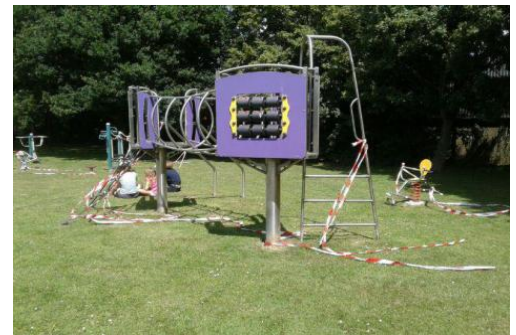
There is algae or moss on the surface of the equipment - Clean and treat appropriately

The grass mats are silted up and the soil is compacted; this may have an effect on the impact absorbing properties of the surface - Consider HIC testing impact absorbing properties to ensure the correct surface qualities are maintained for the equipment and replace as required

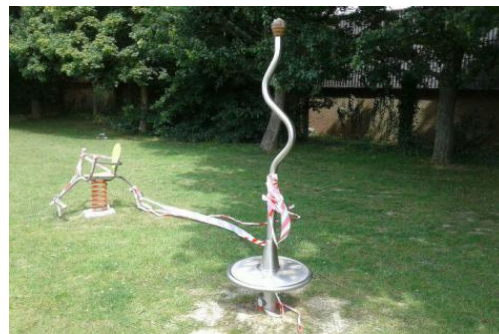
The grass mats are silted up, the soil is compacted and the area will become very slippery when the soil is wet. -
Reinstate as required

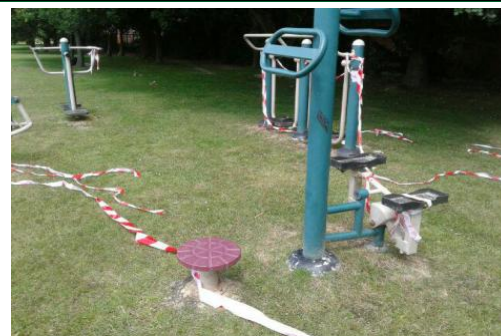
The deflection of the rotating user station exceeds the maximum 105 degrees required by BS EN 16630 - Monitor - No remedial work recommended

The swinging movement of the item exceeds the maximum 55 degrees from the vertical required by BS EN 16630 - Monitor - No remedial work recommended

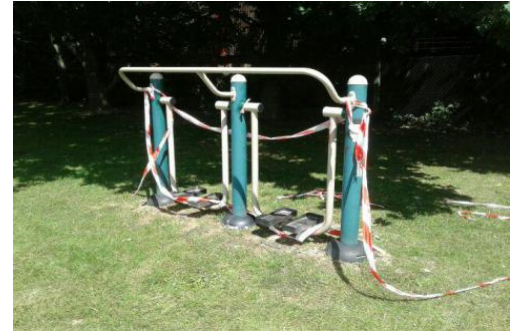
The tree canopy overhangs the equipment and is less than 2.0m away - Lift tree canopy to ensure a minimum clearance of 2.0m from the equipment

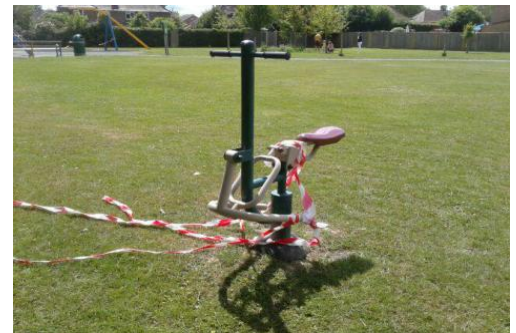
The item is slightly loose in its foundations - Monitor for any further deterioration and repair as required

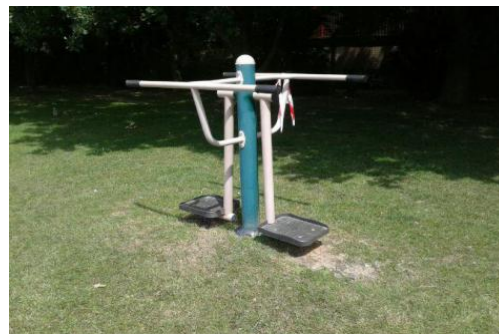
The swinging movement of the item exceeds the maximum 55 degrees from the vertical required by BS EN 16630 - Monitor - No remedial work recommended

There is minor damage to the hand grips - Monitor for any further damage and replace

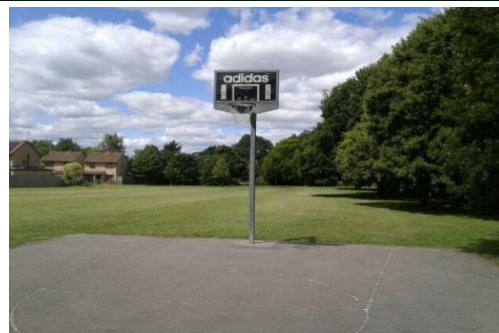
There are weeds/vegetation growth between or around the edges of the surfacing - Remove weeds/vegetation growth

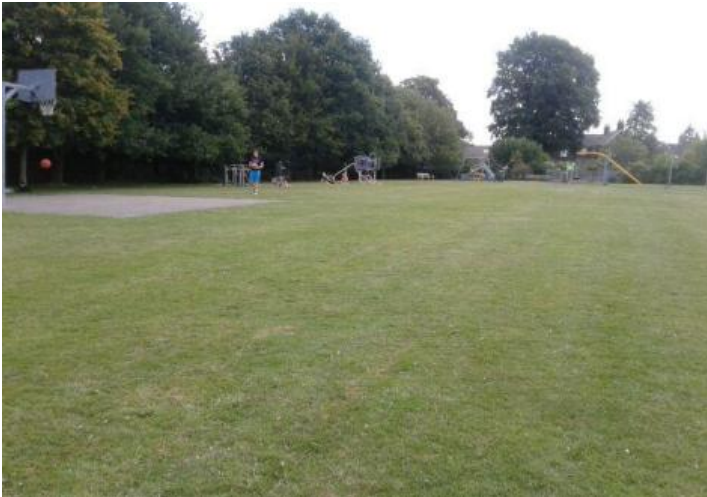
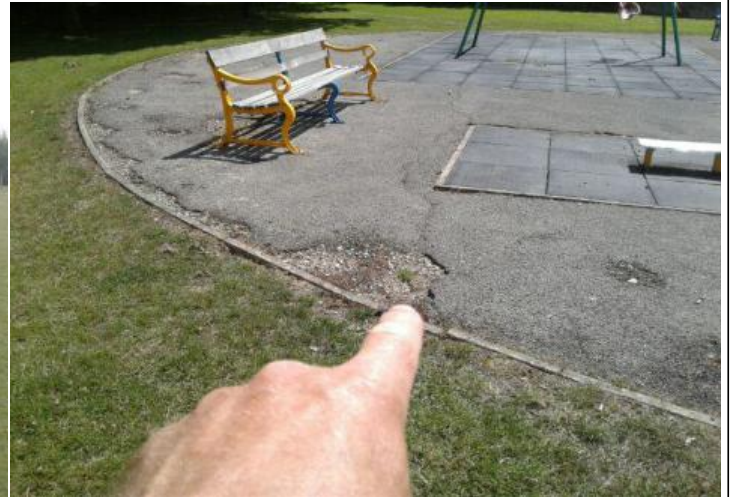
Finding: There are trip hazards present in the play area

Action: Reinstate surrounding surfaces to level to remove the trip points area

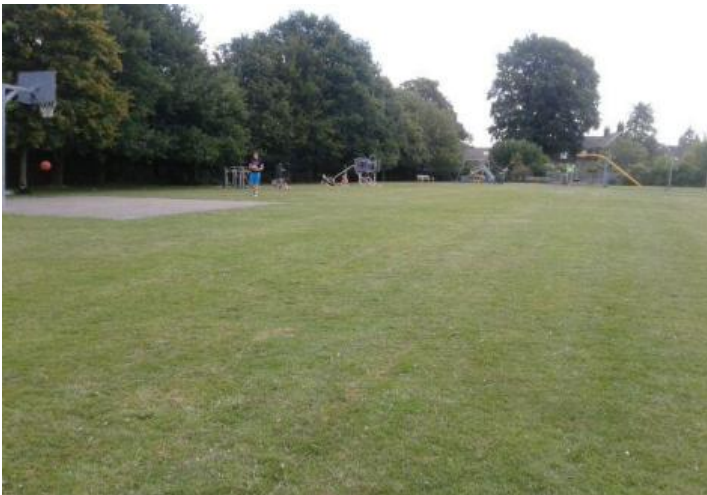
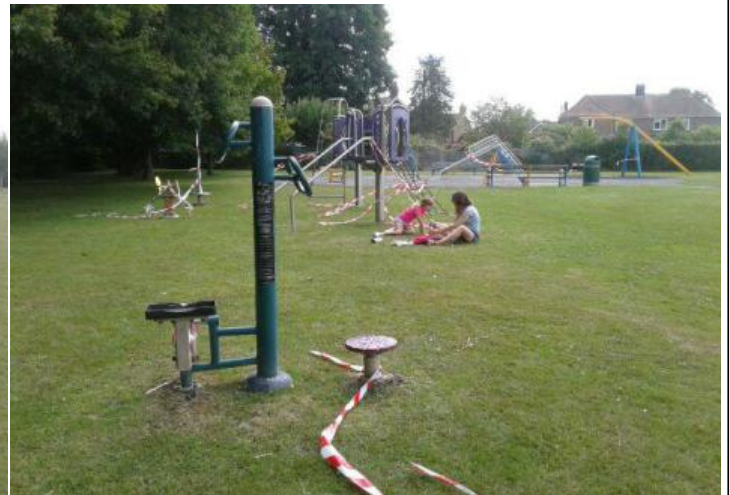
Finding: It is recommended that Adult Outdoor Fitness equipment is installed a minimum of 25m away from a childrens playground or separated and screened to discourage access by younger children

Action: Monitor use and review risk assessment regularly

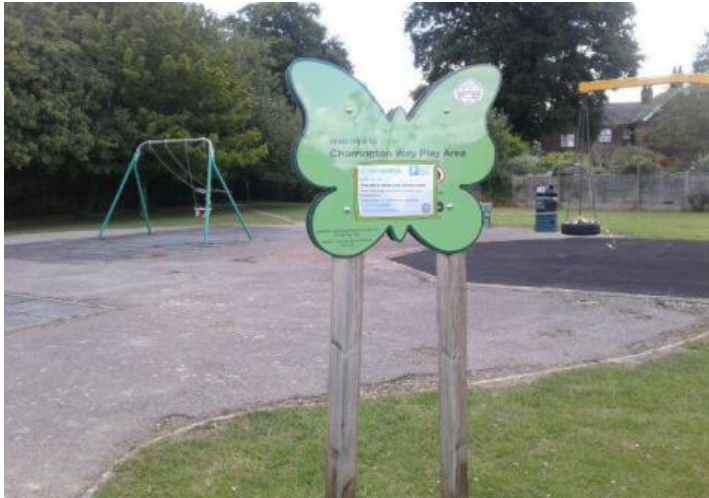
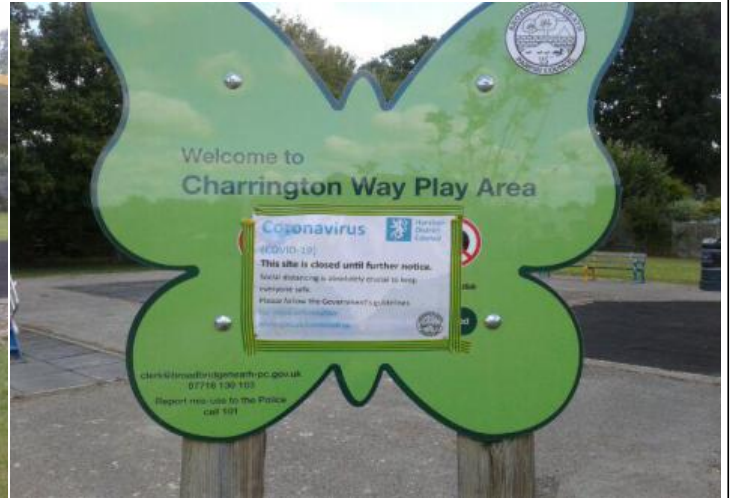
Finding: BS EN 1176 Part 7 recommends that signage shall include the site name / address
Action: Provide additional information

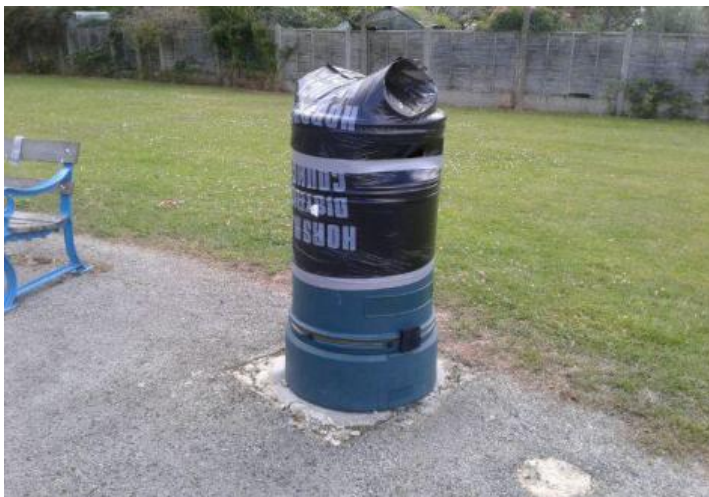
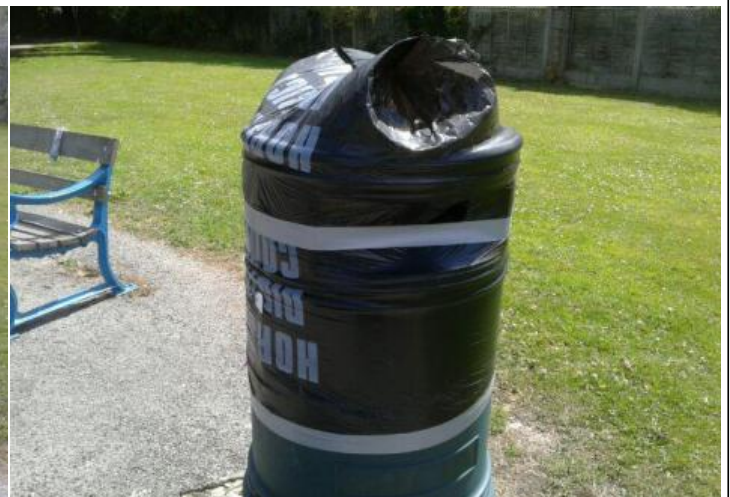
Finding: Bins were cordoned off at the time of inspection and the inspector was unable to make a full assessment

Action: Ensure the bin is inspected/emptied as required

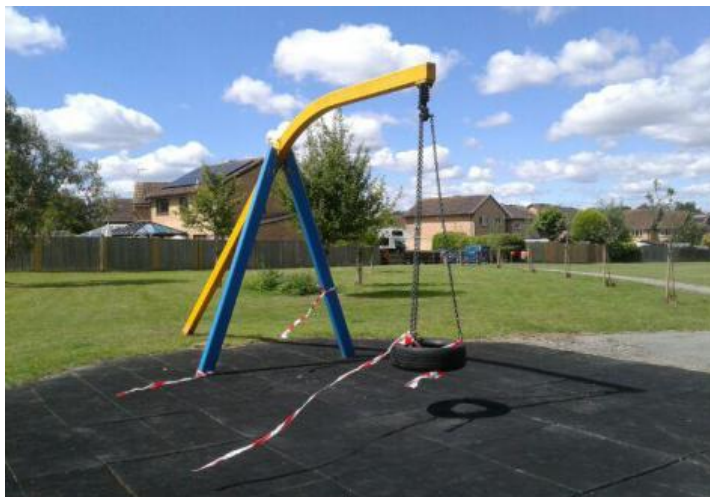
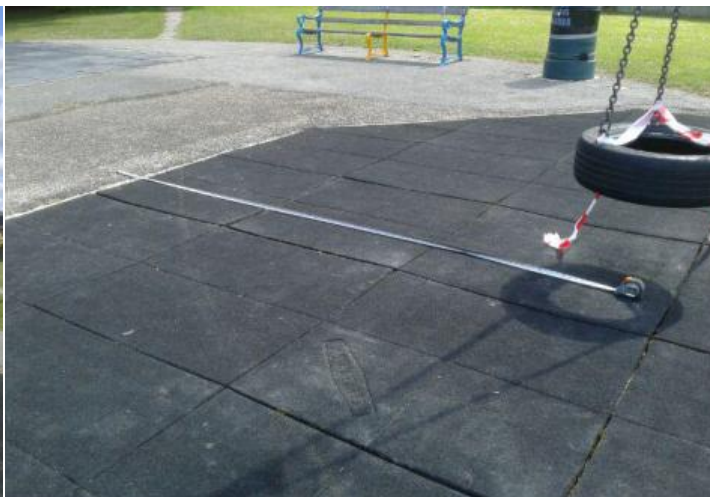
Finding: The surfacing dimensions are short and do not meet with the requirements of the current applicable standard

Action: Monitor - no remedial action recommended

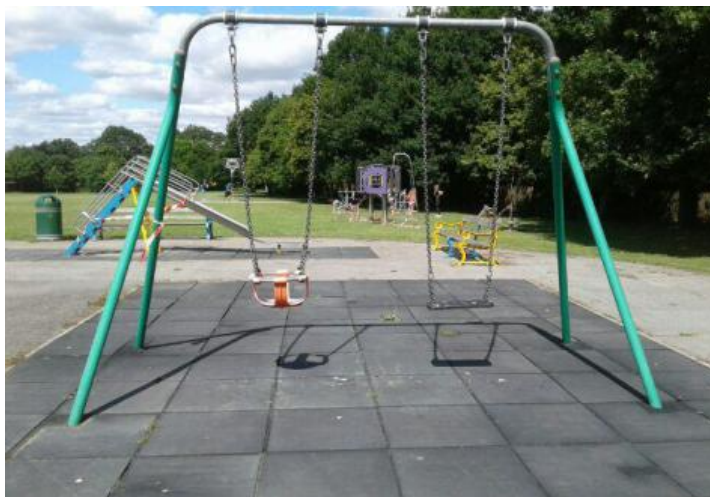
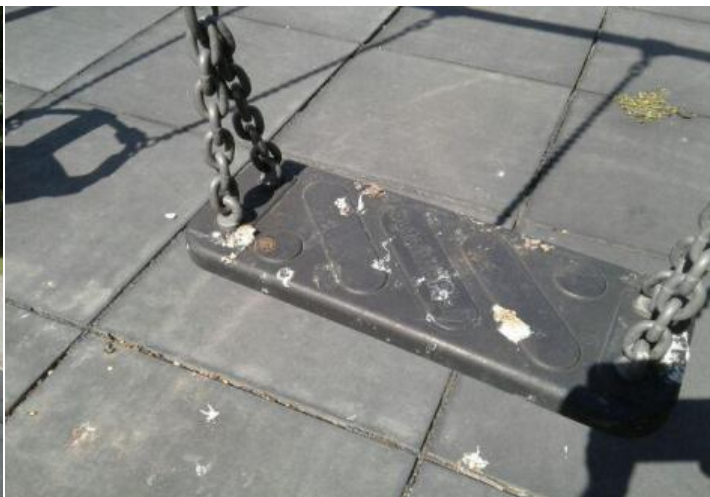
Finding: Bird muck is present on the seats

Action: Clear the muck and maintain

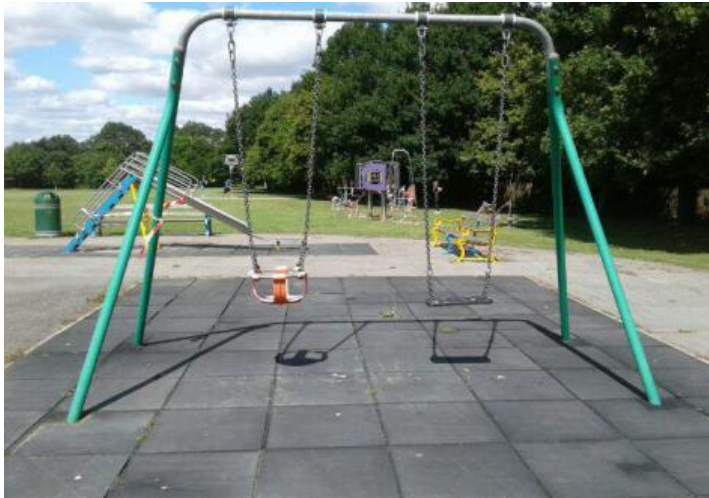
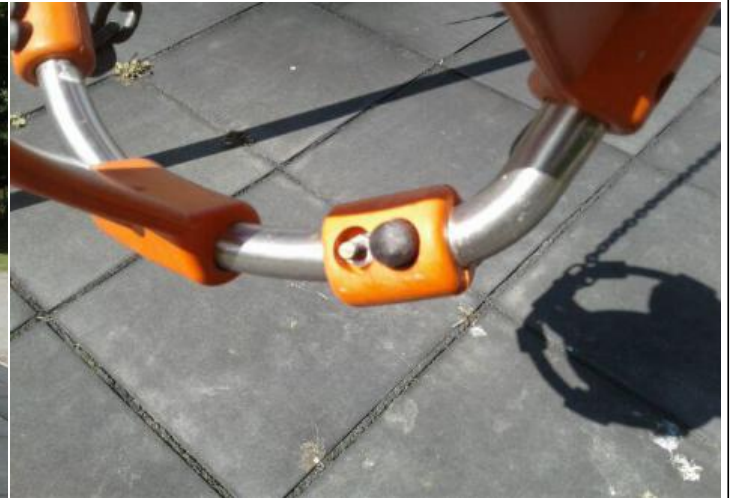
Finding: There are caps missing from the underside of the seats

Action: Replace missing caps under the seats

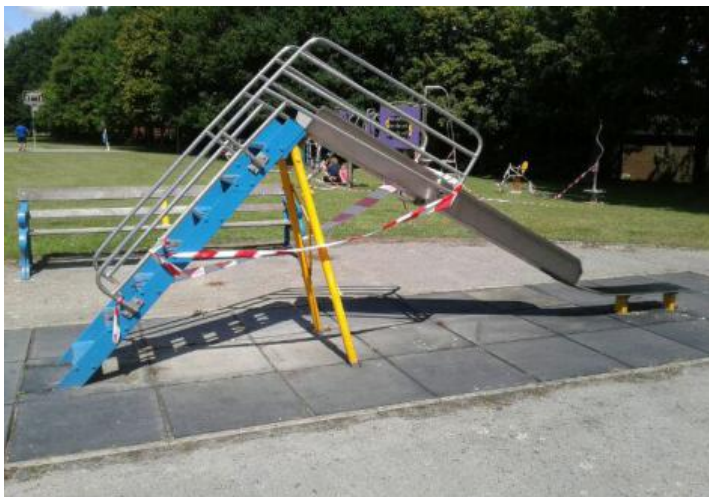
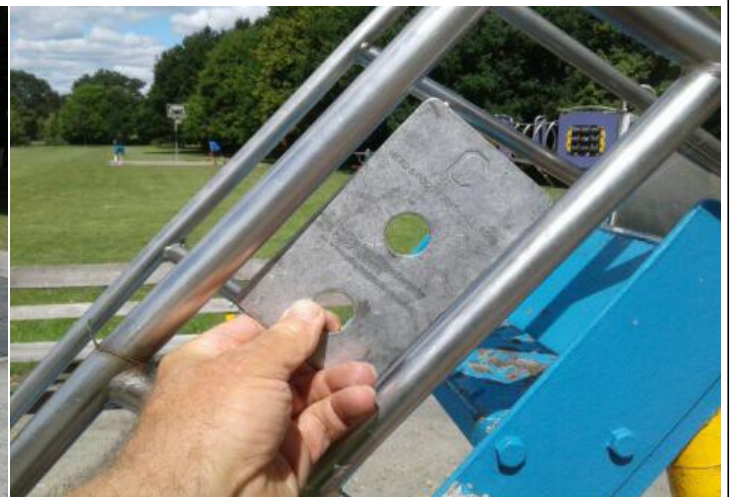
Finding: The item fails to meet the requirements of BS EN 1176 Part 1 4.2.7.2 head and neck entrapment in the barriers and/or steps

Action: Monitor - No remedial work recommended

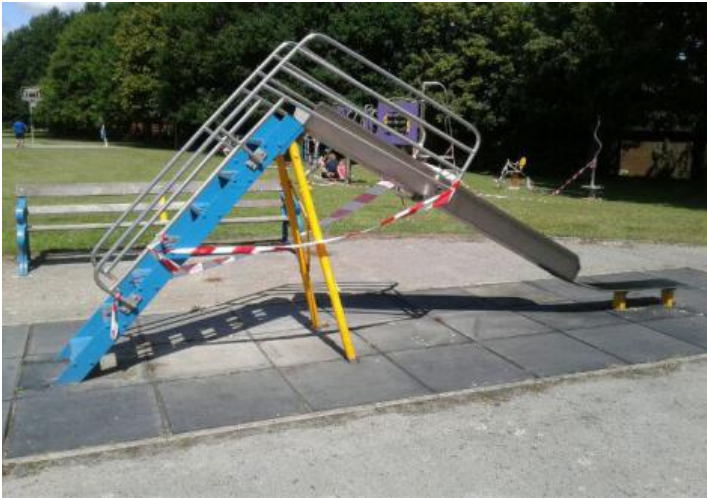
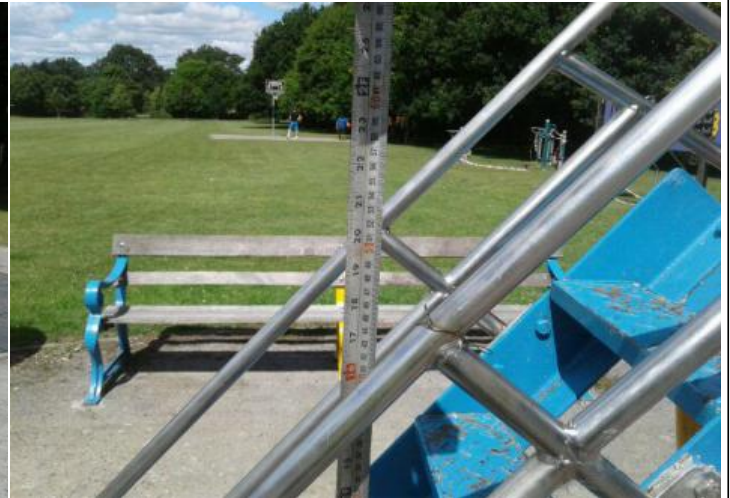
Finding: The height of the barrier(s) is insufficient and fails to meet the recommendations of BS EN 1176 Part 1

Action: Monitor - No remedial work recommended

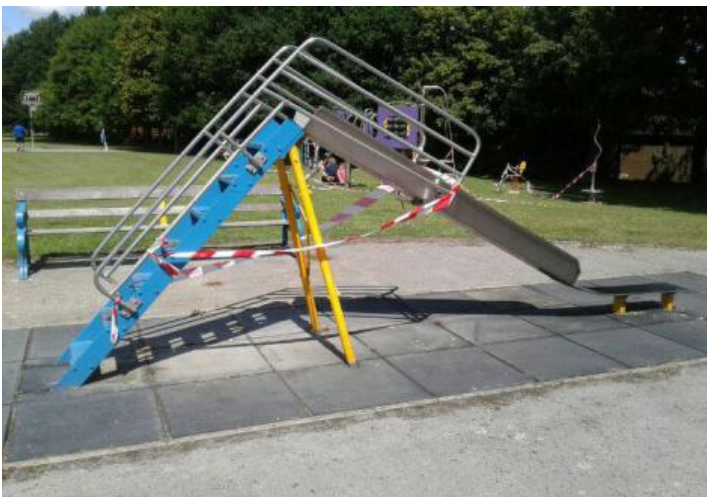
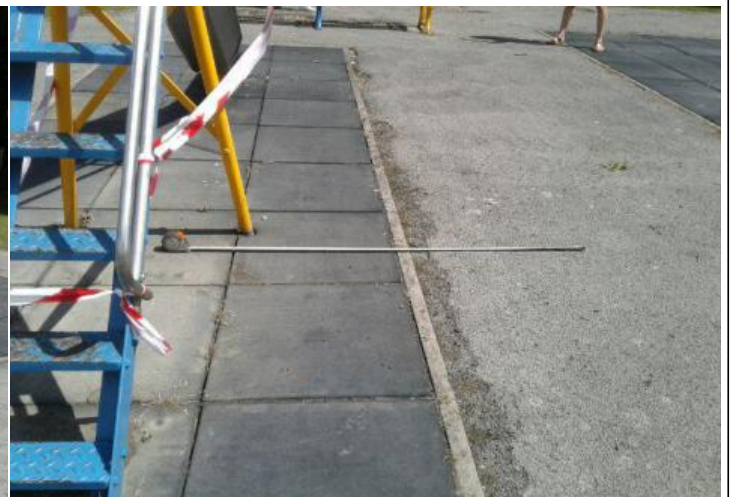
Finding: The surfacing dimensions are significantly short and do not meet with the requirements of the current applicable standard (1500mm required / 700mm provided)

Action: Extend surface area to comply

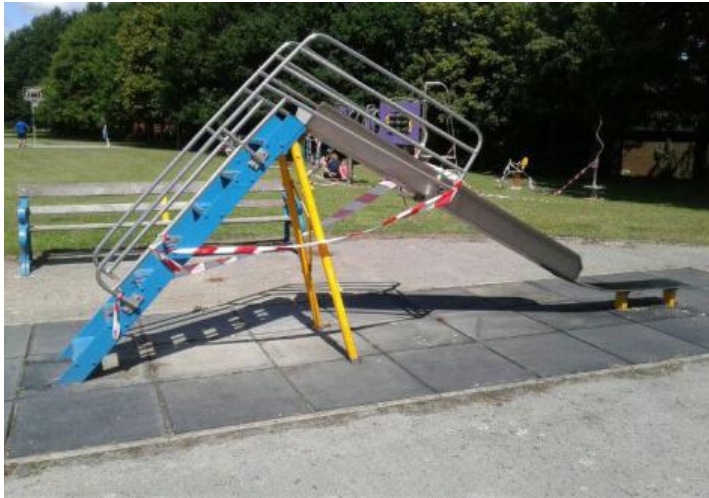
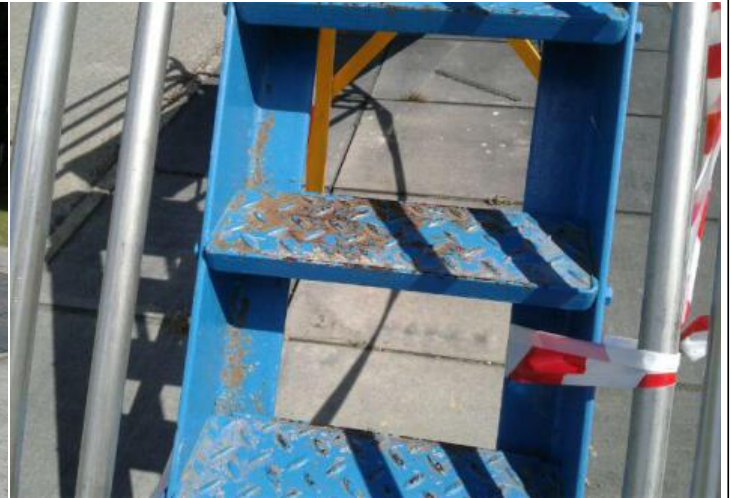
Finding: There is surface corrosion present on the item

Action: Consider treating the item

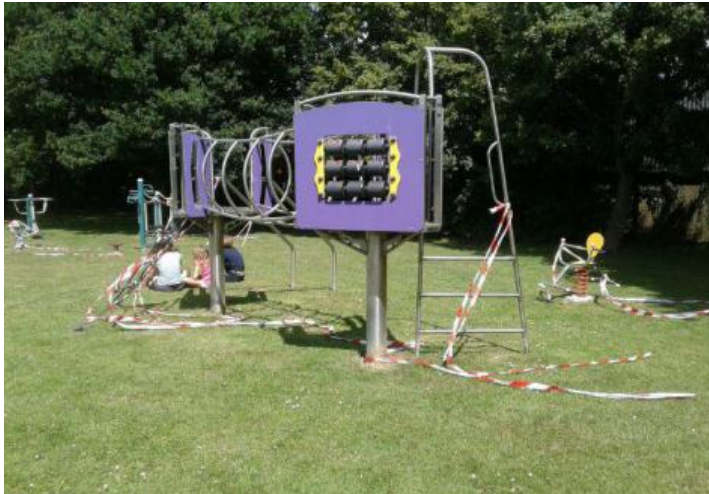
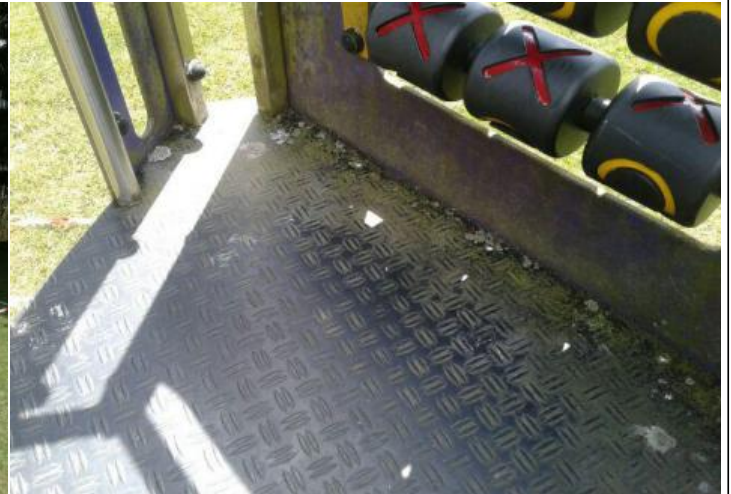
Finding: There is algae or moss on the surface of the equipment

Action: Clean and treat appropriately

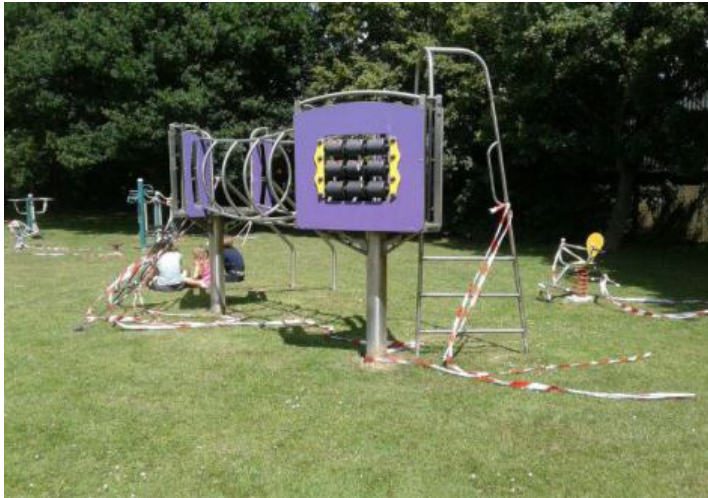
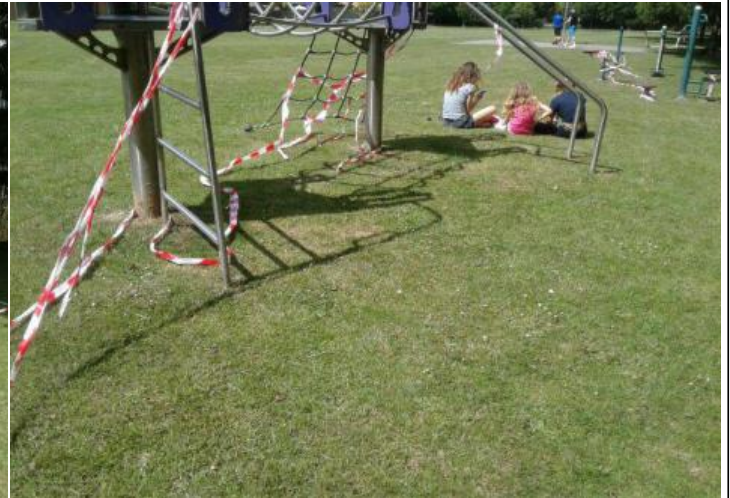
Finding: The grass mats are silted up and the soil is compacted; this may have an effect on the impact absorbing properties of the surface

Action: Consider HIC testing impact absorbing properties to ensure the correct surface qualities are maintained for the equipment and replace as required

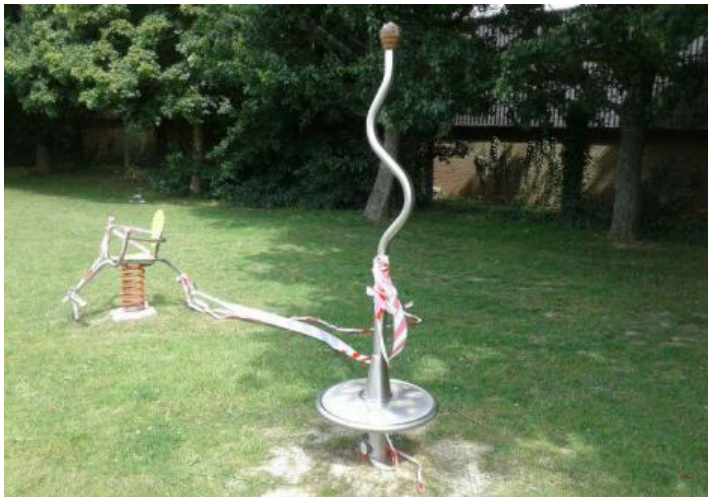
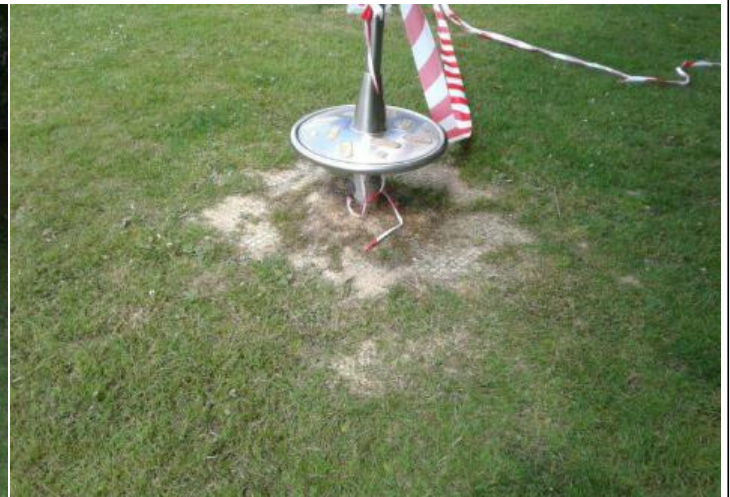
Finding: The grass mats are silted up, the soil is compacted and the area will become very slippery when the soil is wet.

Action: Reinstate as required

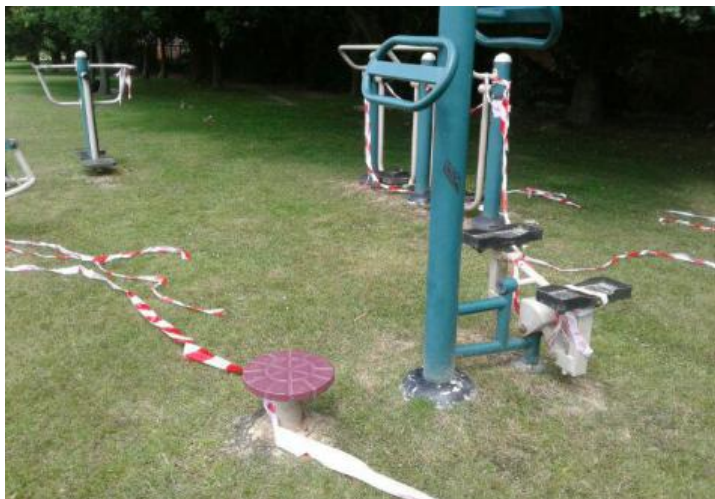
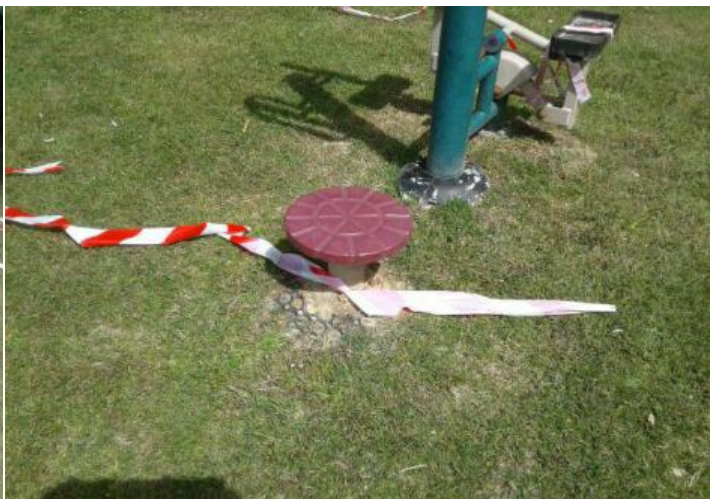
Finding: The deflection of the rotating user station exceeds the maximum 105 degrees required by BS EN 16630 **Action:** Monitor - No remedial work recommended

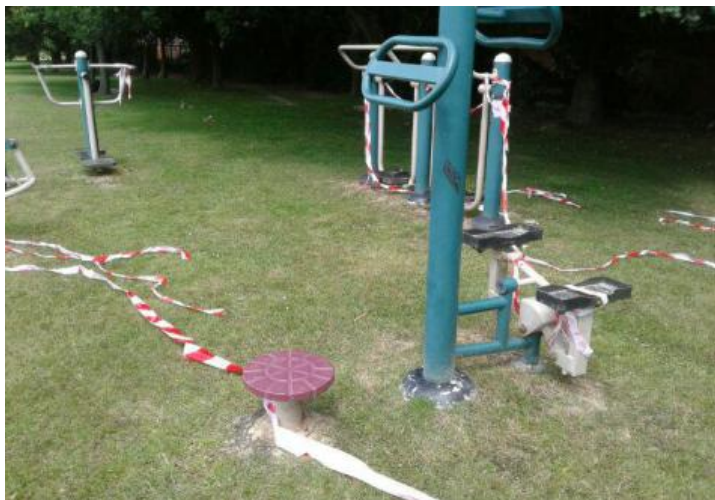
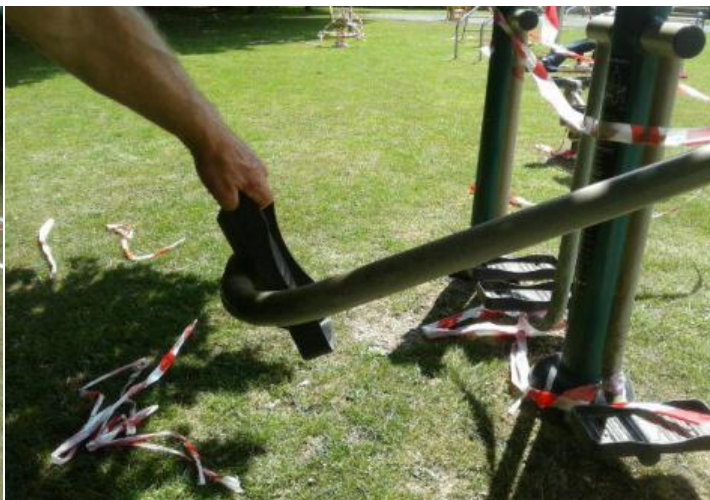
Finding: The swinging movement of the item exceeds the maximum 55 degrees from the vertical required by BS EN 16630 **Action:** Monitor - No remedial work recommended

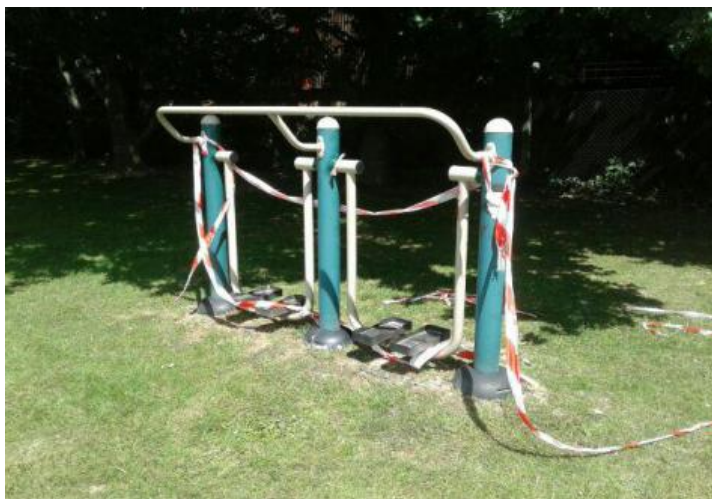
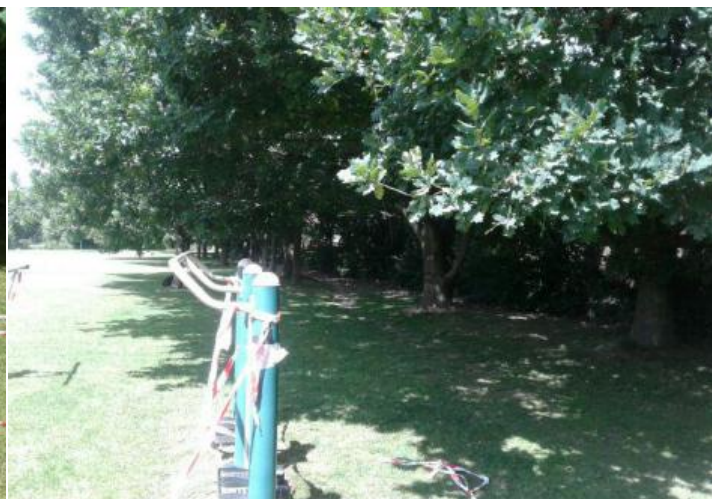
Finding: The tree canopy overhangs the equipment and is less than 2.0m away

Action: Lift tree canopy to ensure a minimum clearance of 2.0m from the equipment

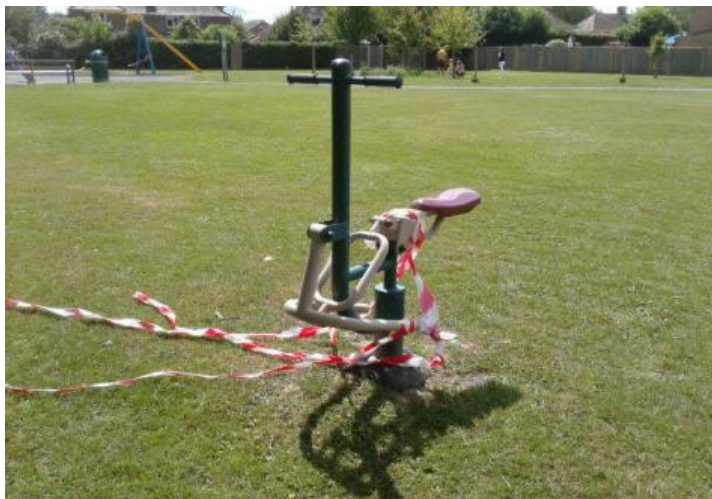
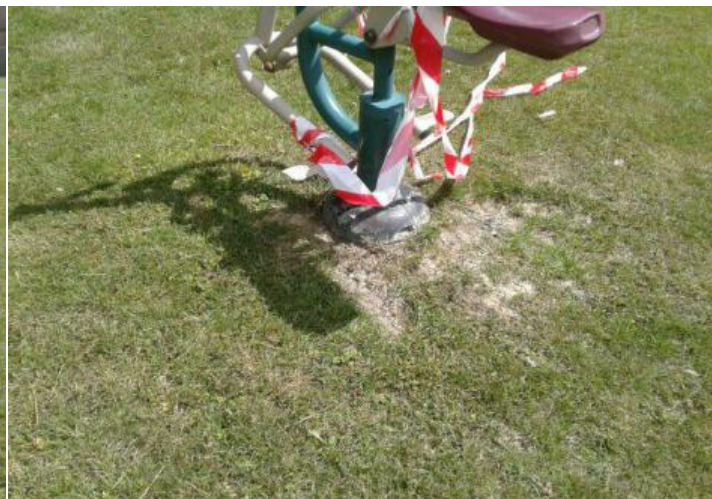
Finding: The item is slightly loose in its foundations

Action: Monitor for any further deterioration and repair as required

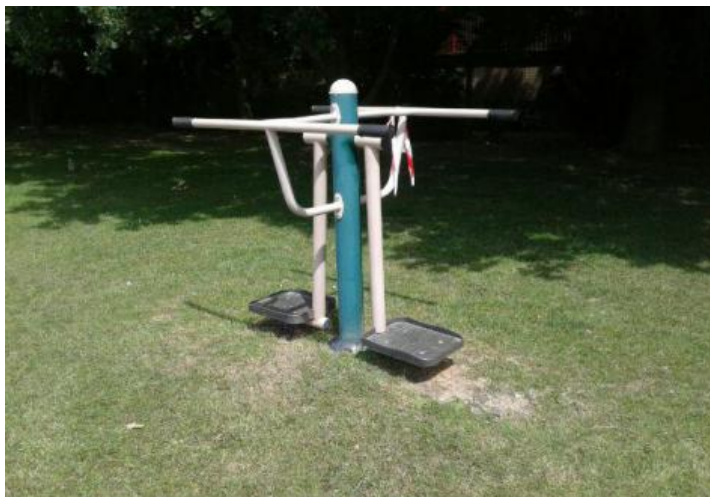
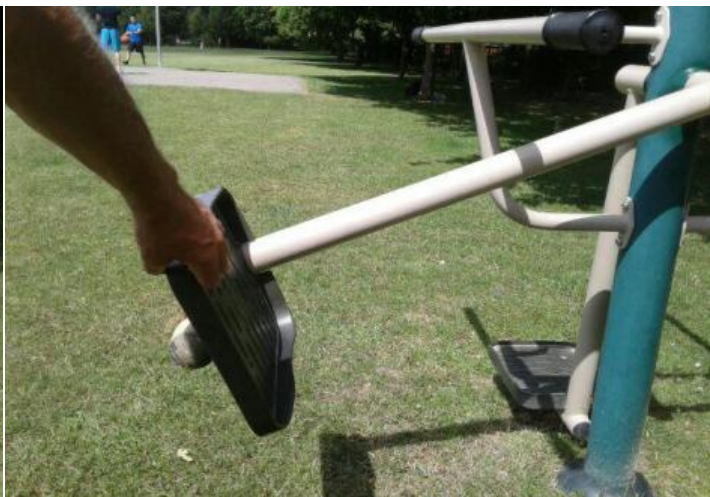
Finding: The swinging movement of the item exceeds the maximum 55 degrees from the vertical required by BS EN 16630

Action: Monitor - No remedial work recommended

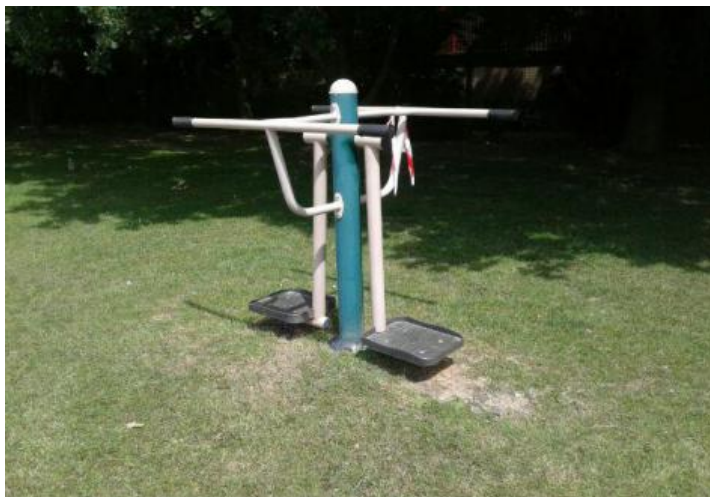
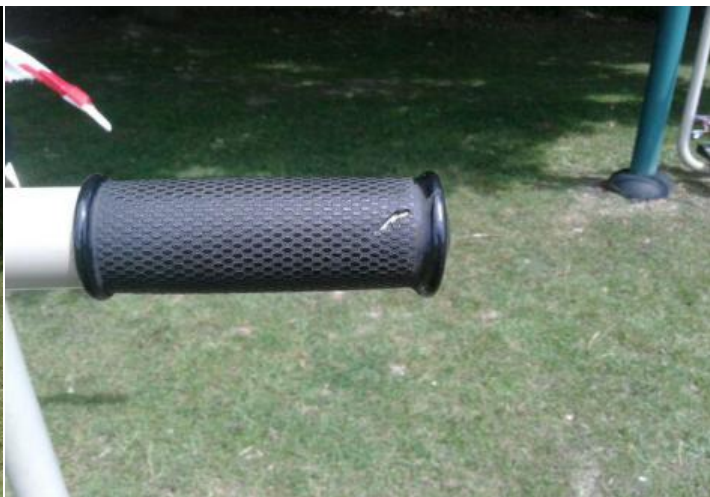
Finding: There is minor damage to the hand grips

Action: Monitor for any further damage and replace

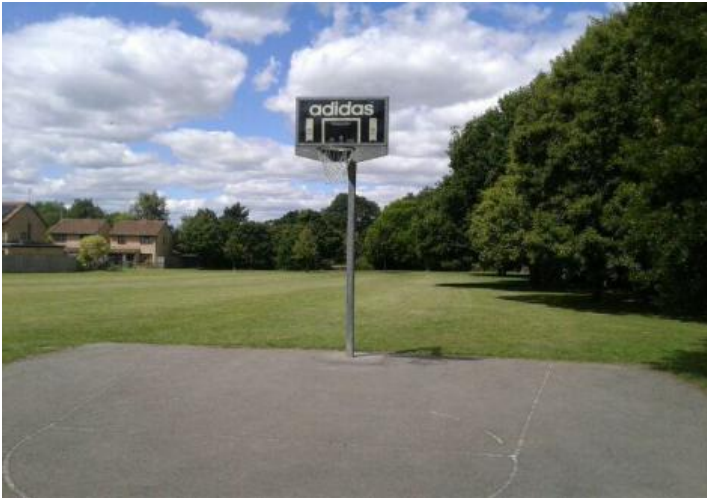
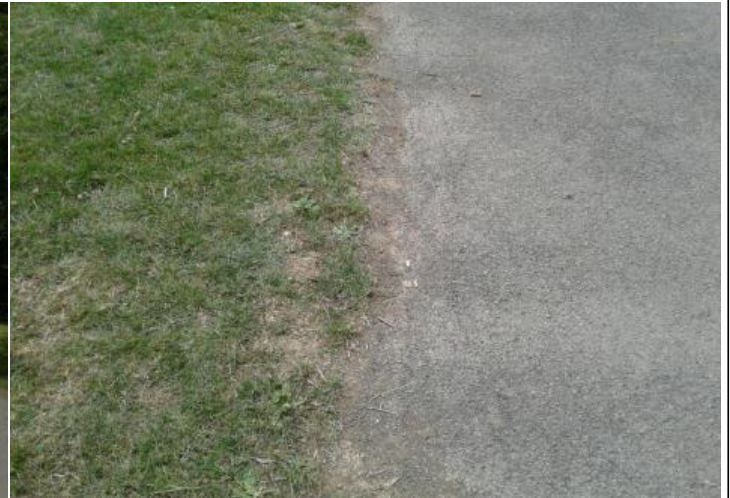
Finding: There are weeds/vegetation growth between or around the edges of the surfacing

Action: Remove weeds/vegetation growth
