the **play inspection** company

Annual Inspection

Broadbridge Heath Parish Council

Charrington Way Play Area

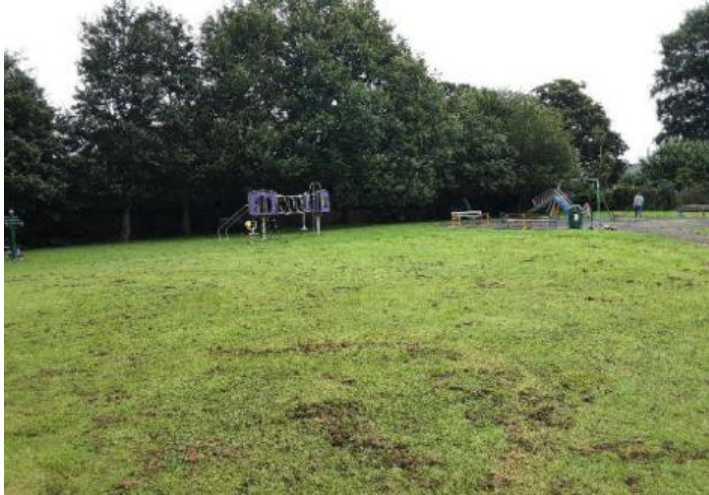
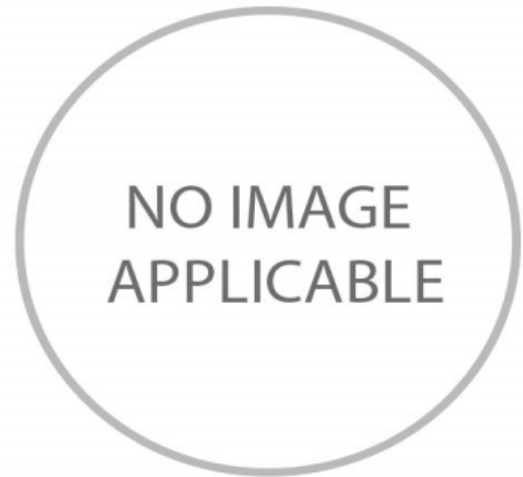
Finding: The site is accessible to the public during the COVID 19 pandemic. The government have released guidelines for safely re-opening these types of facilities which is available on the government website.

Action: Ensure there is an appropriate risk assessment in place and review regularly

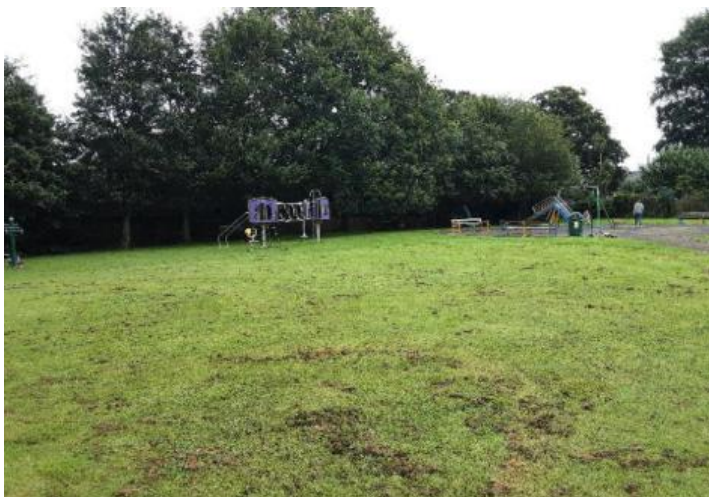
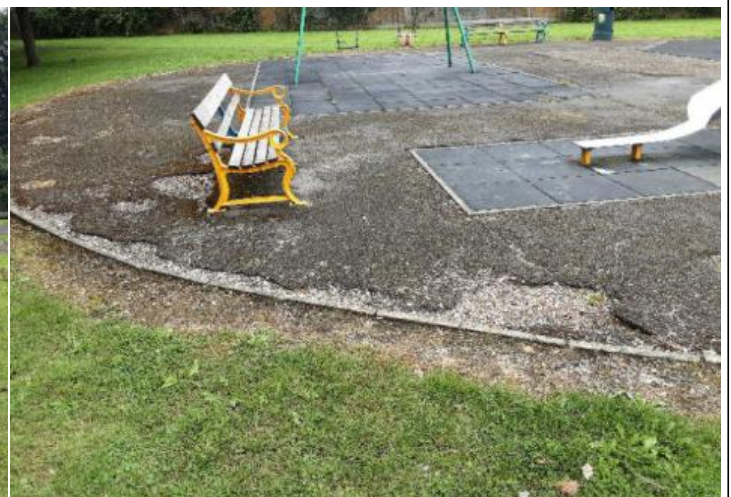
Finding: There is moderate damage to the surface

Action: Repair the damaged areas of surfacing

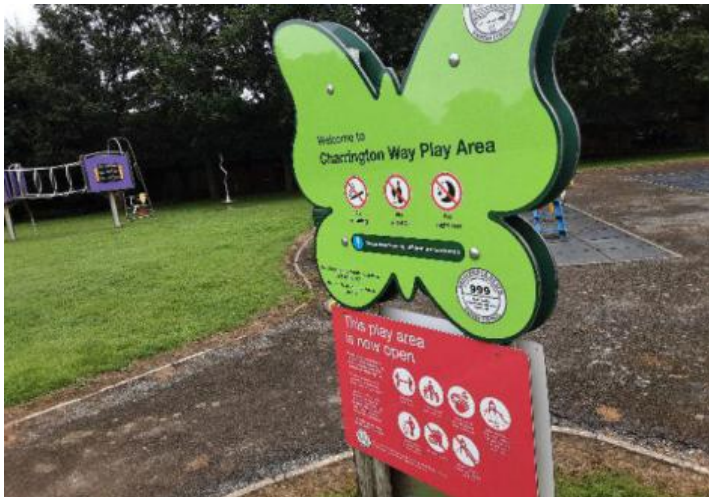
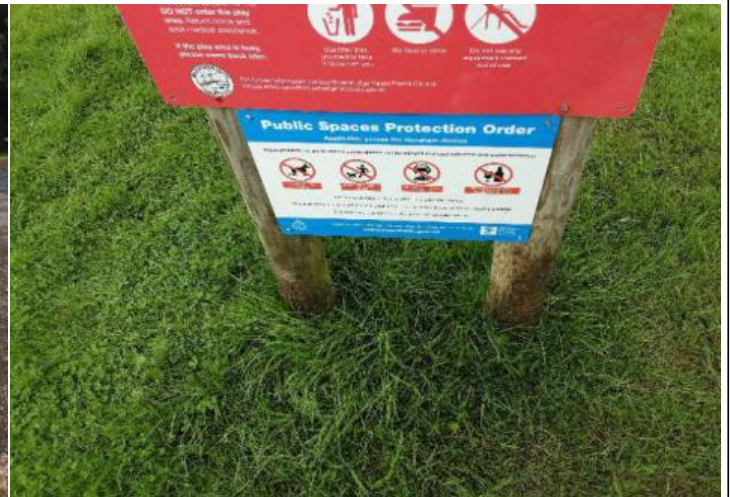
Finding: The item is slightly loose in its foundations

Action: Monitor for any further deterioration and repair as required

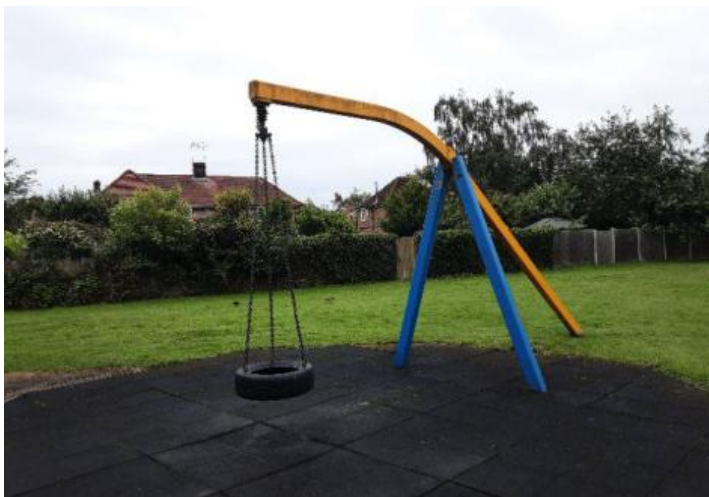
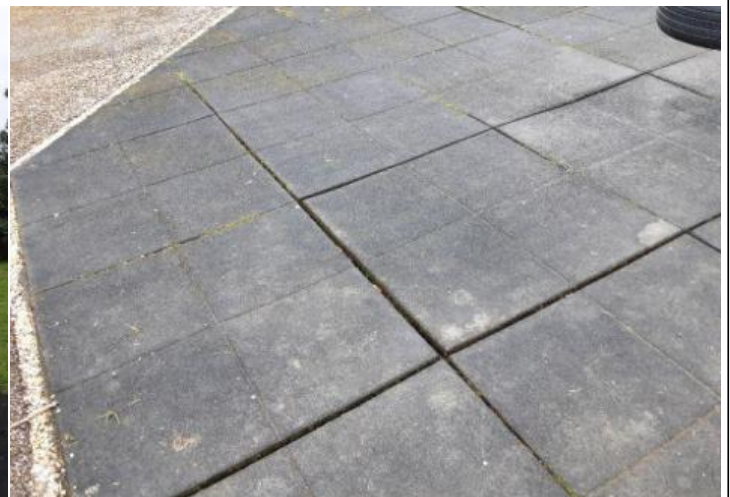
Finding: There are gaps opening in between the tiles

Action: Monitor for any further deterioration and repair as required

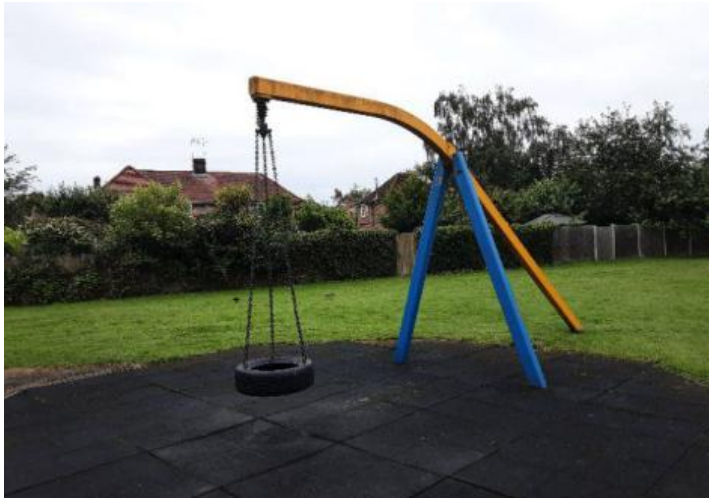
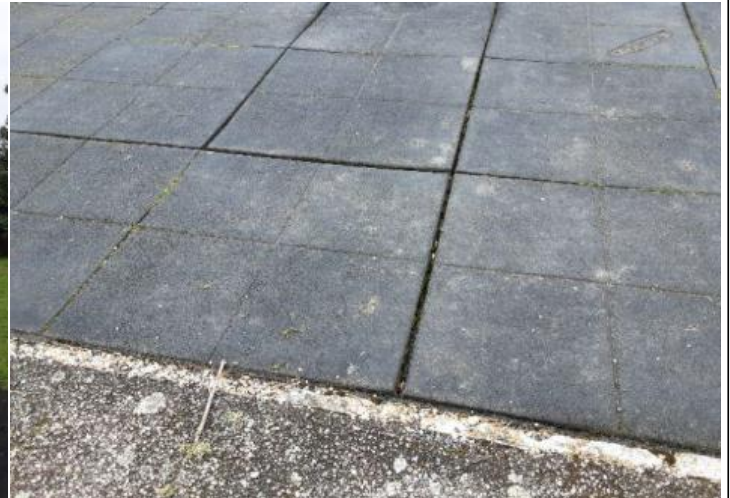
Finding: The tiles can easily be lifted or are lifting along the edges of the area
Action: Lift and re-glue tiles to secure

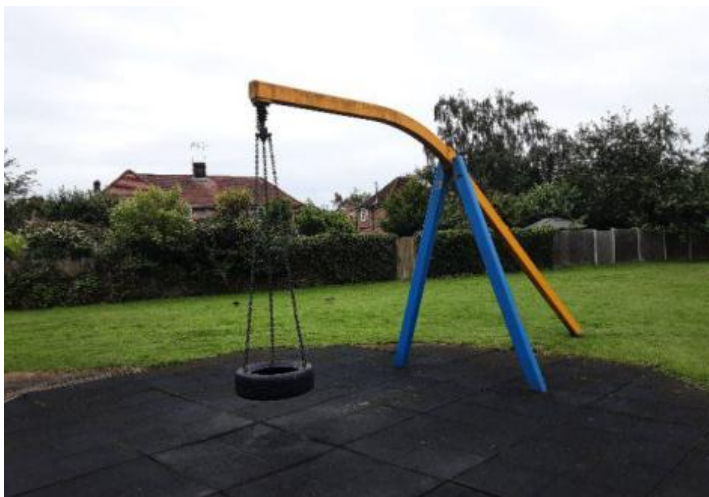
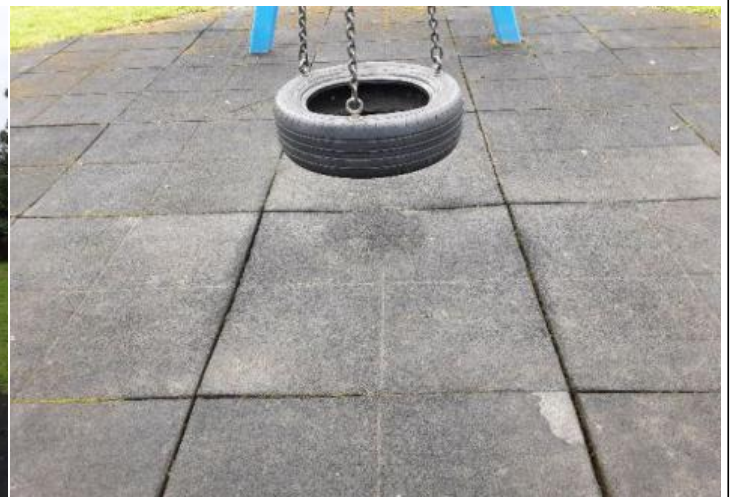
Finding: There is some minor damage to the surface
Action: Monitor for any further deterioration and repair as required

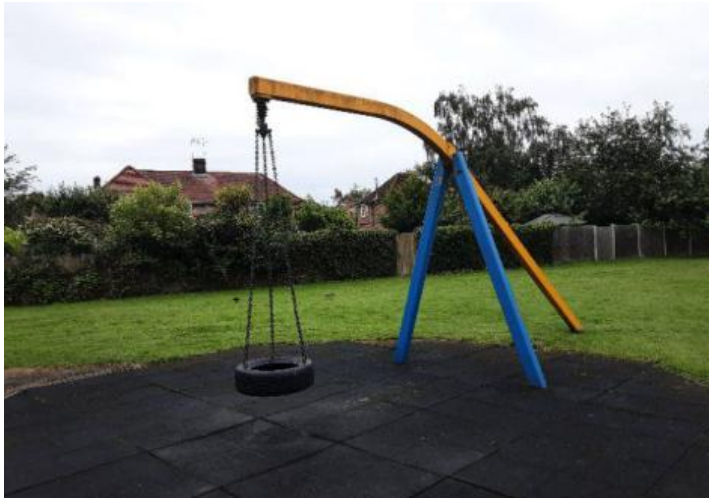
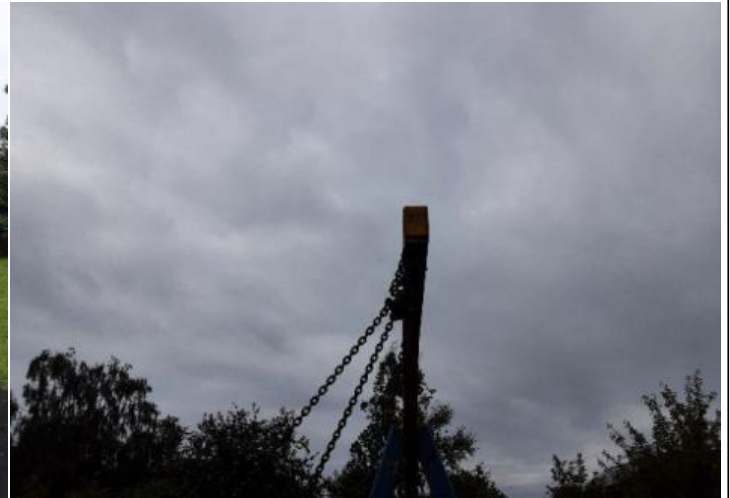
Finding: The gaiter is damaged

Action: Replace all affected components

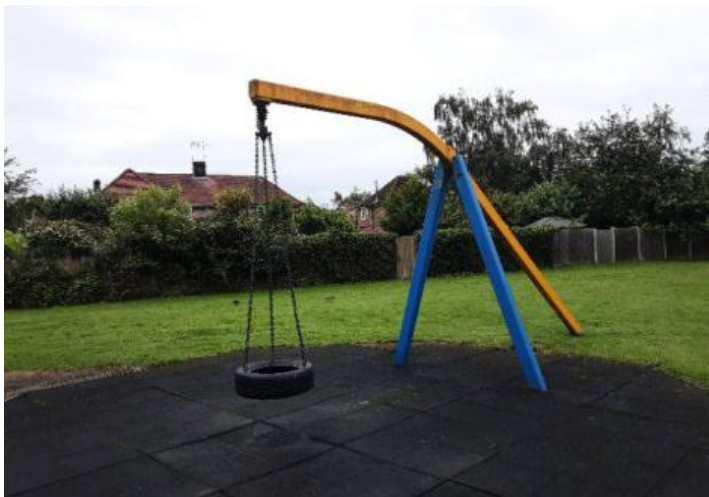
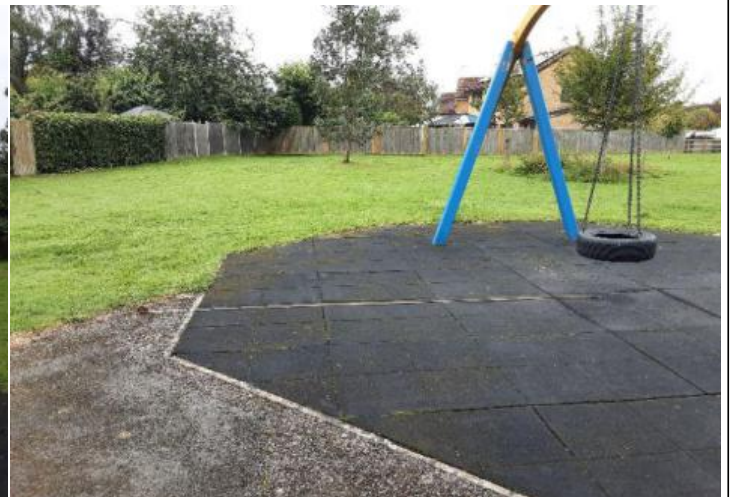
Finding: The surfacing dimensions are short and do not meet with the requirements of the current applicable standard

Action: Monitor - no remedial action recommended

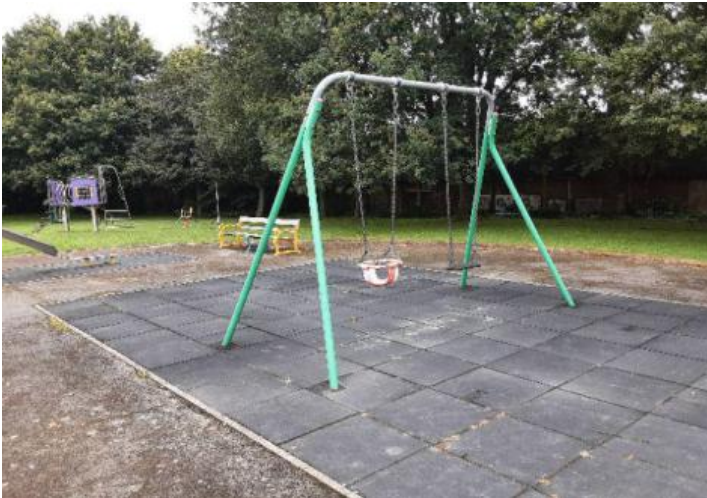
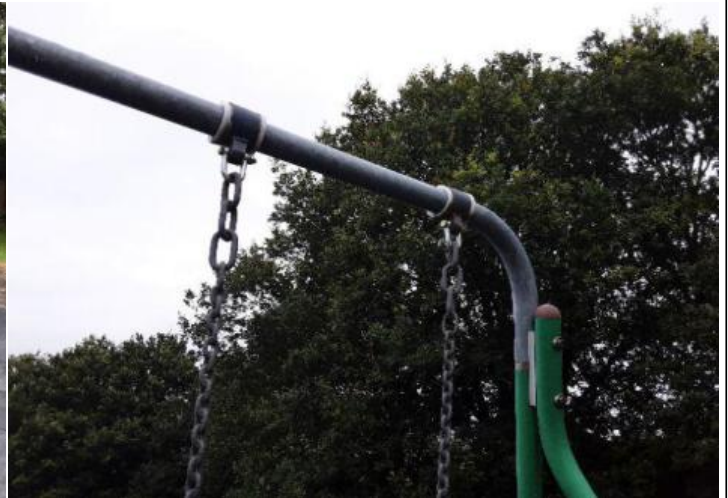
Finding: The shackles have been overtightened or seized transferring wear to the chain links below

Action: Loosen shackles to ensure free movement at the pivot

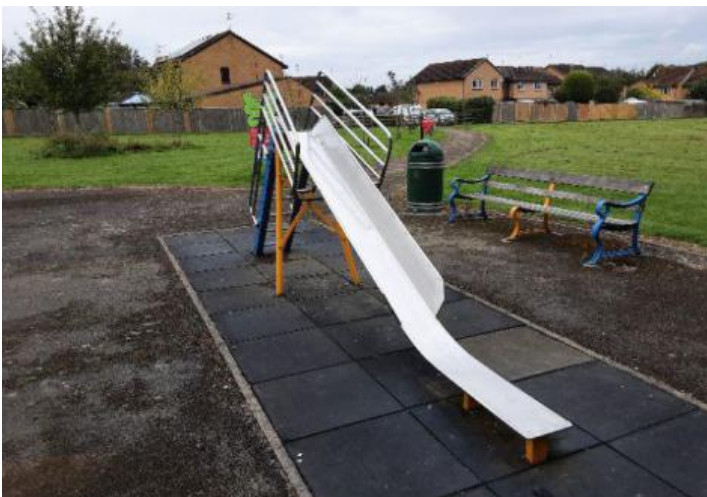
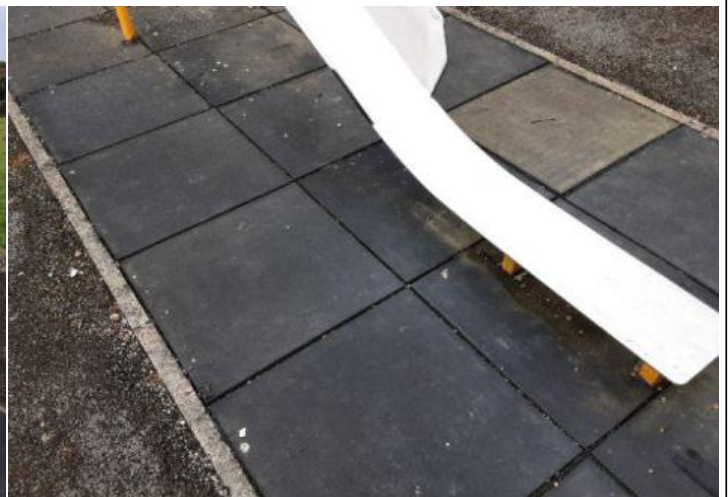
Finding: There are gaps opening in between the tiles

Action: Monitor for any further deterioration and repair as required

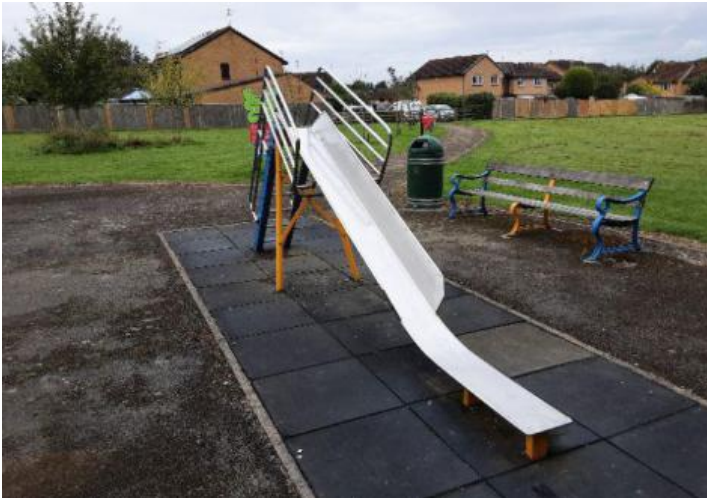
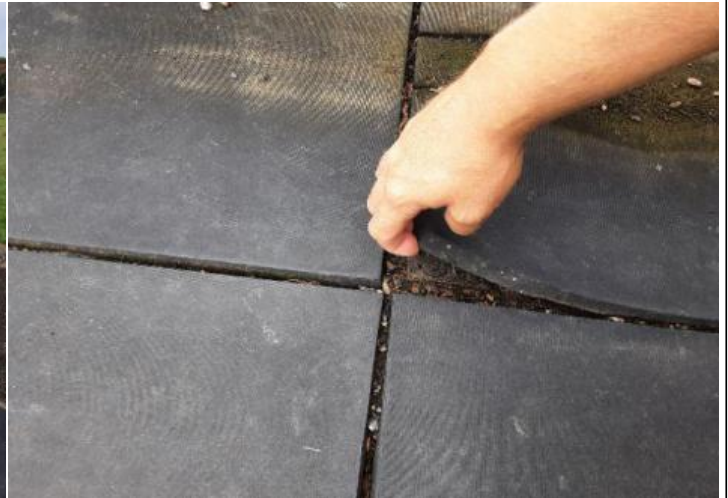
Finding: The tiles can easily be lifted or are lifting along the edges of the area
Action: Lift and re-glue tiles to secure

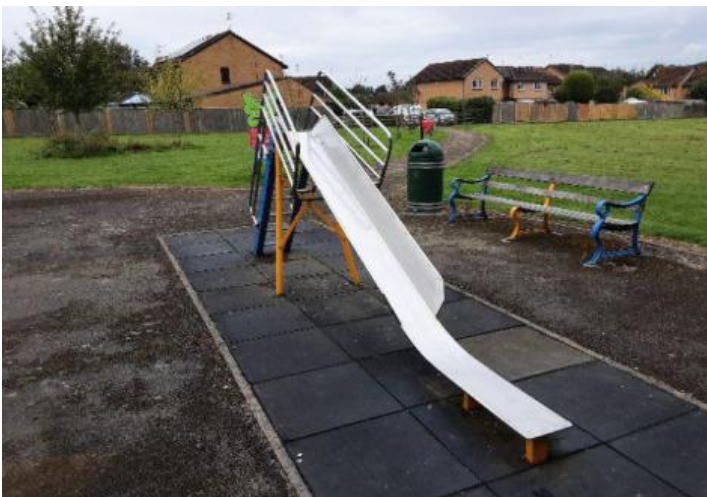
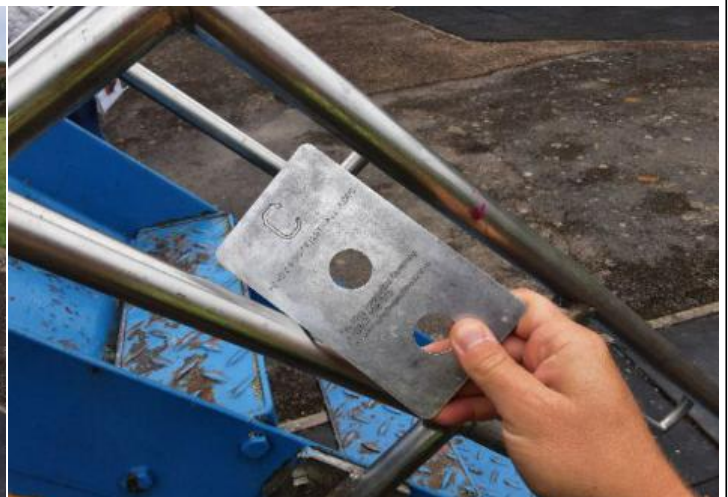
Finding: The item fails to meet the requirements of BS EN 1176 Part 1 4.2.7.2 head and neck entrapment in the barriers and/or steps
Action: Monitor - No remedial work recommended

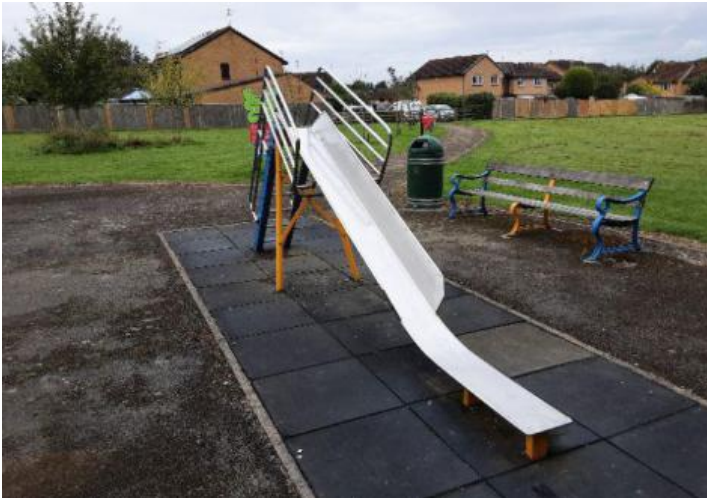
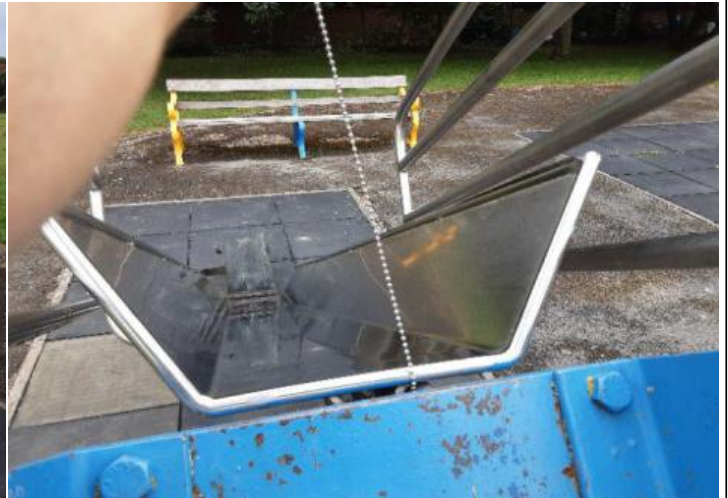
Finding: There is / are toggle entrapment/s present in contravention of the recommendations set out in BS EN 1176 Part 3

Action: Monitor - no remedial work recommended

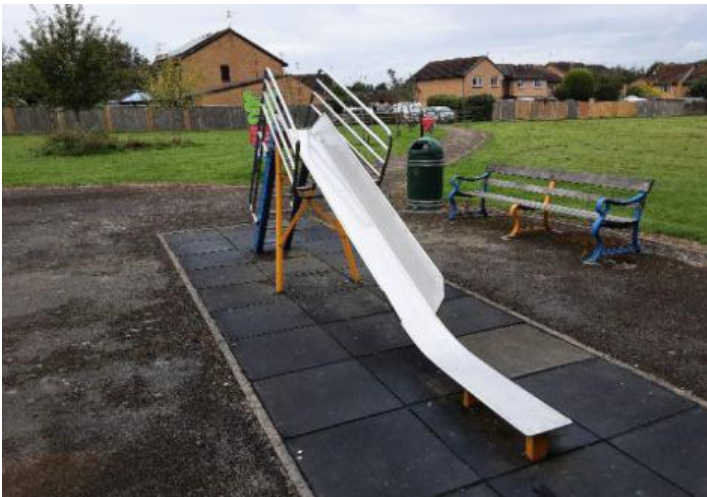
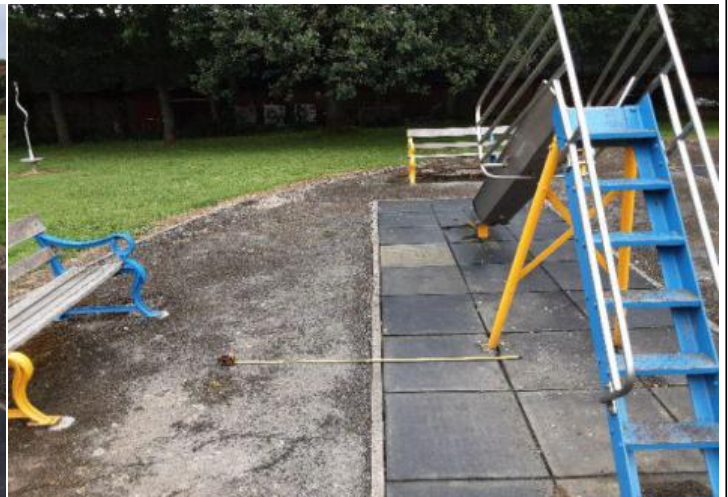
Finding: The surfacing dimensions are significantly short and do not meet with the requirements of the current applicable standard (1500mm required / 700mm provided)

Action: Extend surface area to comply

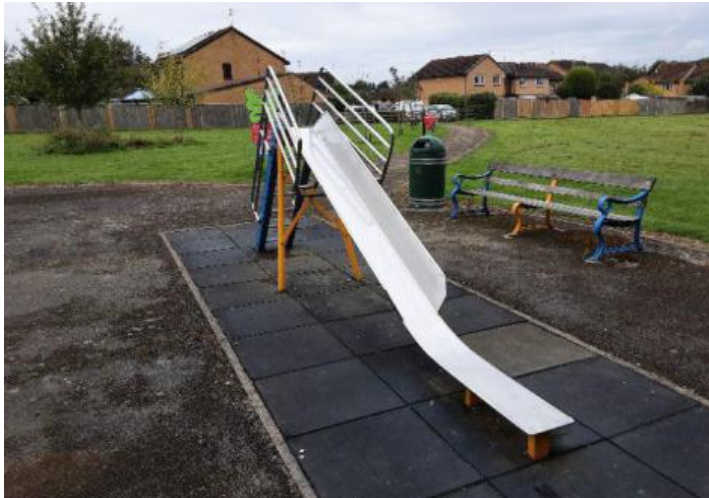
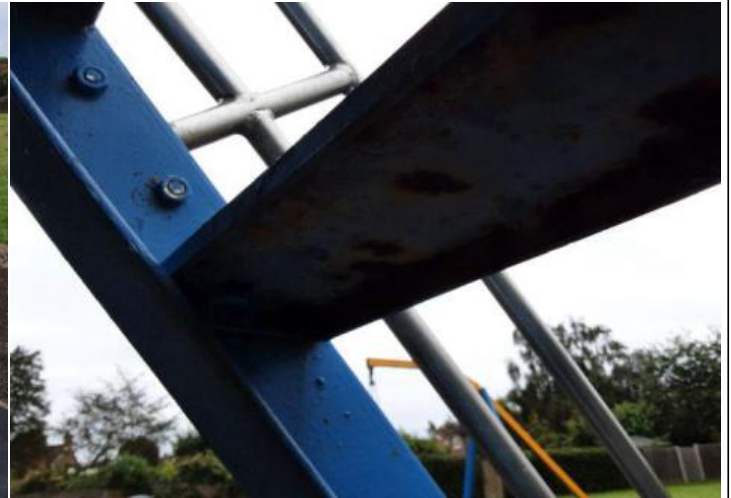
Finding: The paintwork on this item has been damaged or worn exposing the metal underneath which is rusting

Action: Treat any rusting components and repaint

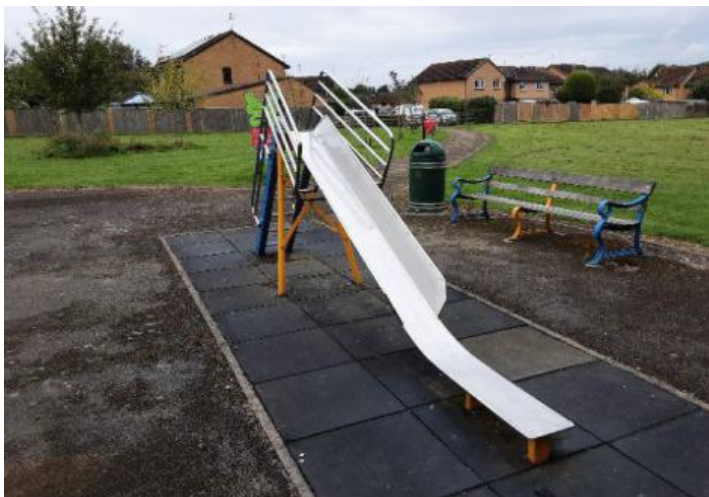
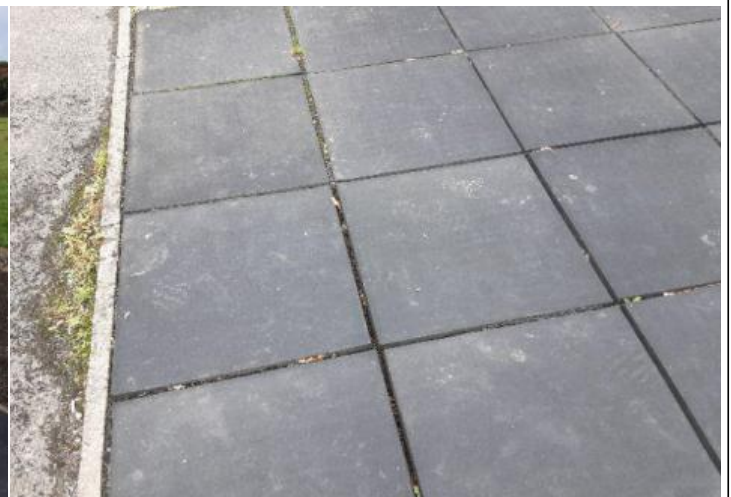
Finding: There are gaps opening in between the tiles

Action: Monitor for any further deterioration and repair as required

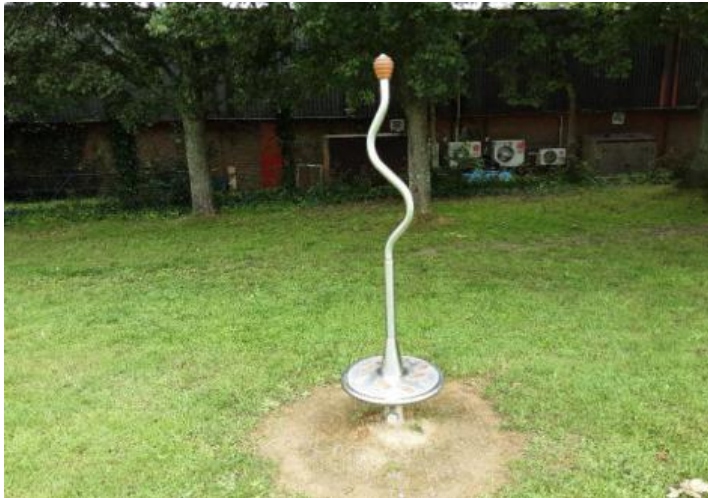
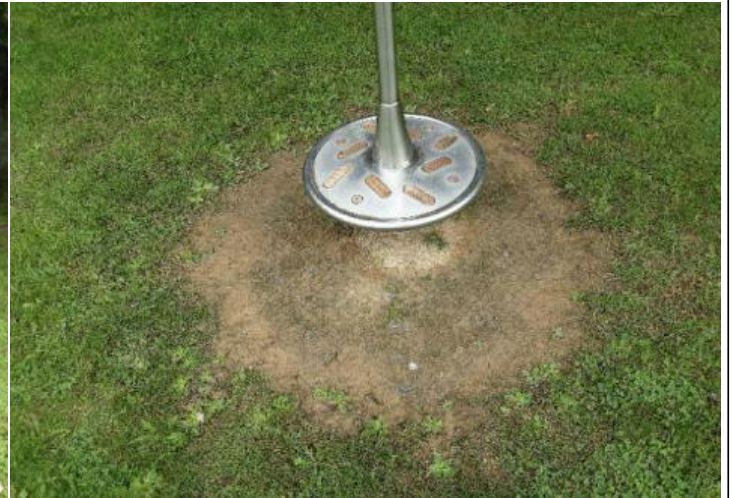
Finding: The grass mats are silted up and the soil is compacted; this may have an effect on the impact absorbing properties of the surface

Action: Consider HIC testing impact absorbing properties to ensure the correct surface qualities are maintained for the equipment and replace as required

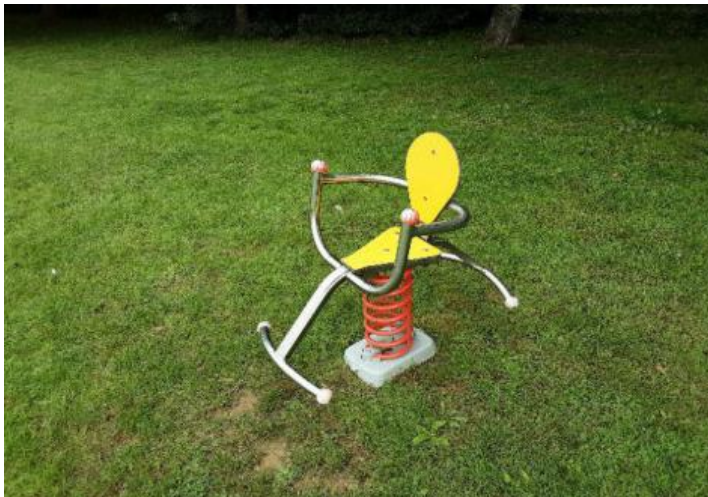
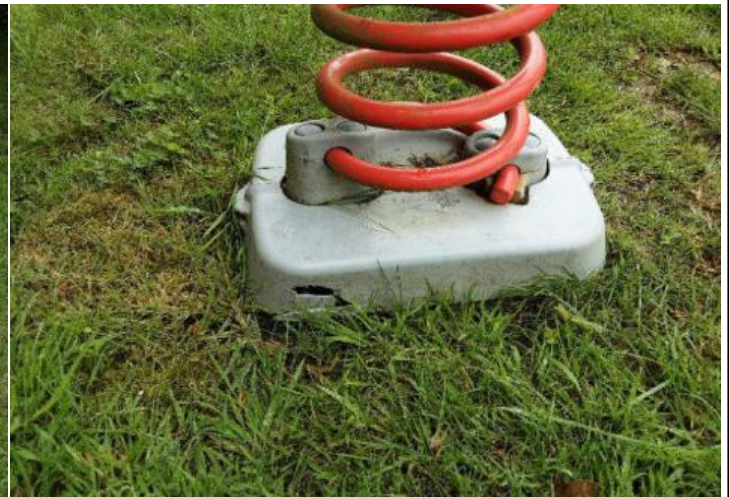
Finding: There is some damage to the spring base

Action: Repair or replace as required

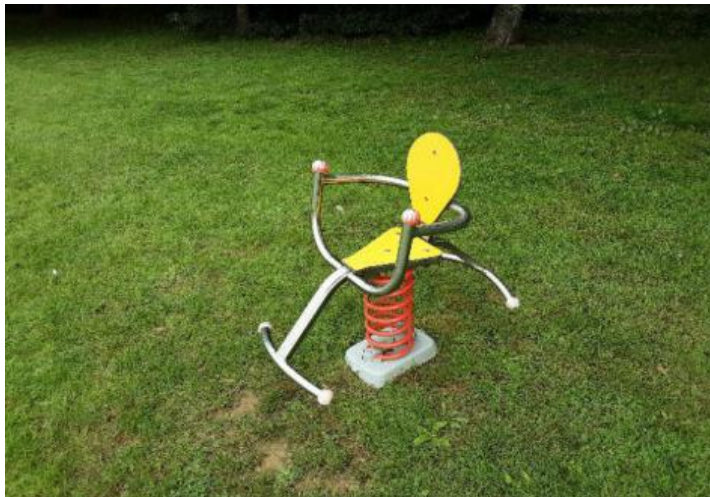
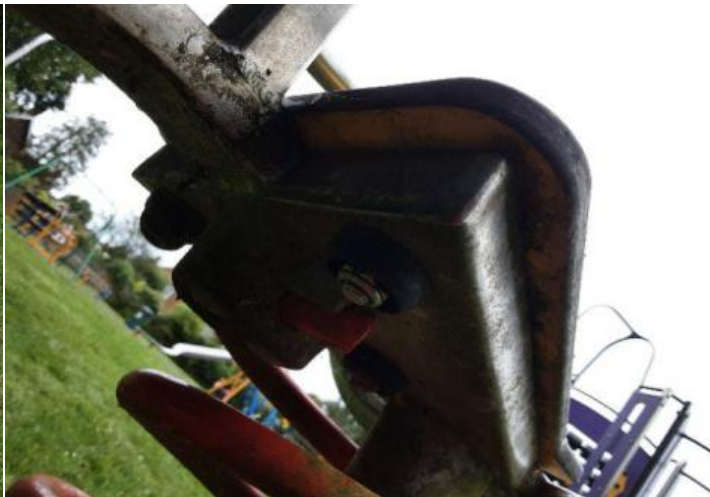
Finding: There is/are bolt cap covers missing or damaged on the item

Action: Replace missing or damaged bolt cap covers

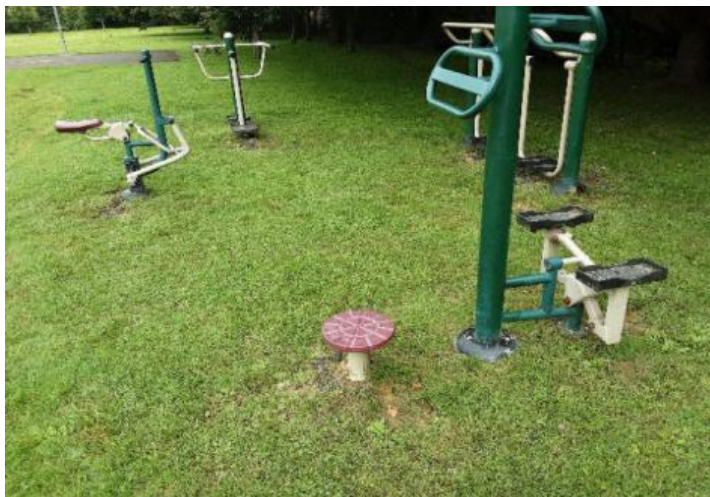
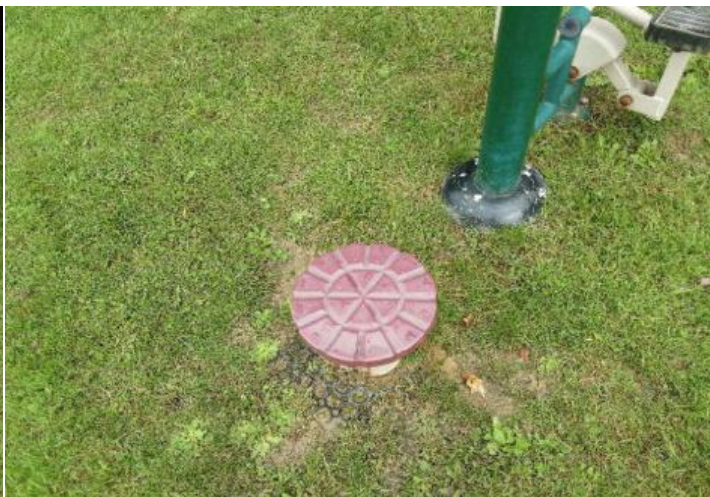
Finding: The deflection of the rotating user station exceeds the maximum 105 degrees required by BS EN 16630

Action: Monitor - No remedial work recommended

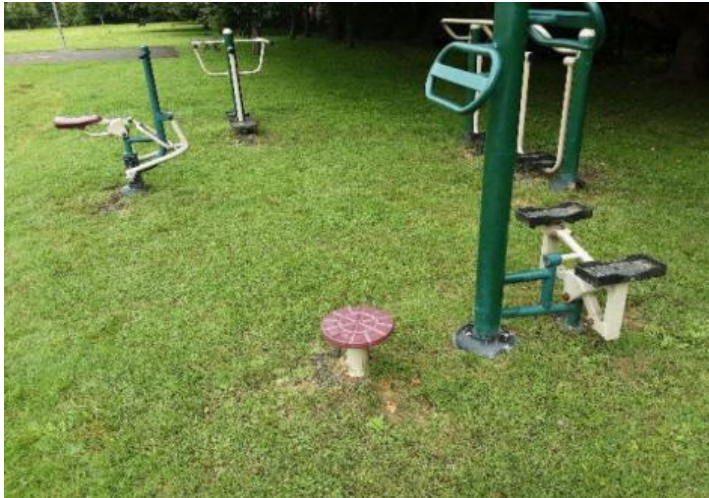
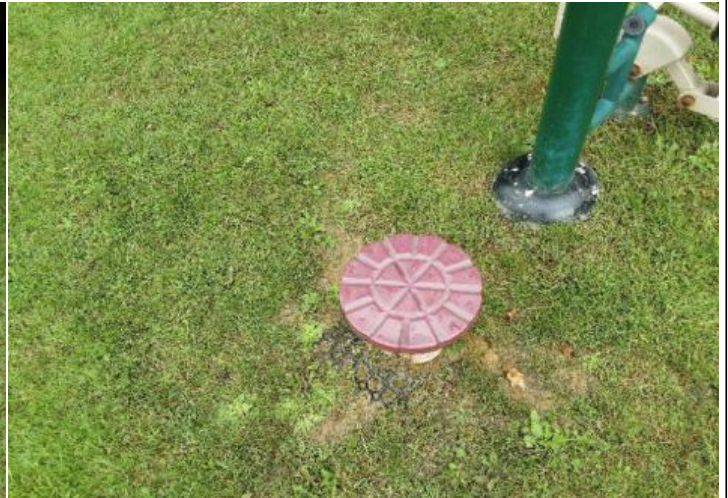
Finding: The rotating user station is not appropriately marked with a guideline of user direction and/or the original position as required by BS EN 16630

Action: Monitor - No remedial work recommended

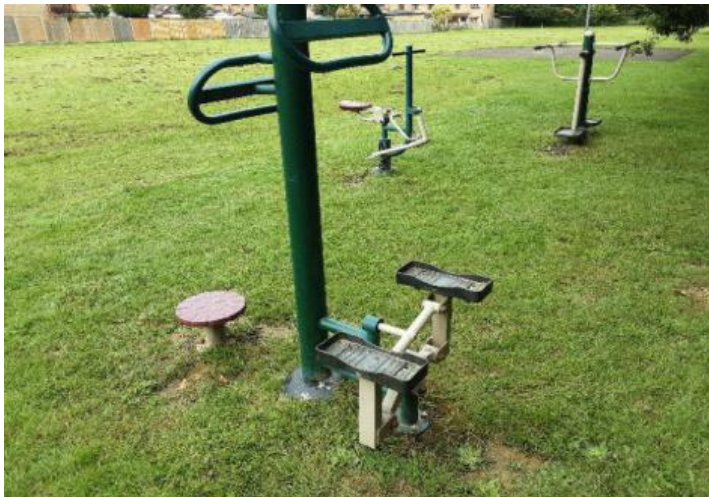
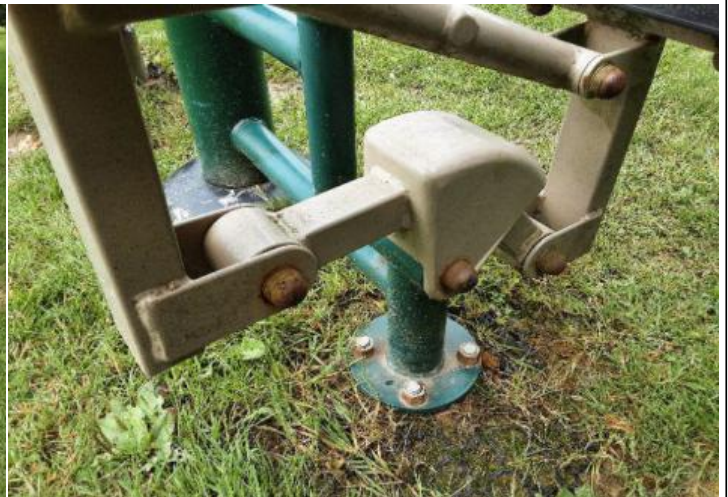
Finding: The bushes are showing signs of wear

Action: Monitor for any further deterioration and replace as required

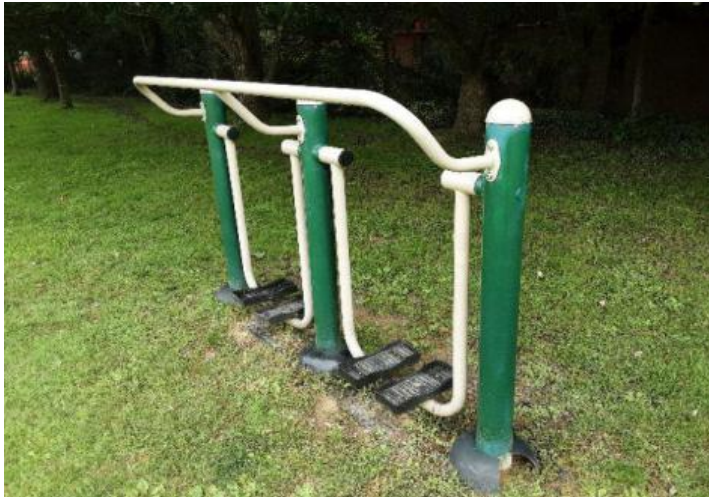
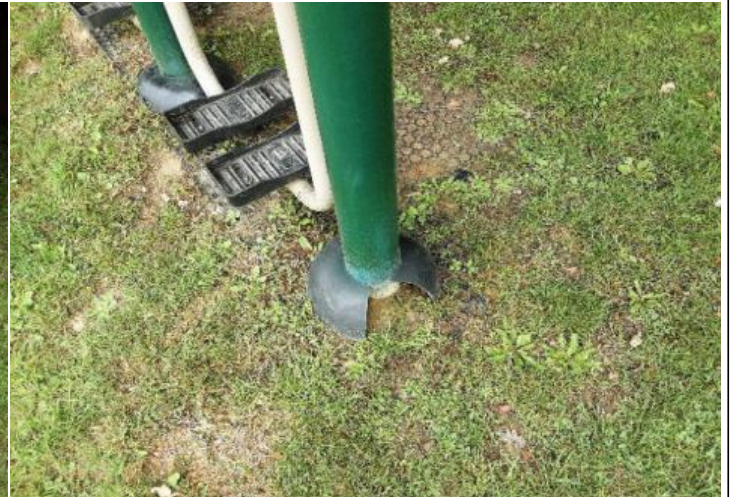
Finding: One of the post ground covers has been damaged **Action:** Replace all affected components

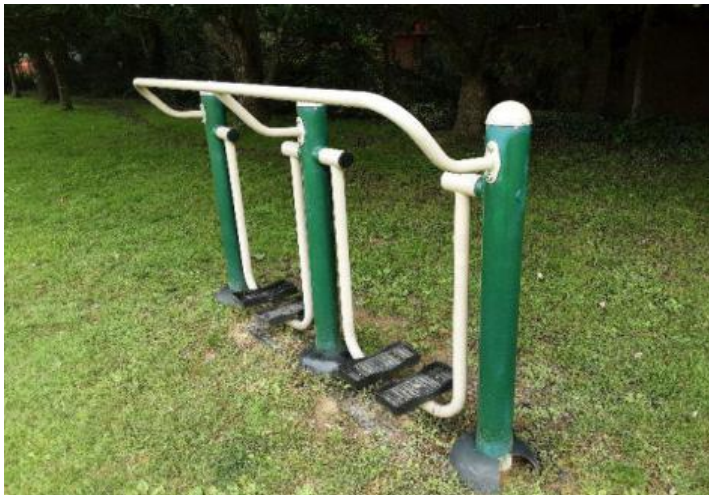
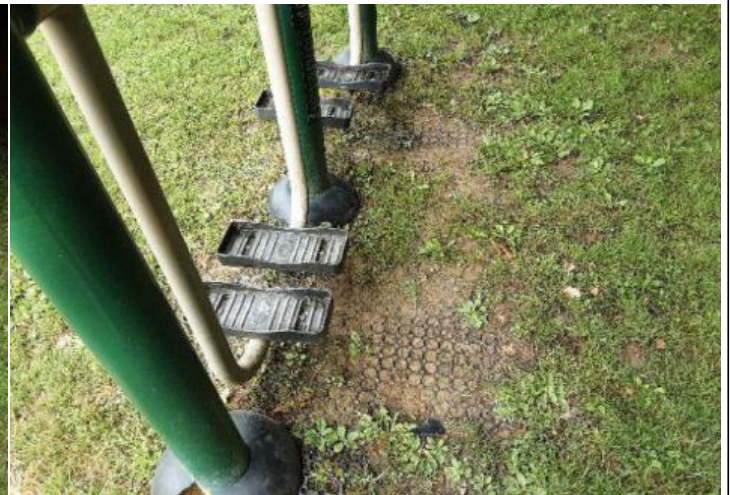
Finding: The grass mats are silted up, the soil is compacted and the area will become very slippery when the soil is wet. **Action:** Reinststate as required

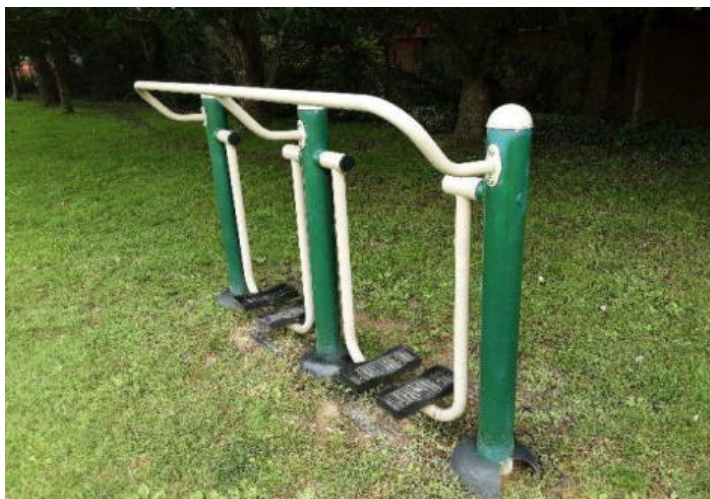
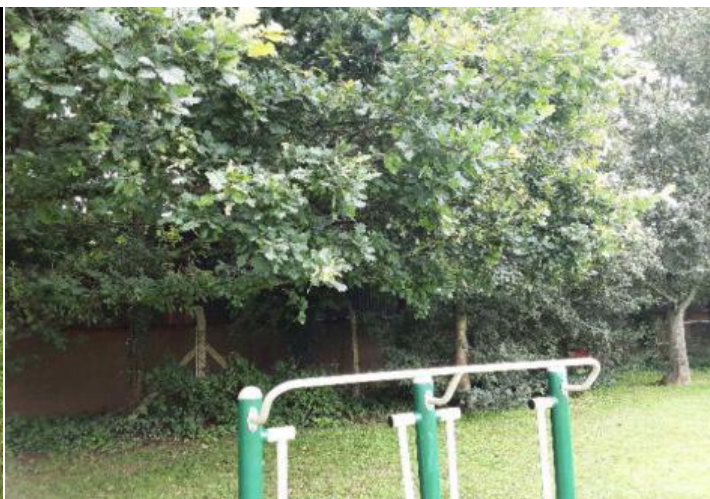
Finding: The tree canopy overhangs the equipment and is less than 2.0m away

Action: Lift tree canopy to ensure a minimum clearance of 2.0m from the equipment

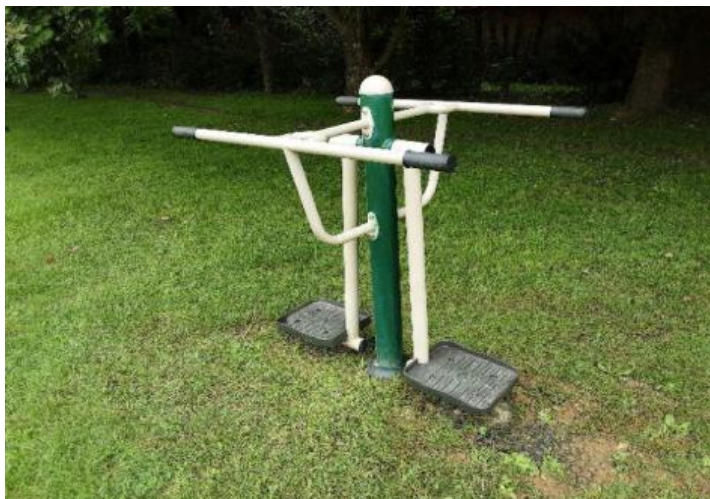
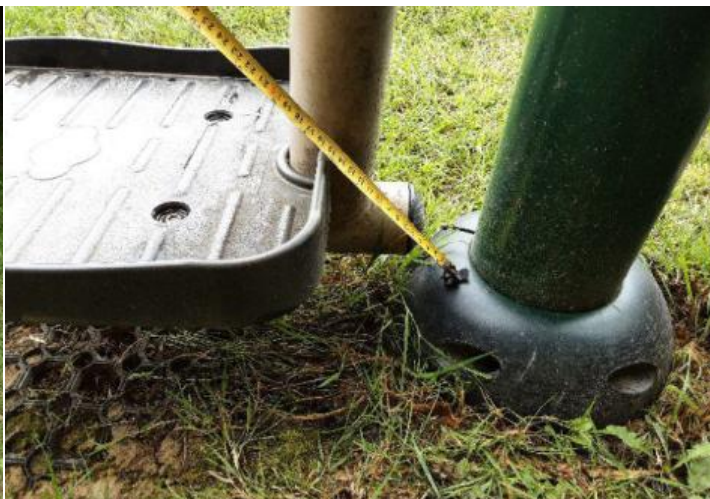
Finding: There are gaps between 8 and 60mm creating a potential crush/shear point in contravention of the requirements of BS EN 16630

Action: Monitor - No remedial work recommended

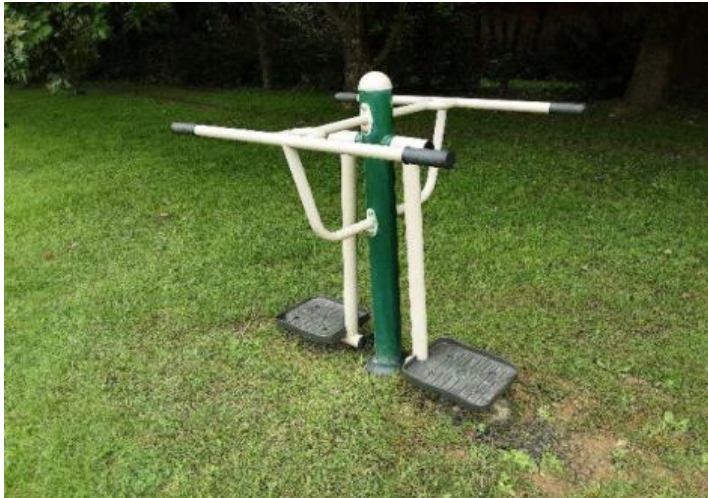
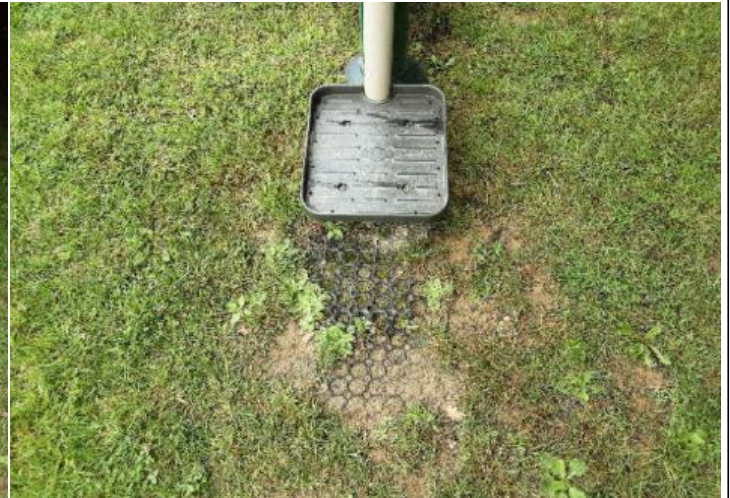
Finding: There is some minor damage to the surface

Action: Monitor for any further deterioration and repair as required

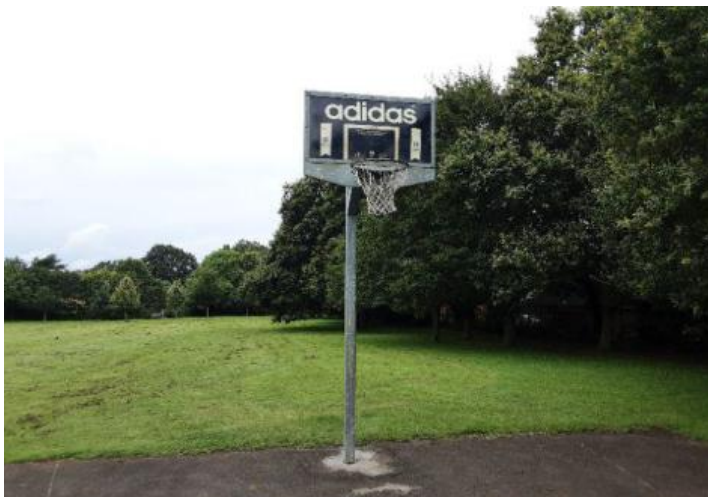
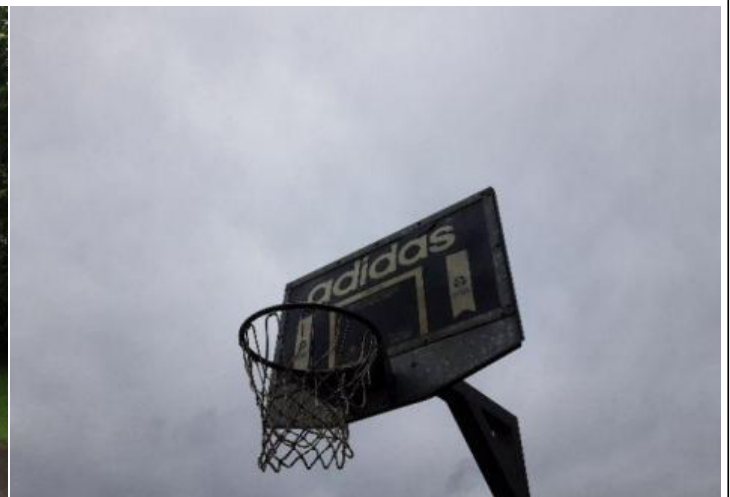
Finding: There is some damage to the backboard

Action: Replace all affected components
