Annual Inspection

Broadbridge Heath Parish Council

The Common

Inspection Ref: 1430778

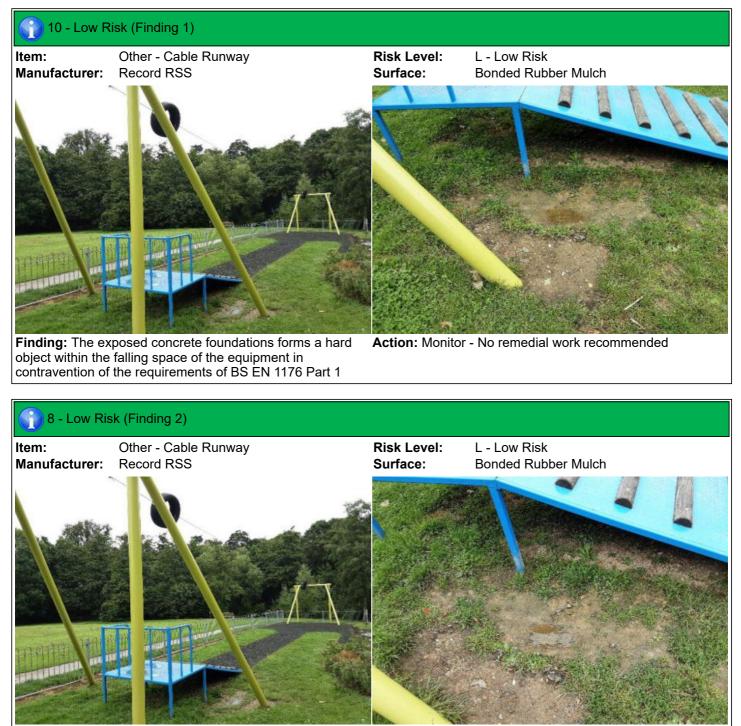
Finding: The area around the item has eroded and may become slippery

Action: Reinstate eroded area

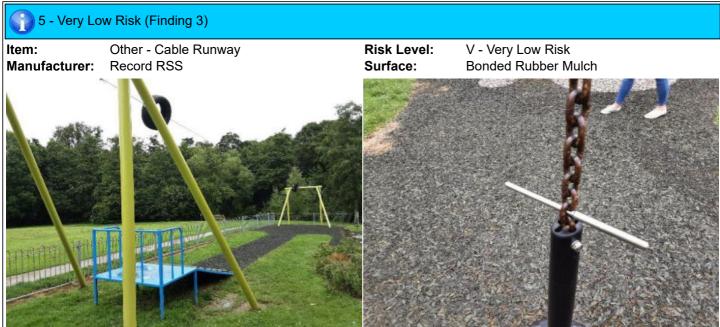
Finding: The chain openings are in excess of the 8.6mm as Action: Monitor - No remedial work recommended recommended by BS EN 1176

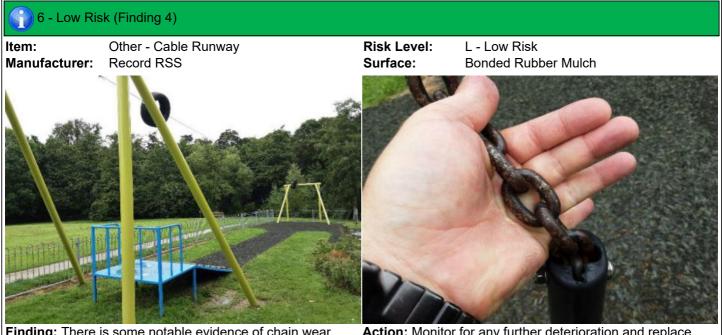
Finding: There is some notable evidence of chain wear

Action: Monitor for any further deterioration and replace when 40% worn

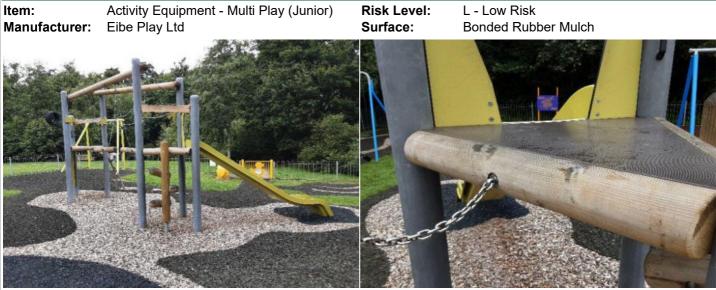
😭 6 - Low Risk (Finding 1)

Finding: A number of fixing(s) have worked loose

Action: Secure all loose fixings
