the play inspection company

Annual Inspection

Broadbridge Heath Parish Council

The Common

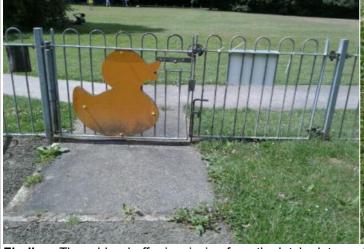
6 - Low Risk (Finding 3)

Finding: The rubber buffer is missing from the latch plate

Action: Replace rubber buffer

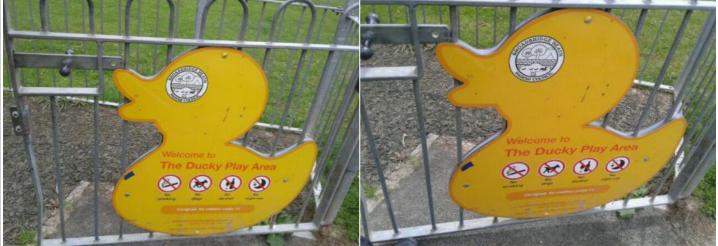
5 - Very Low Risk (Finding 1)

Finding: BS EN 1176 Part 7 recommends that signage shall **Action:** Provide additional information include the site name / address

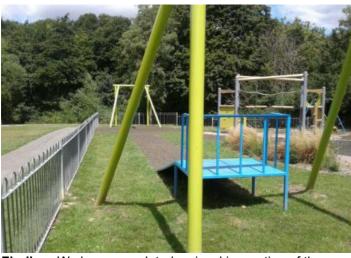
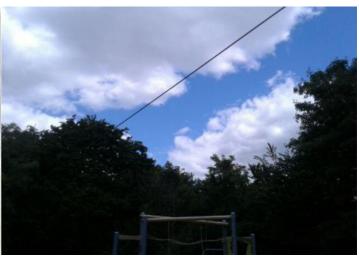
0 - Risk Assessment not Undertaken (Finding 1)

Finding: We have completed a visual inspection of the cable and fixing points from ground level, however it is not possible to fully inspect the cable and fixings without either hiring equipment to gain access or removing the cable and inspecting at ground level. We recommend that the main cable and fixing security is thoroughly inspected at least in accordance with the manufacturers recommendations to check for damage, security or internal rusting, this will help to ensure the continued safe use of the equipment

Action: Inspect in accordance with the manufacturers recommendations

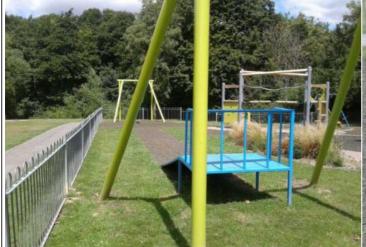
The height of the seat is less than 350mm when loaded and does not meet the requirements of BS EN 1176 Part 4 -Ensure the seat is a minimum of 350mm above ground level when loaded with 69.5kg

Action: Ensure the seat is a minimum of 350mm above

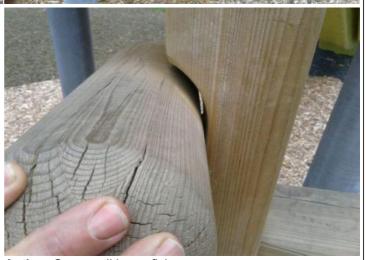
Finding: A number of fixing(s) have worked loose on the ladder climb presenting the user with an unpredictable movement

Action: Secure all loose fixings
