Annual Inspection

Broadbridge Heath Parish Council

Singleton Road

Inspection Ref: 1140100

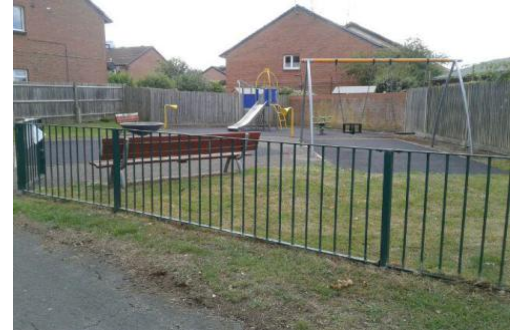
Item: Site General
Manufacturer: Owner/Operator
Surface Type: N/A
Item Quantity: 1
Equipment Compliance: N/A
Surface Area Compliance: N/A

There are gaps opening between the surfacing and the edging surround or between the joints in the surfacing - Monitor for any further deterioration and repair as required

There are trip hazards present - Reinstate surrounding surfaces to level to remove the trip points

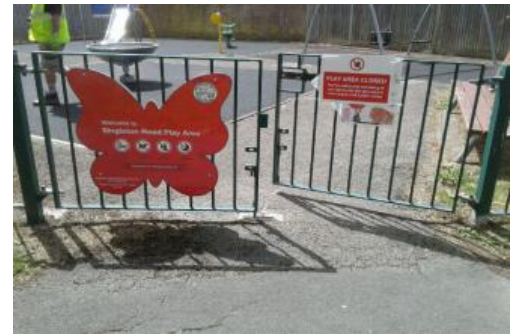
Item: Gate - Combination
Manufacturer: Owner/Operator
Surface Type: N/A
Item Quantity: 1
Equipment Compliance: N/A
Surface Area Compliance: N/A

This item is satisfactory - no work required -

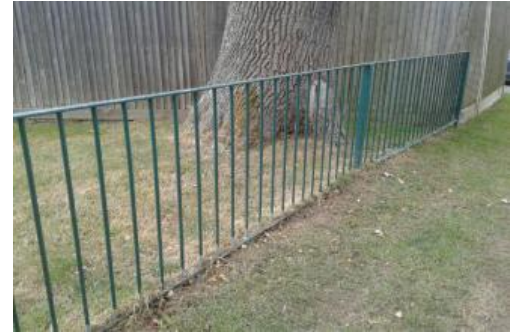
Item: Fencing - Flat Top
Manufacturer: Owner/Operator
Surface Type: N/A
Item Quantity: 1
Equipment Compliance: N/A
Surface Area Compliance: N/A

This item is satisfactory - no work required -

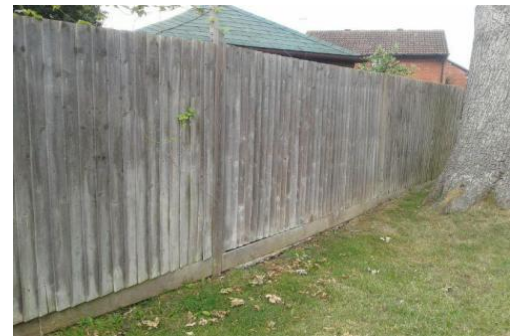
Item: Fencing - Timber
Manufacturer: Owner/Operator
Surface Type: N/A
Item Quantity: 1
Equipment Compliance: N/A
Surface Area Compliance: N/A

There is some evidence of rot in the timber posts - Monitor for any further deterioration and replace as required

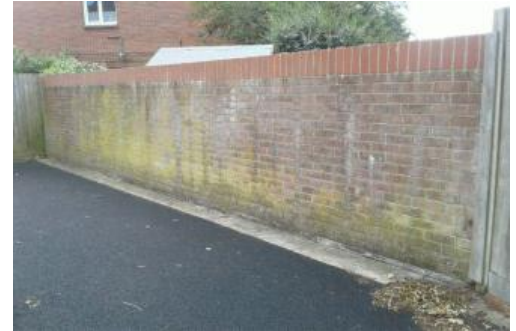
Item: Brick Wall
Manufacturer: Owner/Operator
Surface Type: N/A
Item Quantity: 1
Equipment Compliance: N/A
Surface Area Compliance: N/A

This item is satisfactory - no work required -

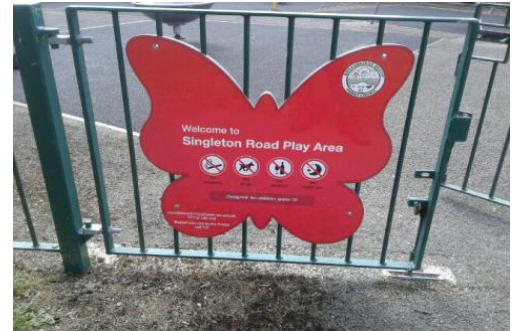
Item: Sign
Manufacturer: Owner/Operator
Surface Type: N/A
Item Quantity: 1
Equipment Compliance: N/A
Surface Area Compliance: N/A

BS EN 1176 Part 7 recommends that signage shall include the site name / address - Provide additional information

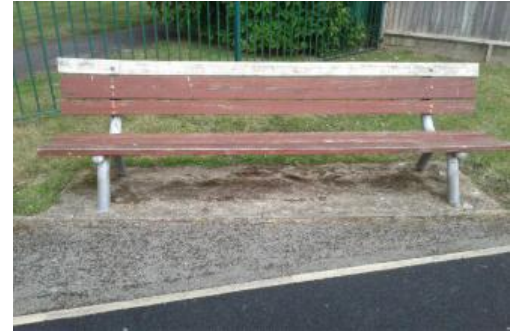
Item: Bench
Manufacturer: Owner/Operator
Surface Type: N/A
Item Quantity: 3
Equipment Compliance: N/A
Surface Area Compliance: N/A

This item is satisfactory - no work required -

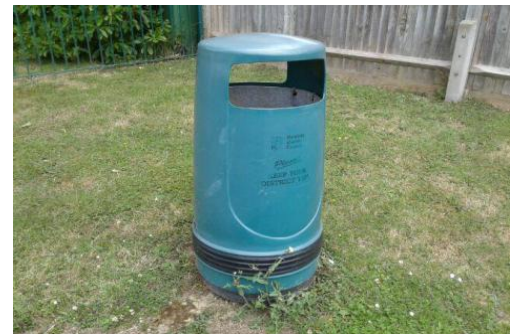
Item: Litter Bin
Manufacturer: Owner/Operator
Surface Type: N/A
Item Quantity: 1
Equipment Compliance: N/A
Surface Area Compliance: N/A

The bin is not securely fixed to the surface and there is some possibility of the item tipping or rolling over - Secure the bin to the ground

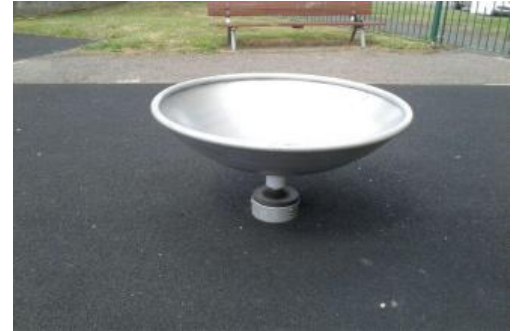
Item: Dish Roundabout
Manufacturer: Hags
Surface Type: Wet Pour
Item Part Number:
Surface Nominal Depth: 70mm
Item Quantity: 1
Equipment Compliance: Yes
Surface Area Compliance: Yes
Total Findings: 1

This item is satisfactory - no work required -

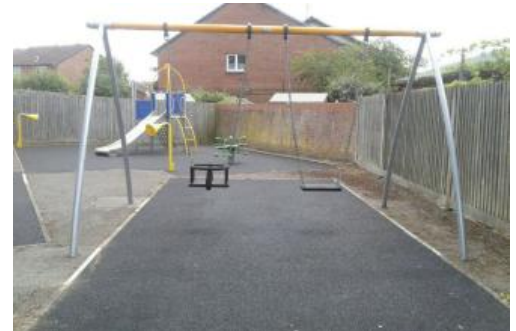
Item: 1 Bay Mixed Seat, 1 Cradle, 1 Flat
Manufacturer: Hags
Surface Type: Wet Pour
Surface Nominal Depth: 60mm
Item Quantity: 1
Equipment Compliance: Yes
Surface Area Compliance: Yes
Total Findings: 1

This item is satisfactory - no work required -

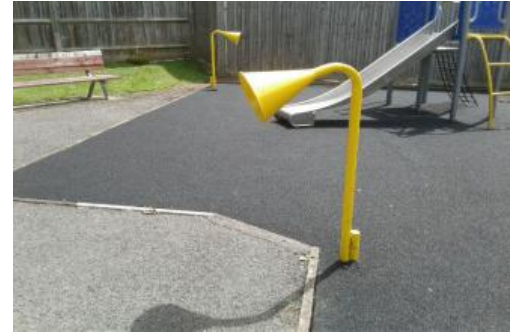
Item: Talk Tubes
Manufacturer: Not Identified
Surface Type: Wet Pour
Item Quantity: 1
Equipment Compliance: Yes
Surface Area Compliance: Yes

This item is satisfactory - no work required -

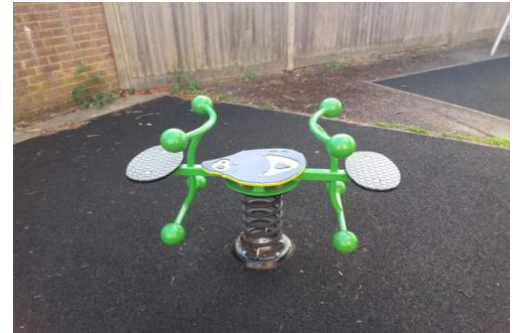
Item: Spring See-Saw
Manufacturer: Hags
Surface Type: Wet Pour
Surface Nominal Depth: 45mm
Item Quantity: 1
Equipment Compliance: No
Surface Area Compliance: Yes
Total Findings: 1

The talk tube forms a hard object within the impact area of the equipment in contravention of the requirements of BS EN 1176 Part 1 - Monitor - No remedial work recommended

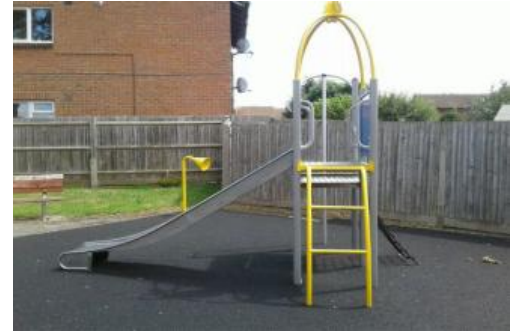
Item: Multi Play (Junior)
Manufacturer: Hags
Surface Type: Wet Pour
Item Part Number:
Surface Nominal Depth: 50mm
Item Quantity: 1
Equipment Compliance: Yes
Surface Area Compliance: Yes
Total Findings: 1

This item is satisfactory - no work required -

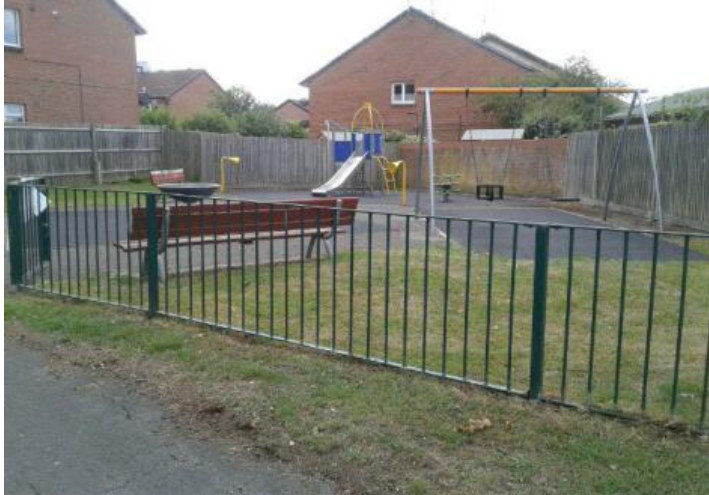
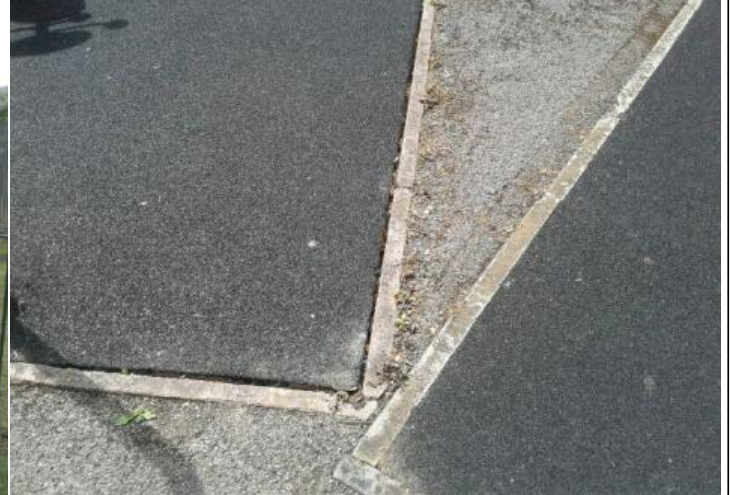
Item: Ancillary Items - Site General
Manufacturer: Owner/Operator

Finding: There are gaps opening between the surfacing and the edging surround or between the joints in the surfacing
Action: Monitor for any further deterioration and repair as required

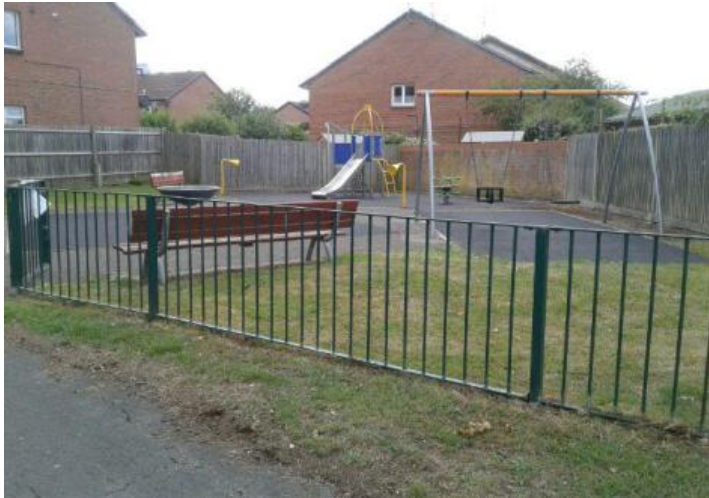
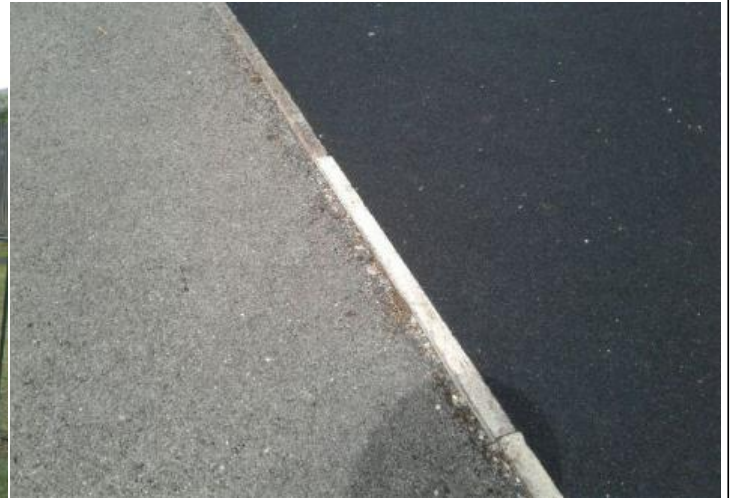
Item: Ancillary Items - Site General
Manufacturer: Owner/Operator

Finding: There are trip hazards present

Action: Reinstate surrounding surfaces to level to remove the trip points

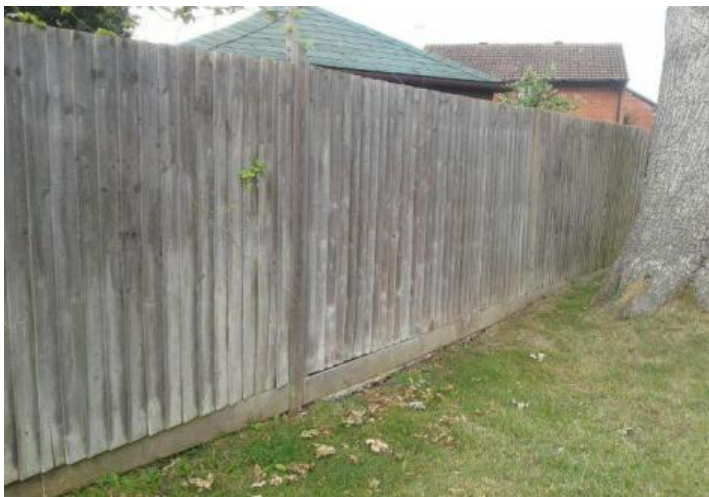
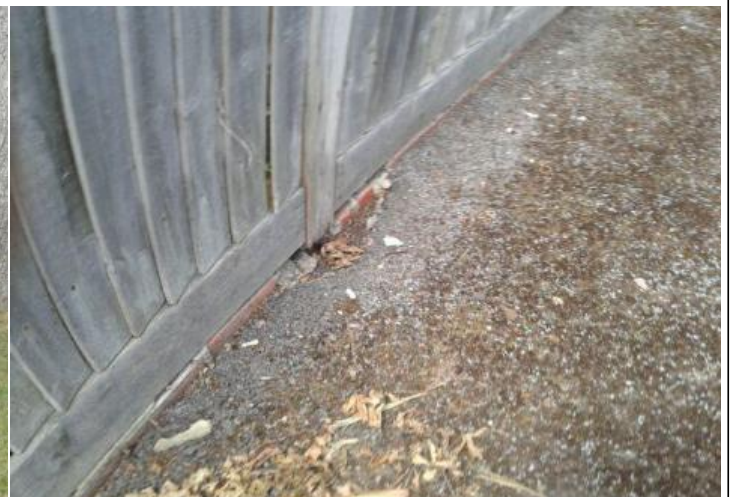
Item: Ancillary Items - Fencing - Timber
Manufacturer: Owner/Operator

Finding: There is some evidence of rot in the timber posts

Action: Monitor for any further deterioration and replace as required

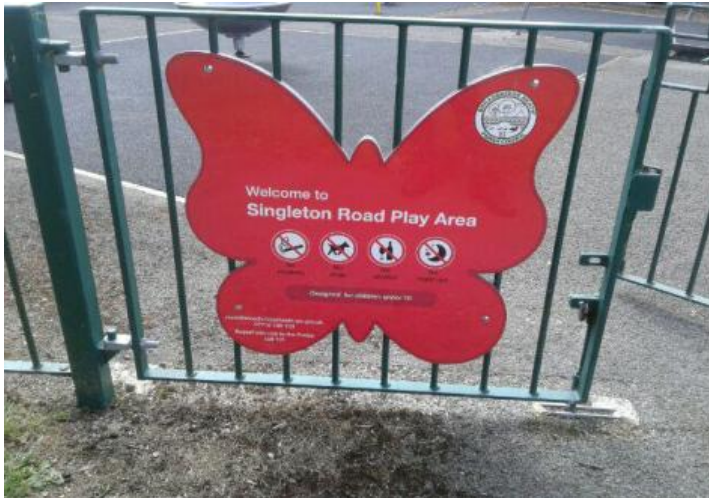
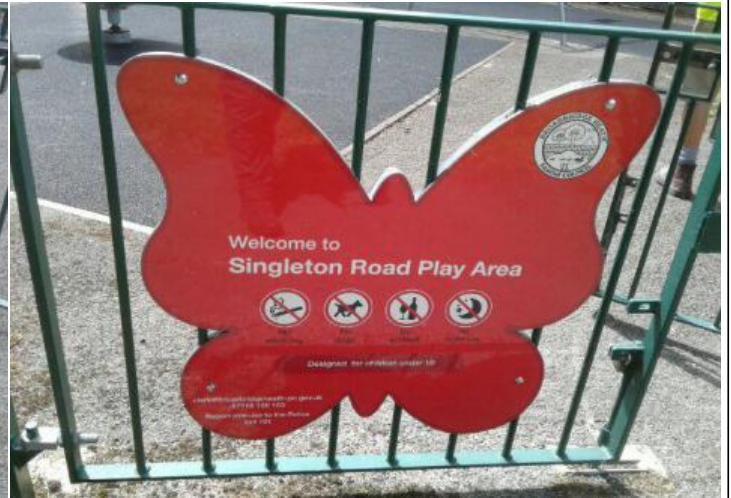
Item: Ancillary Items - Sign
Manufacturer: Owner/Operator

Finding: BS EN 1176 Part 7 recommends that signage shall include the site name / address
Action: Provide additional information

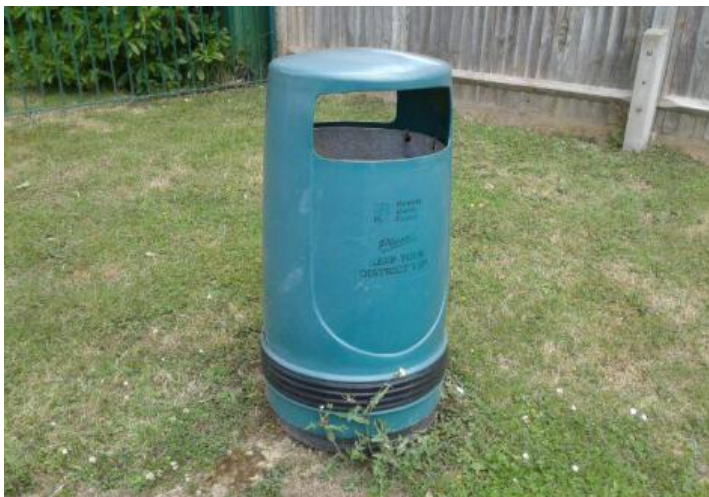
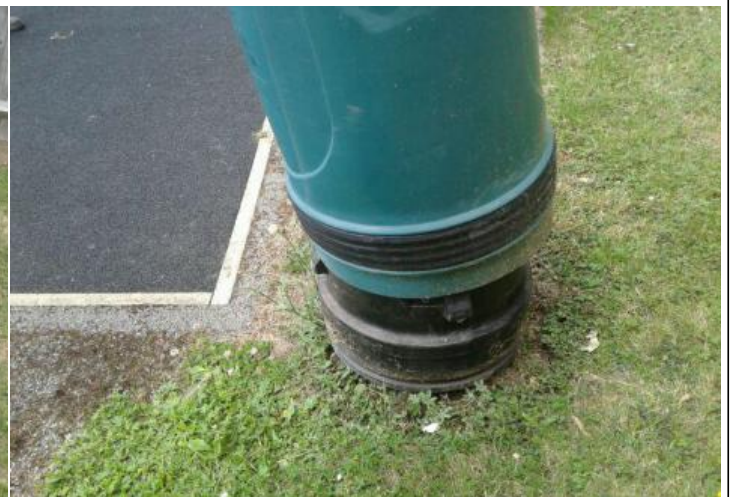
Item: Ancillary Items - Litter Bin
Manufacturer: Owner/Operator

Finding: The bin is not securely fixed to the surface and there is some possibility of the item tipping or rolling over

Action: Secure the bin to the ground

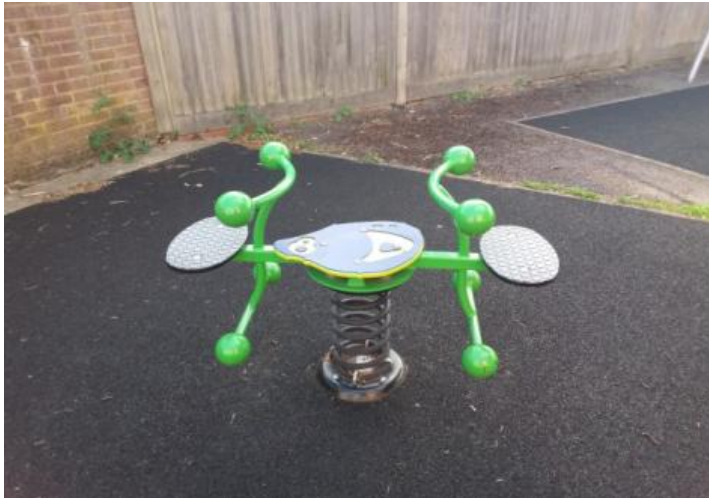
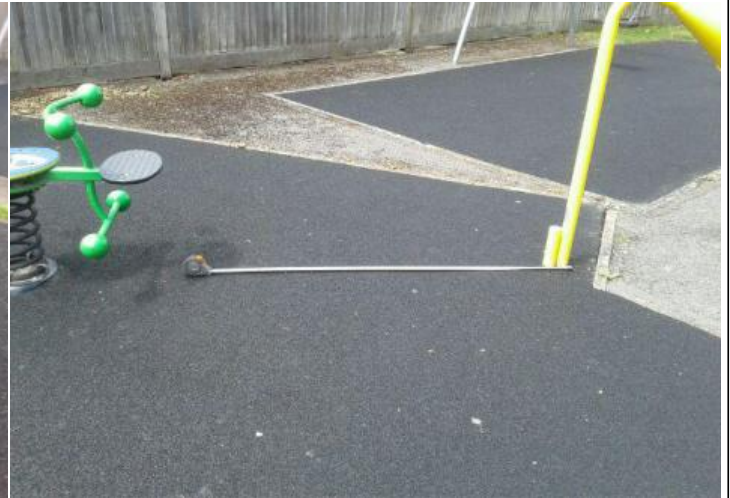
Item: Rocking Equipment - Spring See-Saw
Manufacturer: Hags

Finding: The talk tube forms a hard object within the impact area of the equipment in contravention of the requirements of BS EN 1176 Part 1
Action: Monitor - No remedial work recommended
