the play inspection company

Annual Inspection

Broadbridge Heath Parish Council

Singleton Road

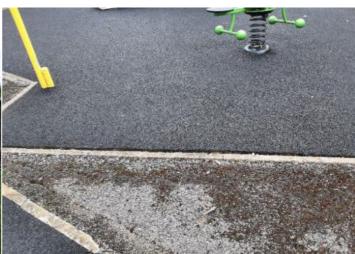
The surface is lifting at the edges and creating trip points - Repair perimeter of surfacing to remove trip points

Finding: The surface is lifting at the edges and creating trip Action: Repair perimeter of surfacing to remove trip points points

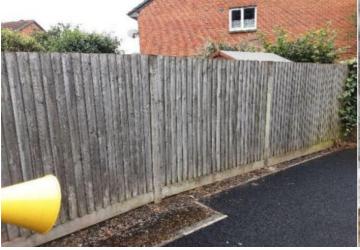
There is some evidence of rot in the timber posts - Monitor for any further deterioration and replace as required

Finding: There is some evidence of rot in the timber posts

Action: Monitor for any further deterioration and replace as required
