# the play inspection company

## **Annual Inspection**

Broadbridge Heath Parish Council

Village Centre

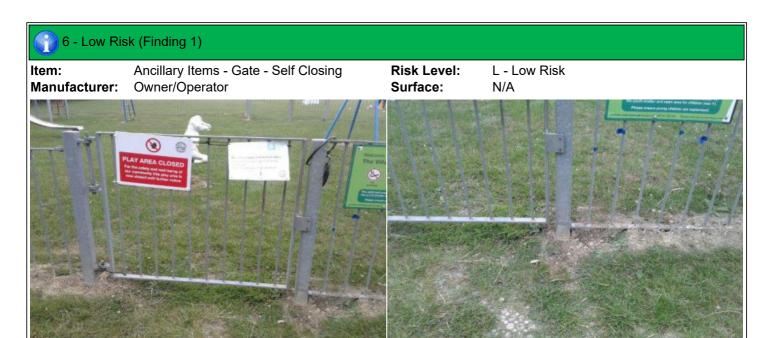
Finding: The kissing post is loose in it foundation

The kissing post is loose in it foundation - Secure the kissing post

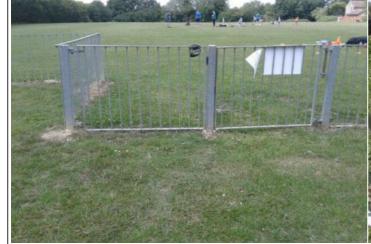
Item: Ancillary Items - Gate - Combination Risk Level: L - Low Risk

There are openings that are less than 12mm that could trap or crush fingers - Where possible a 12mm gap should be maintained on both sides or between the gate leafs

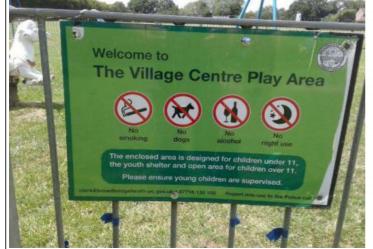
#### 5 - Very Low Risk (Finding 1)

**Finding:** BS EN 1176 Part 7 recommends that signage shall **Action:** Provide additional information include the site name / address

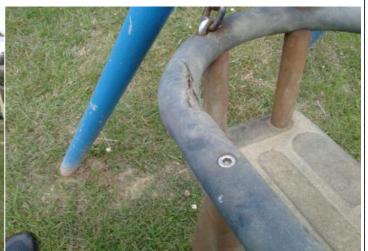
Finding: The seat has minor damage or wear

Action: Monitor for any further deterioration and replace as required

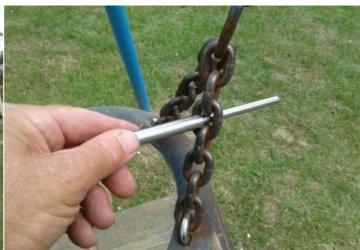
V - Very Low Risk Swings - 1 Bay 2 Seat (Cradle) Risk Level: Item: Wicksteed Playgrounds Surface: **Grass Matrix Tiles** Manufacturer:

Finding: The chain openings are in excess of the 8.6mm as Action: Monitor - No remedial work recommended recommended by BS EN 1176

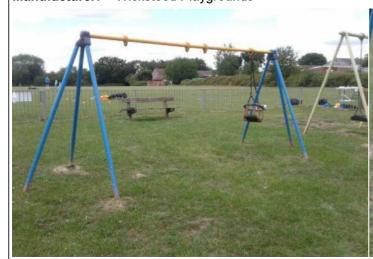
#### 8 - Low Risk (Finding 4)

Finding: The grass mats are silted up and the soil is compacted; this may have an effect on the impact absorbing ensure the correct surface qualities are maintained for the properties of the surface

Action: Consider HIC testing impact absorbing properties to equipment and replace as required

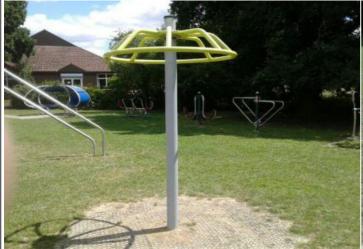
#### 8 - Low Risk (Finding 1)

Finding: The grass mats are silted up and the soil is compacted; this may have an effect on the impact absorbing ensure the correct surface qualities are maintained for the properties of the surface

Action: Consider HIC testing impact absorbing properties to equipment and replace as required

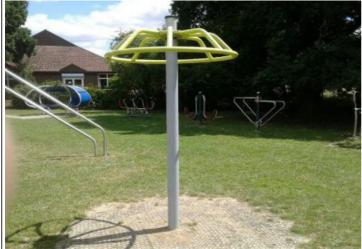
#### 6 - Low Risk (Finding 3)

Finding: There are gaps opening between the grass mat tiles

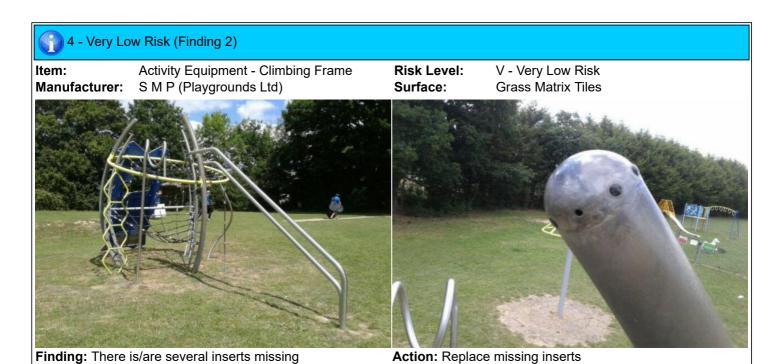
Item:Activity Equipment - Climbing FrameRisk Level:L - Low RiskManufacturer:S M P (Playgrounds Ltd)Surface:Grass Matrix Tiles

Finding: The ropes/nets are worn/damaged in places

**Action:** Monitor for any further deterioration and repair or replace as required

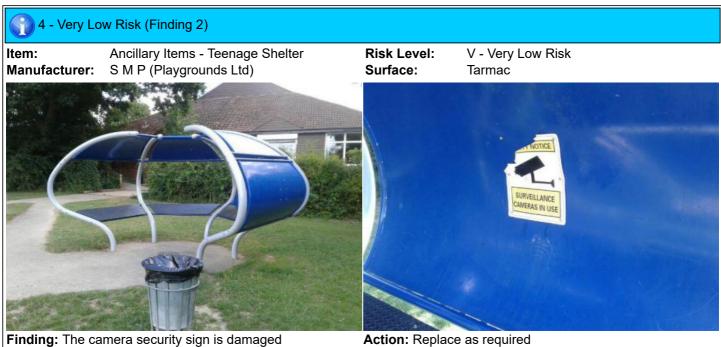
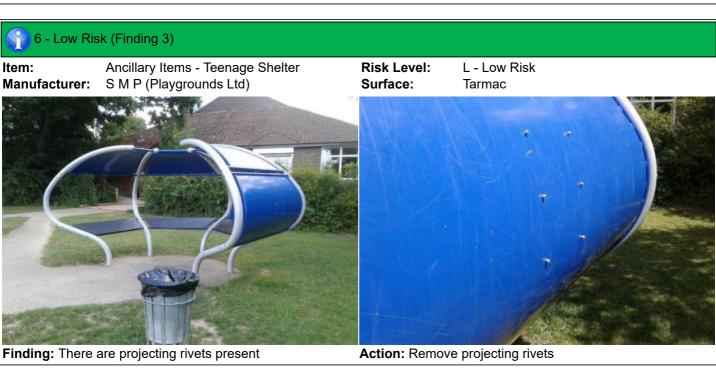
**Finding:** There is some evidence of fire damage to the bitmac surfacing

**Action:** Monitor for any further deterioration and repair as required
