the **play inspection** company

Annual Inspection

Broadbridge Heath Parish Council

Village Centre

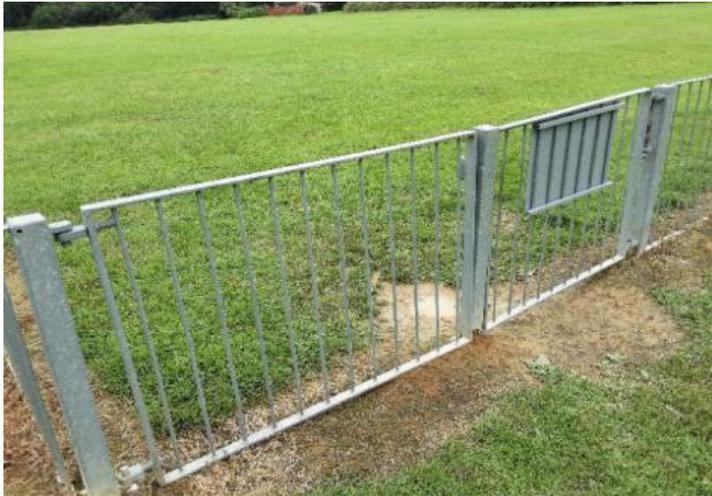
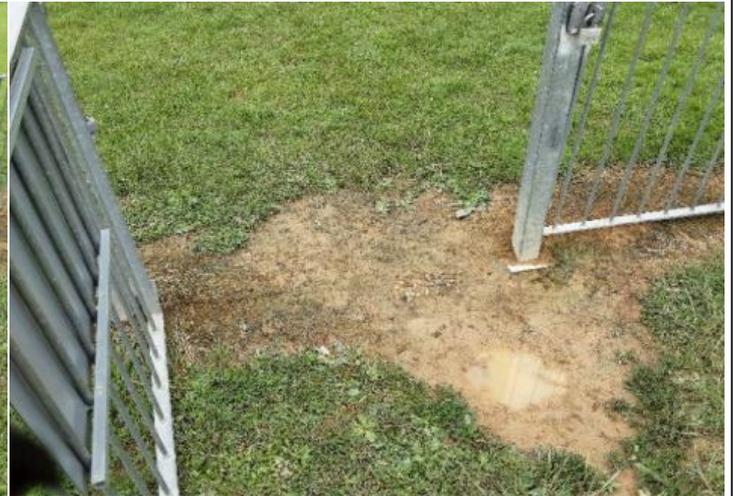
Item: Gates - Gate - Combination
Manufacturer: Owner/Operator

The area under the gate has eroded leaving uneven areas, or the concrete foundations exposed, resulting in trip hazards at the entrance/exit to the playground - Reinstate to level with surrounding surfaces

Finding: The area under the gate has eroded leaving uneven areas, or the concrete foundations exposed, resulting in trip hazards at the entrance/exit to the playground

Action: Reinstate to level with surrounding surfaces

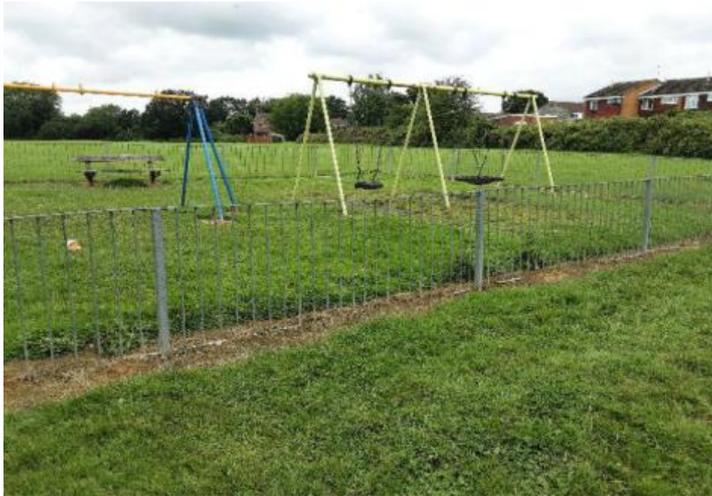
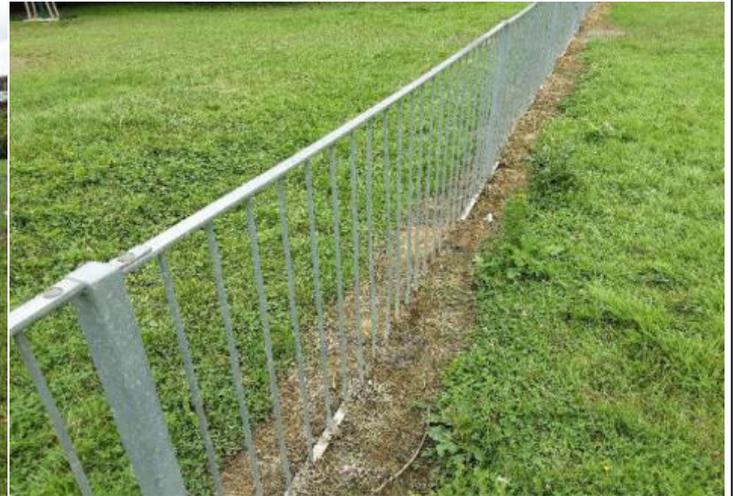
Item: Fences - Fencing - Flat Top
Manufacturer: Owner/Operator

There is some damage to the fence sections - Monitor for any further deterioration and repair as required

Finding: There is some damage to the fence sections

Action: Monitor for any further deterioration and repair as required

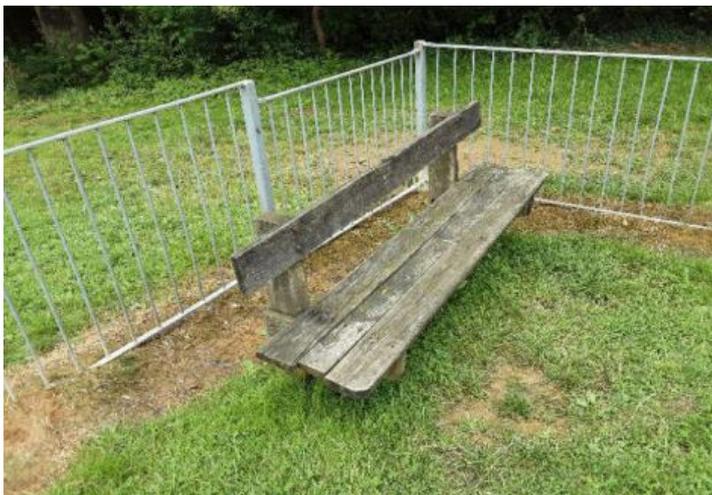
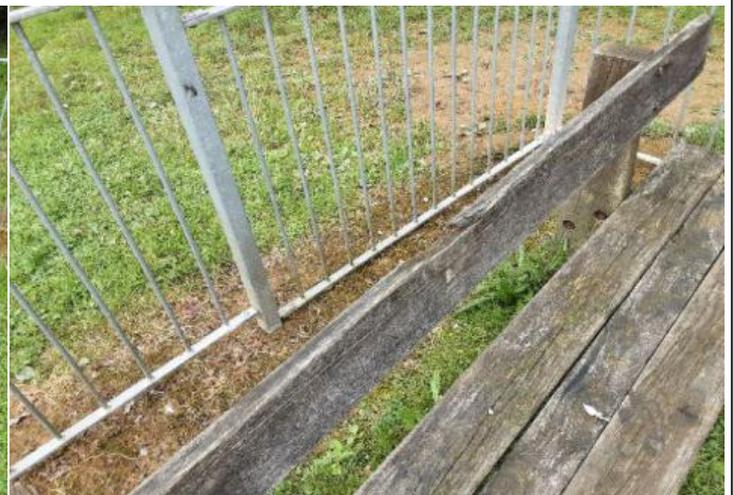
Item: Ancillary Items - Bench
Manufacturer: Owner/Operator

There is some evidence of rot in the timber - Monitor for any further deterioration and replace as required

Finding: There is some evidence of rot in the timber

Action: Monitor for any further deterioration and replace as required

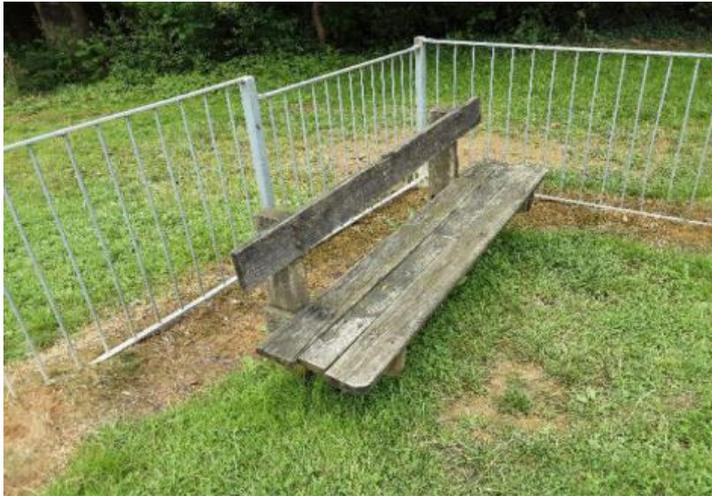
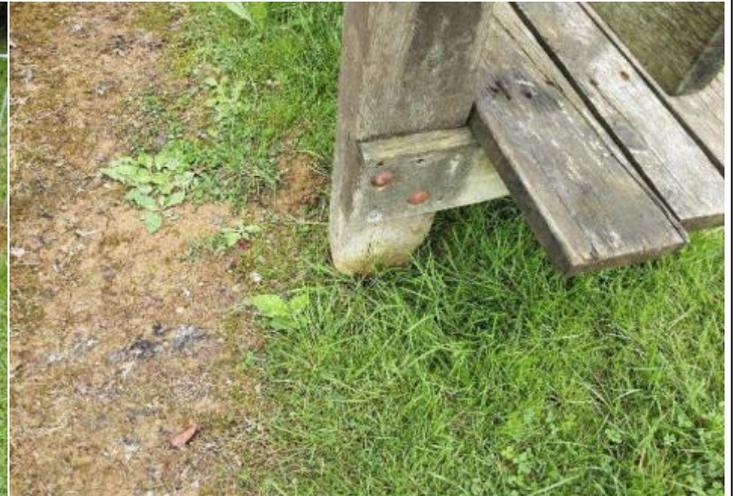
Item: Ancillary Items - Bench
Manufacturer: Owner/Operator

There is some strimmer / machinery damage apparent on the posts, this can penetrate the preservative applied to the timber and accelerate the rotting process - Monitor for any deterioration (rot) and replace as required

Finding: There is some strimmer / machinery damage apparent on the posts, this can penetrate the preservative applied to the timber and accelerate the rotting process

Action: Monitor for any deterioration (rot) and replace as required

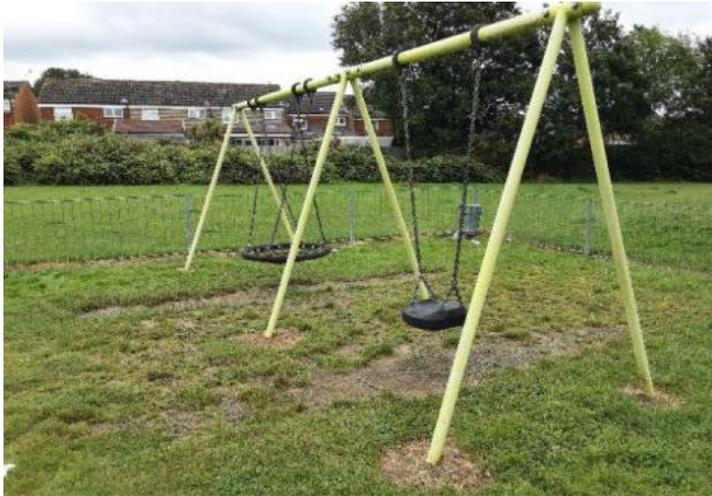
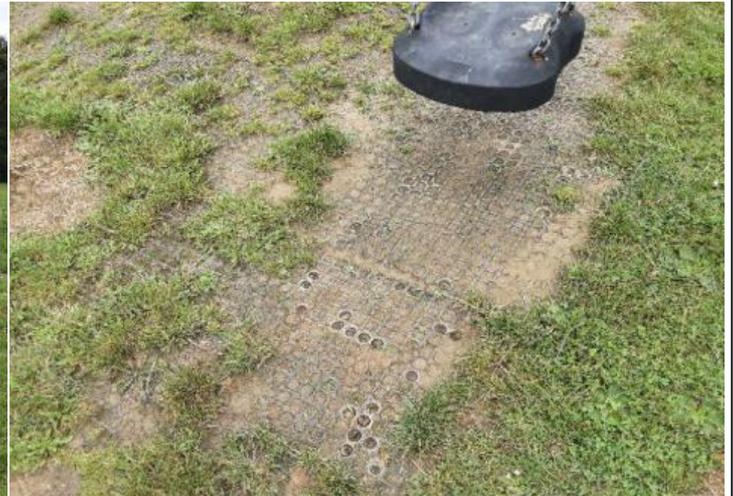
Item: Swings - 2 Bay Swing
Manufacturer: S M P (Playgrounds Ltd)

Finding: The grass mats are silted up and the soil is compacted; this may have an effect on the impact absorbing properties of the surface

Action: Consider HIC testing impact absorbing properties to ensure the correct surface qualities are maintained for the equipment and replace as required

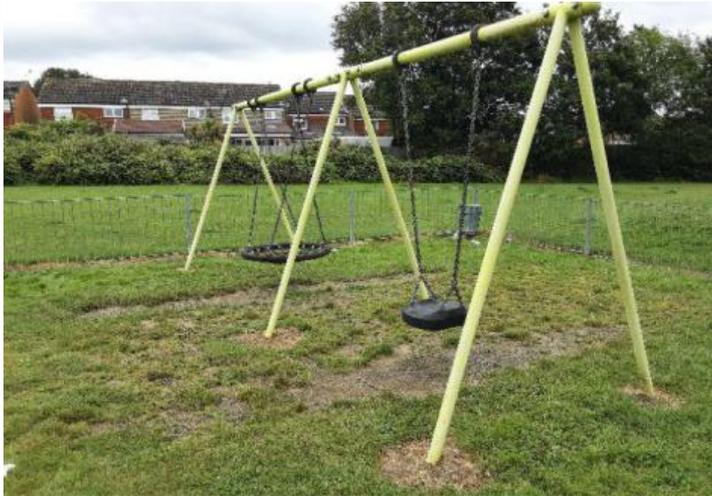
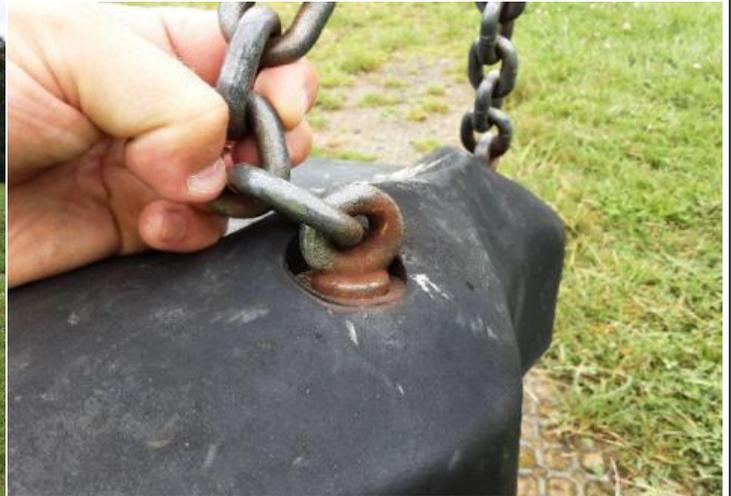
Item: Swings - 2 Bay Swing
Manufacturer: S M P (Playgrounds Ltd)

The swing seat connectors have some wear present - Monitor for further deterioration and replace when 40% worn

Finding: The swing seat connectors have some wear present

Action: Monitor for further deterioration and replace when 40% worn

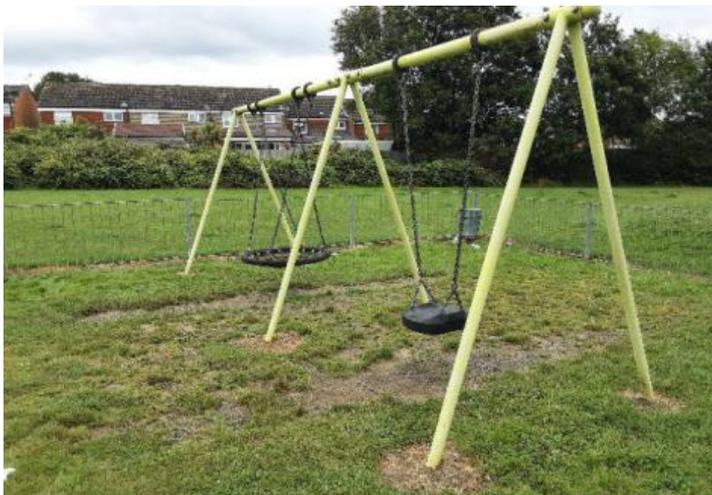
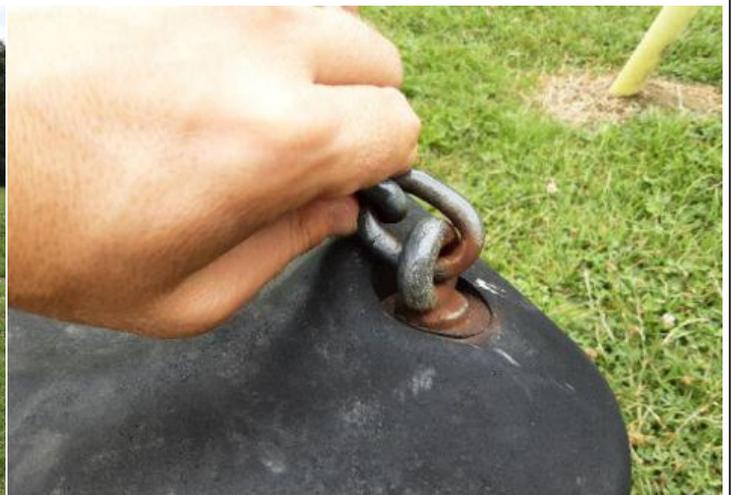
Item: Swings - 2 Bay Swing
Manufacturer: S M P (Playgrounds Ltd)

There is some notable evidence of chain wear - Monitor for any further deterioration and replace when 40% worn

Finding: There is some notable evidence of chain wear

Action: Monitor for any further deterioration and replace when 40% worn

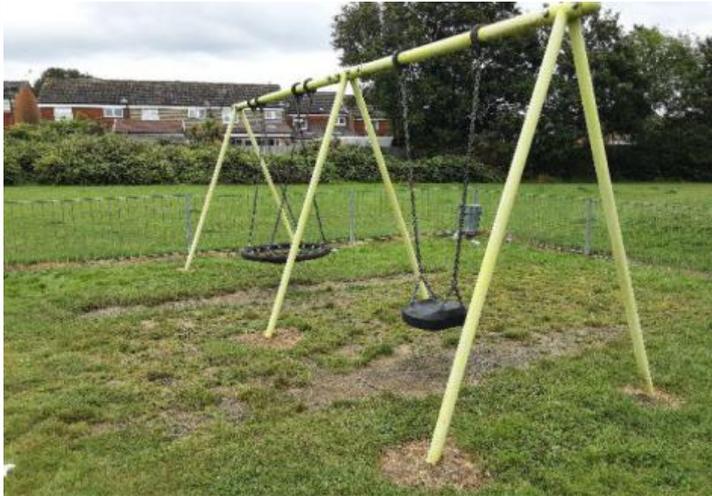
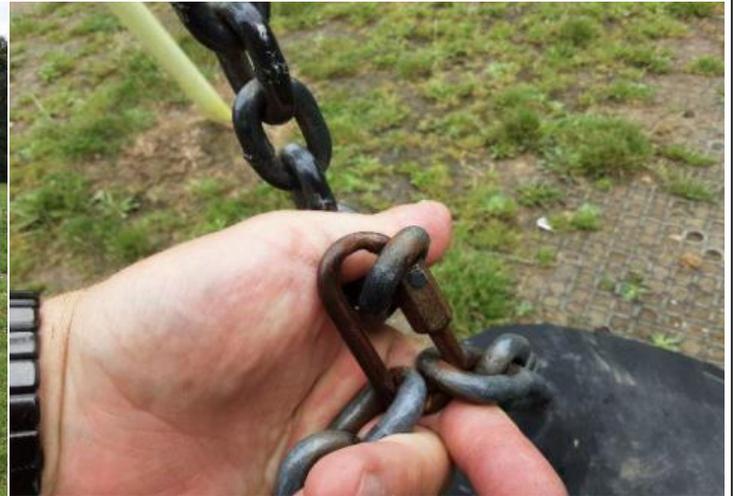
Item: Swings - 2 Bay Swing
Manufacturer: S M P (Playgrounds Ltd)

There is some wear to the shackles. - Monitor for any further deterioration and replace when 40% worn

Finding: There is some wear to the shackles.

Action: Monitor for any further deterioration and replace when 40% worn

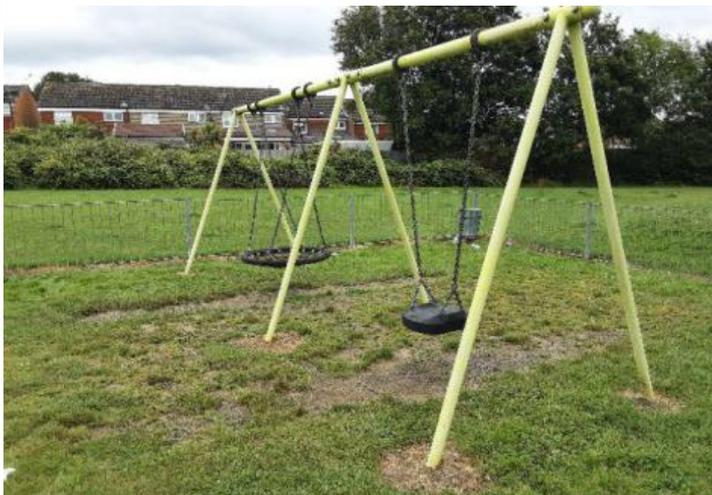
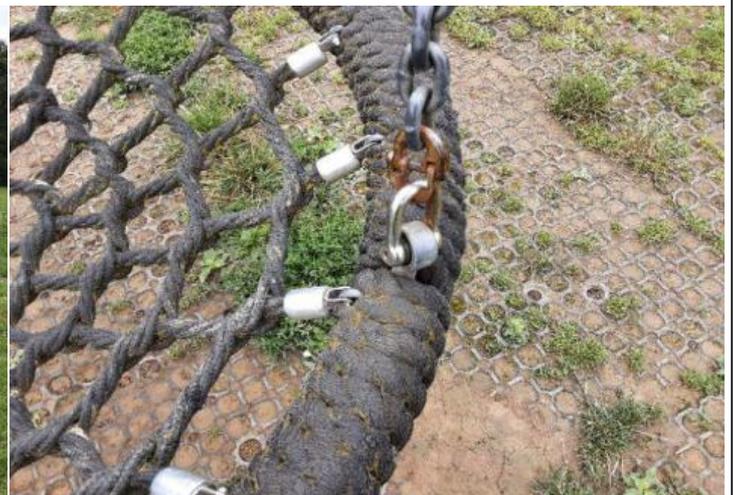
Item: Swings - 2 Bay Swing
Manufacturer: S M P (Playgrounds Ltd)

The bushes are showing signs of wear - Monitor for any further deterioration and replace as required

Finding: The bushes are showing signs of wear

Action: Monitor for any further deterioration and replace as required

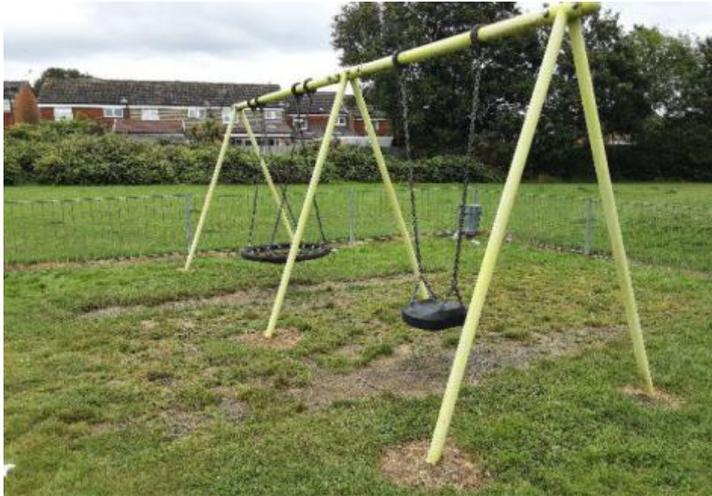
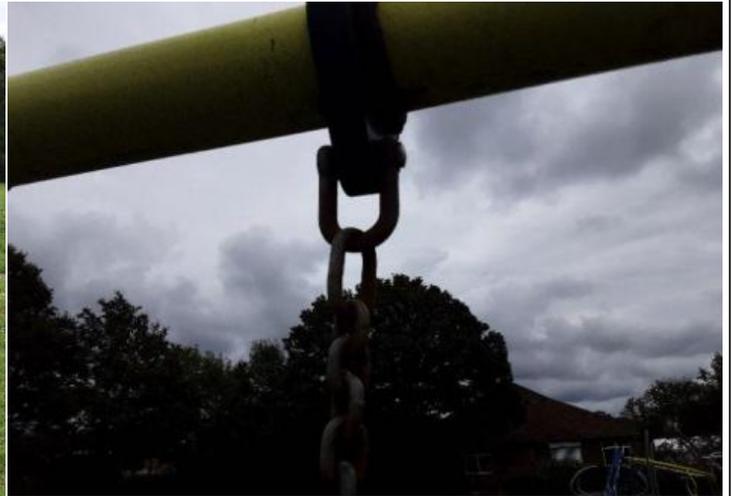
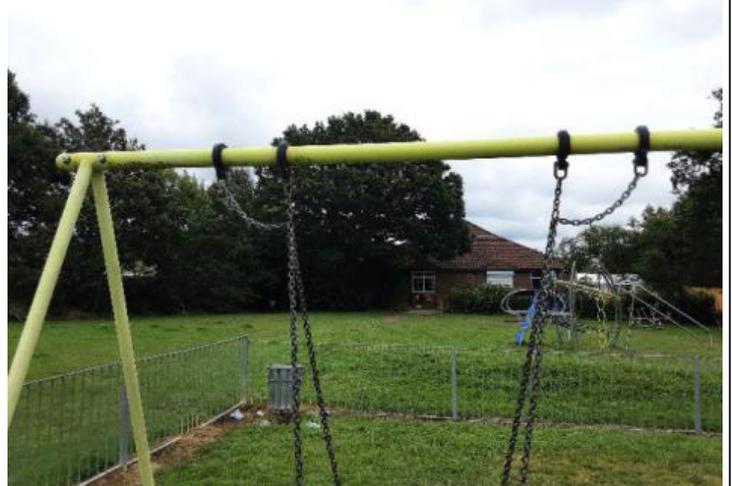
Item: Swings - 2 Bay Swing
Manufacturer: S M P (Playgrounds Ltd)

The chain links are worn in excess of 40% and require renewing on the basket seat - Replace worn chains

Finding: The chain links are worn in excess of 40% and require renewing on the basket seat

Action: Replace worn chains

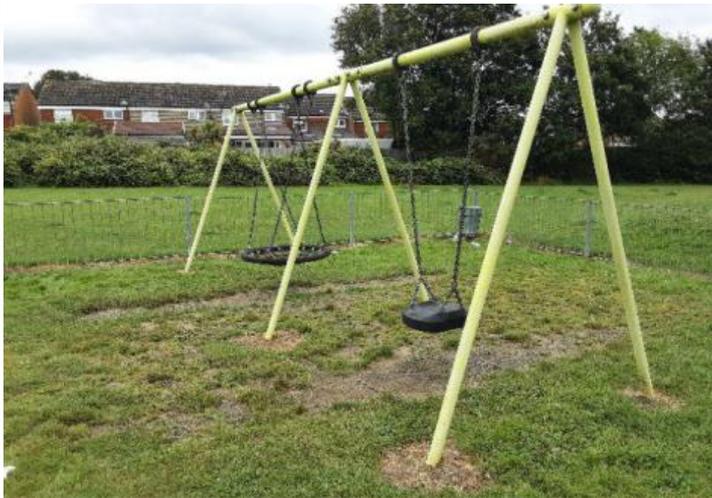
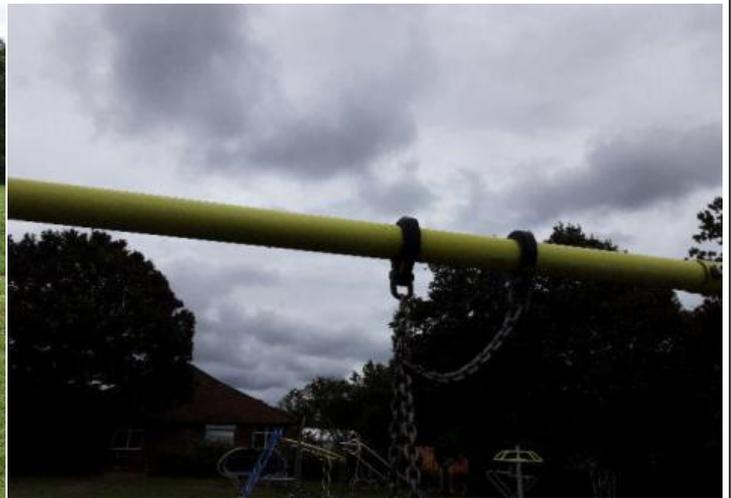
Item: Swings - 2 Bay Swing
Manufacturer: S M P (Playgrounds Ltd)

The Anti Wrap bearings are dry and not moving freely - Lubricate bearings in accordance with the manufacturers recommendations

Finding: The Anti Wrap bearings are dry and not moving freely

Action: Lubricate bearings in accordance with the manufacturers recommendations

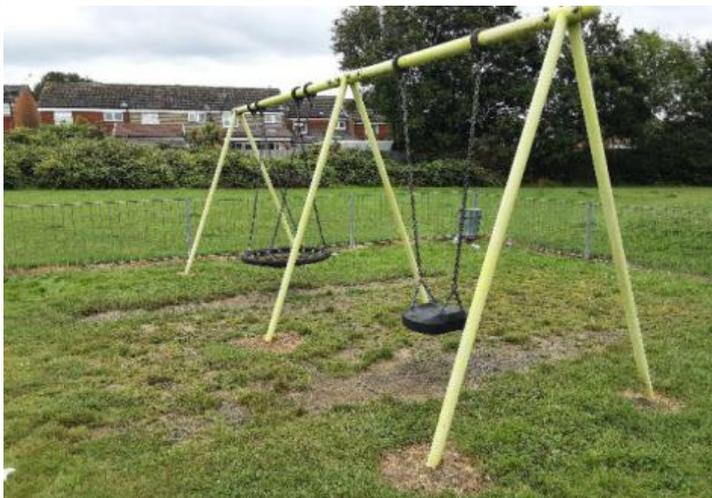
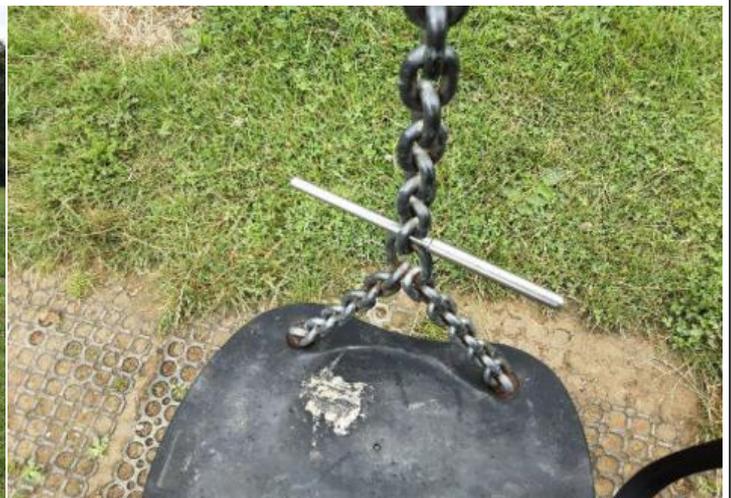
Item: Swings - 2 Bay Swing
Manufacturer: S M P (Playgrounds Ltd)

The chain openings are in excess of the 8.6mm as recommended by BS EN 1176 - Monitor - No remedial work recommended

Finding: The chain openings are in excess of the 8.6mm as recommended by BS EN 1176

Action: Monitor - No remedial work recommended

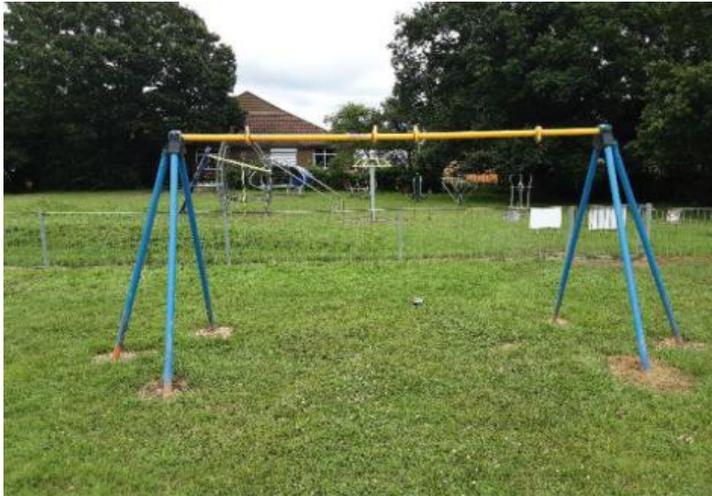
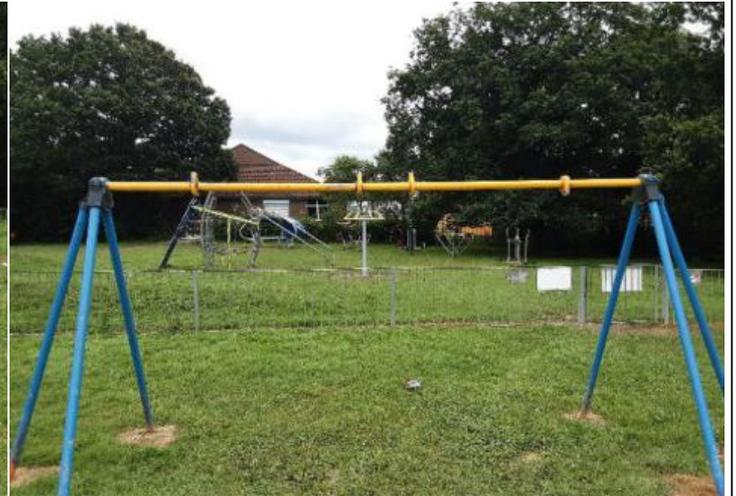
Item: Swings - 1 Bay 2 Seat (Cradle)
Manufacturer: Wicksteed Playgrounds

The seat(s) and suspension were missing at the time of inspection and the inspector was unable to make a full compliance assessment - Replace missing seat(s) and suspension

Finding: The seat(s) and suspension were missing at the time of inspection and the inspector was unable to make a full compliance assessment

Action: Replace missing seat(s) and suspension

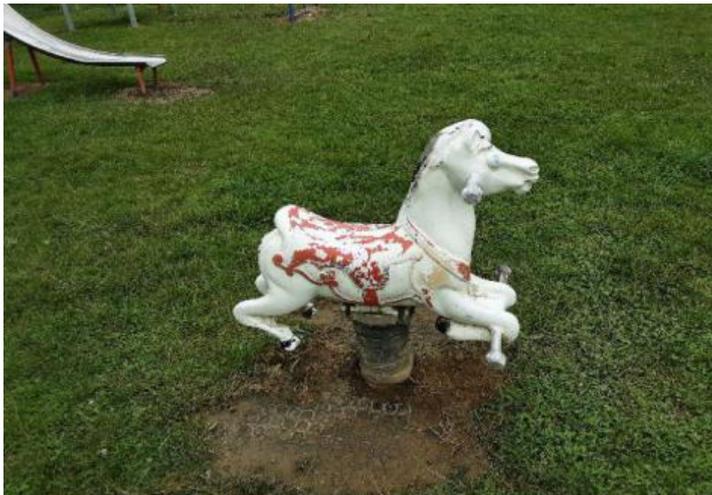
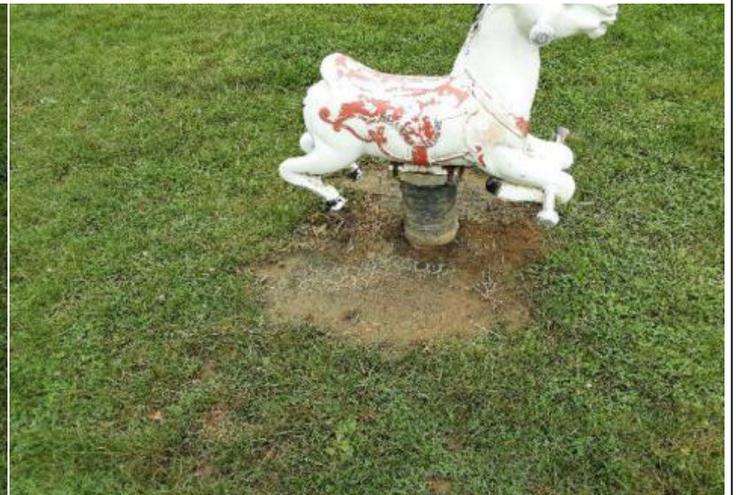
Item: Rocking Equipment - Spring Horse
Manufacturer: Wicksteed Playgrounds

Finding: The grass mats are silted up and the soil is compacted; this may have an effect on the impact absorbing properties of the surface

Action: Consider HIC testing impact absorbing properties to ensure the correct surface qualities are maintained for the equipment and replace as required

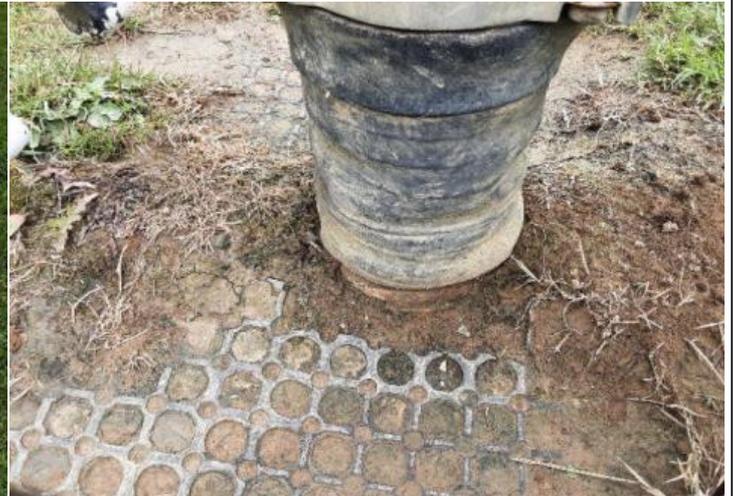
Item: Rocking Equipment - Spring Horse
Manufacturer: Wicksteed Playgrounds

The paintwork on the spring has been damaged or worn exposing the metal underneath which is rusting - Treat any rusting components and repaint

Finding: The paintwork on the spring has been damaged or worn exposing the metal underneath which is rusting
Action: Treat any rusting components and repaint

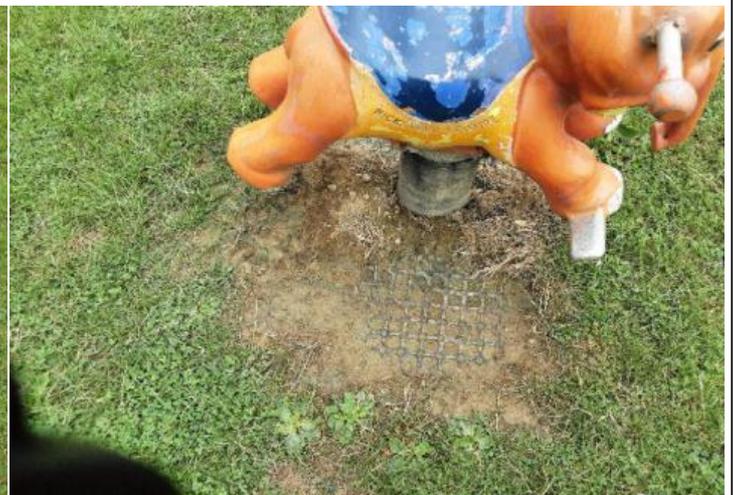
Item: Rocking Equipment - Spring Elephant
Manufacturer: Wicksteed Playgrounds

Finding: The grass mats are silted up and the soil is compacted; this may have an effect on the impact absorbing properties of the surface
Action: Consider HIC testing impact absorbing properties to ensure the correct surface qualities are maintained for the equipment and replace as required

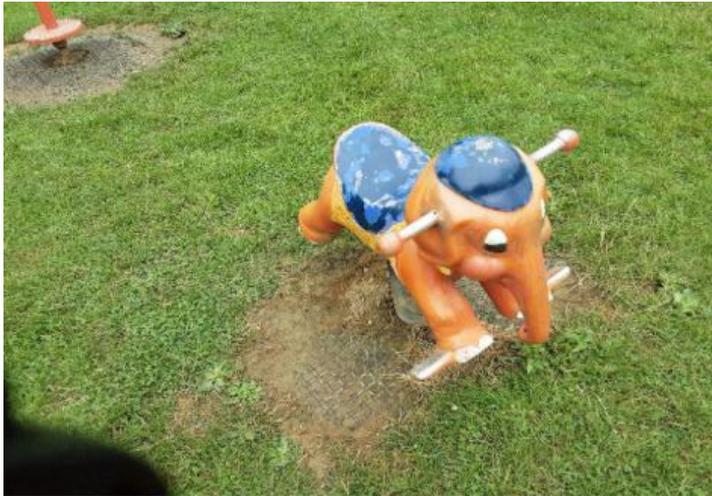
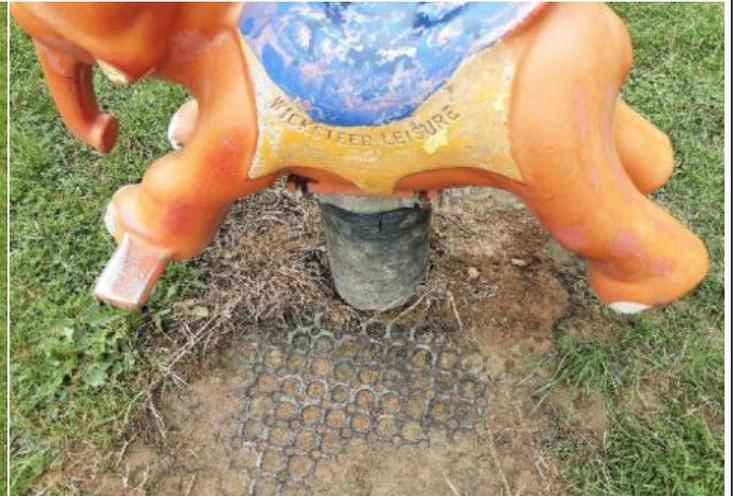
Item: Rocking Equipment - Spring Elephant
Manufacturer: Wicksteed Playgrounds

The spring cover is damaged, split or missing - Monitor for any further deterioration and replace as required

Finding: The spring cover is damaged, split or missing

Action: Monitor for any further deterioration and replace as required

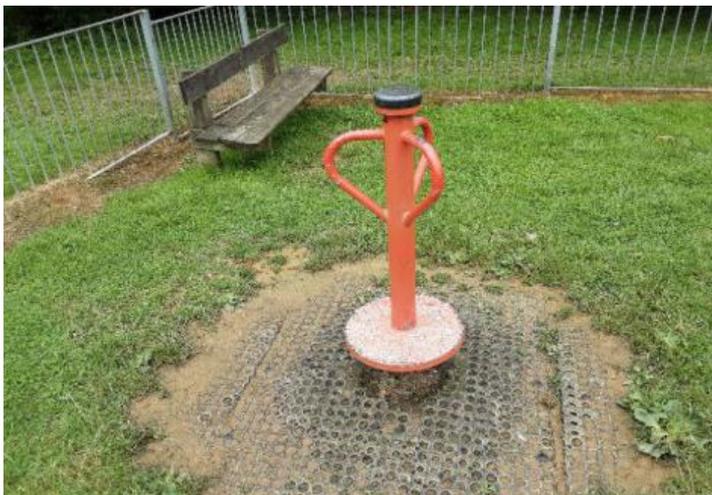
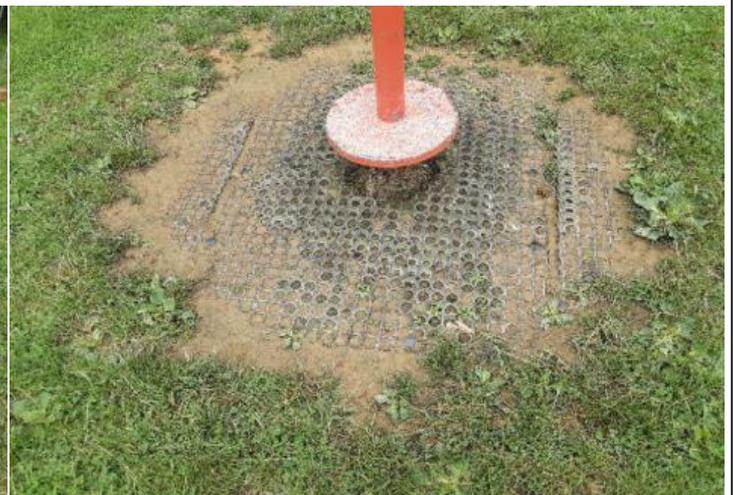
Item: Rotor Play - Spinning Pole
Manufacturer: Wicksteed Playgrounds

Finding: The grass mats are silted up and the soil is compacted; this may have an effect on the impact absorbing properties of the surface

Action: Consider HIC testing impact absorbing properties to ensure the correct surface qualities are maintained for the equipment and replace as required

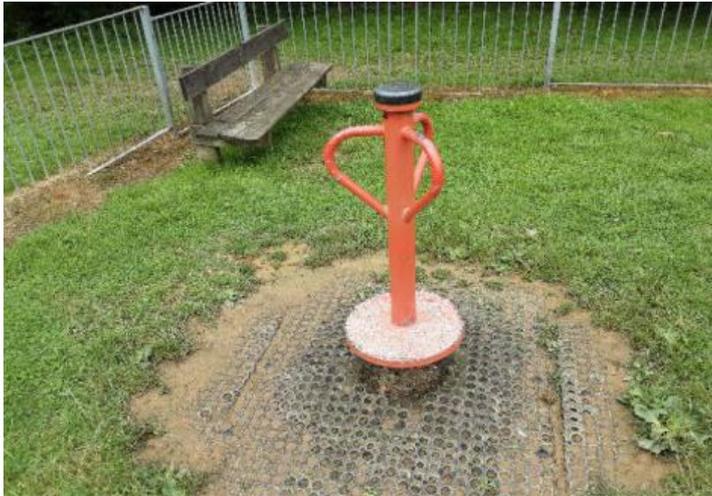
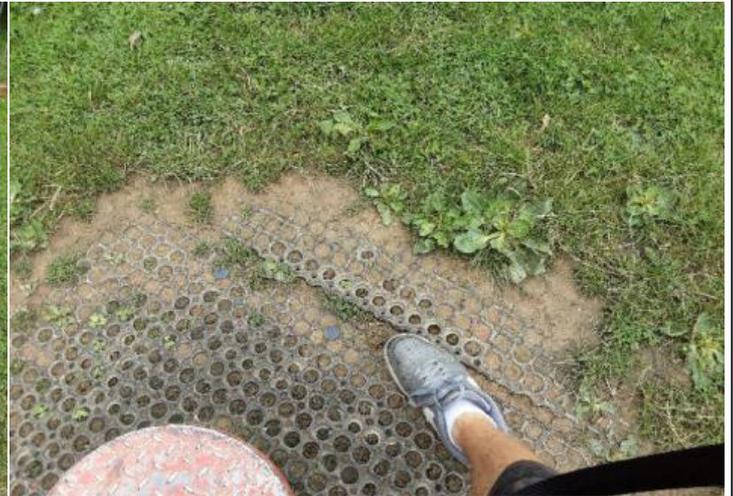
Item: Rotor Play - Spinning Pole
Manufacturer: Wicksteed Playgrounds

There are gaps opening between the grass mat tiles creating trip hazards - Reinstate surface

Finding: There are gaps opening between the grass mat tiles creating trip hazards

Action: Reinststate surface

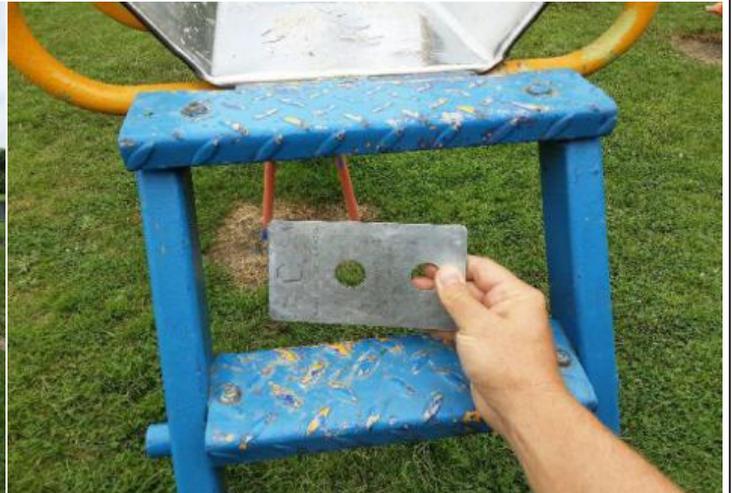
Item: Other - Free Standing Slide
Manufacturer: Wicksteed Playgrounds

The item fails to meet the requirements of BS EN 1176 Part 1 4.2.7.2 head and neck entrapment in the barriers and/or steps - Monitor - No remedial work recommended

Finding: The item fails to meet the requirements of BS EN 1176 Part 1 4.2.7.2 head and neck entrapment in the barriers and/or steps

Action: Monitor - No remedial work recommended

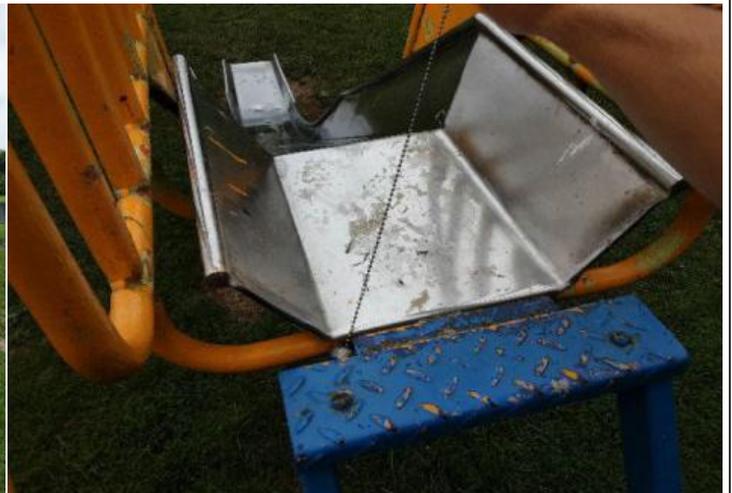
Item: Other - Free Standing Slide
Manufacturer: Wicksteed Playgrounds

There is / are toggle entrapment/s present in contravention of the recommendations set out in BS EN 1176 Part 3 - Monitor - no remedial work recommended

Finding: There is / are toggle entrapment/s present in contravention of the recommendations set out in BS EN 1176 Part 3

Action: Monitor - no remedial work recommended

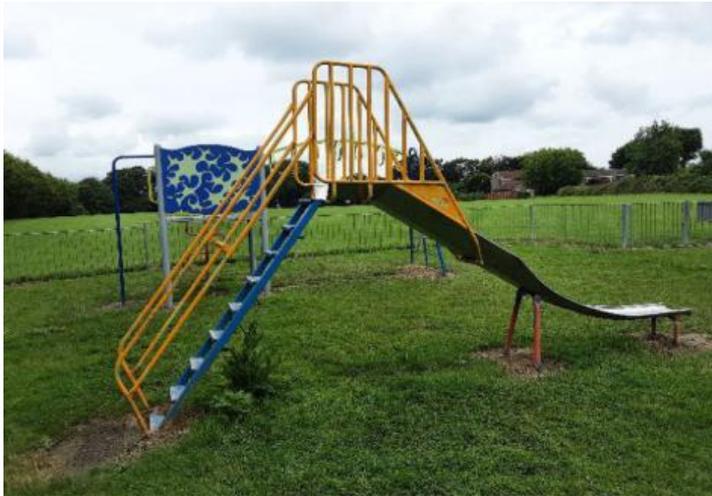
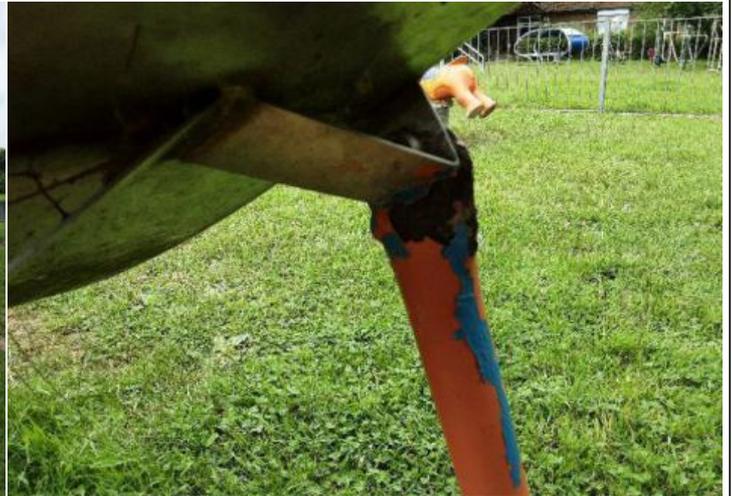
Item: Other - Free Standing Slide
Manufacturer: Wicksteed Playgrounds

Finding: The paintwork on this item has been damaged or worn exposing the metal underneath which is rusting

Action: Treat any rusting components and repaint

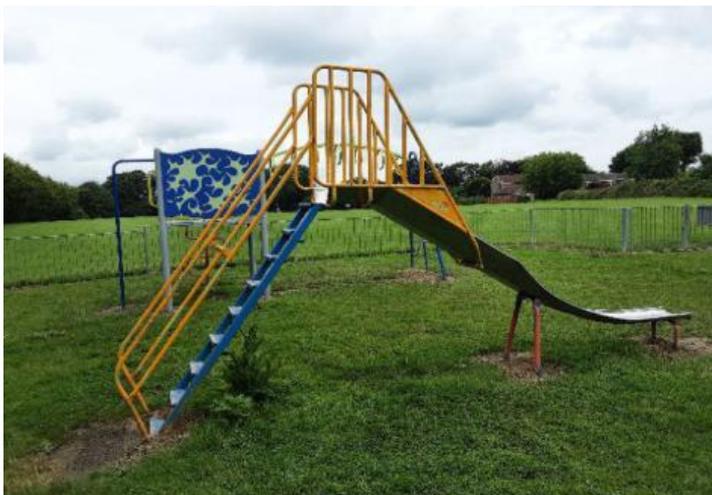
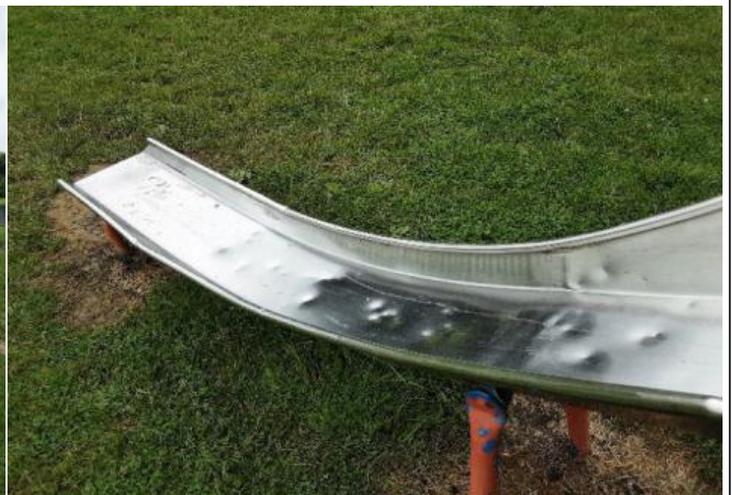
There are a number of dents in the slide surface - Monitor for any further deterioration and repair as required

Finding: There are a number of dents in the slide surface

Action: Monitor for any further deterioration and repair as required

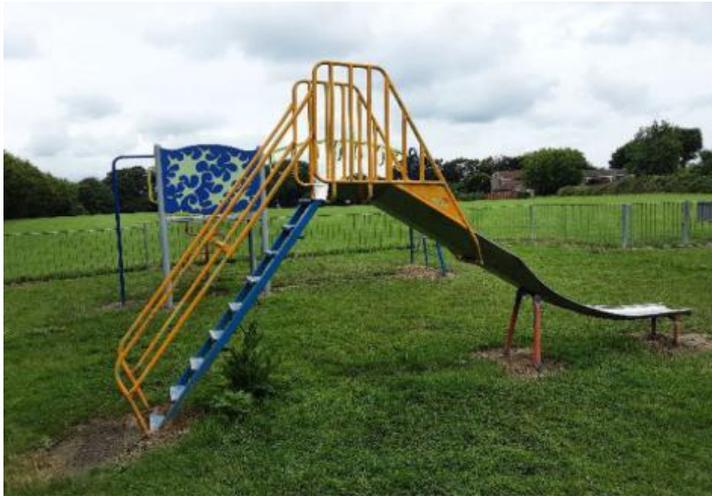
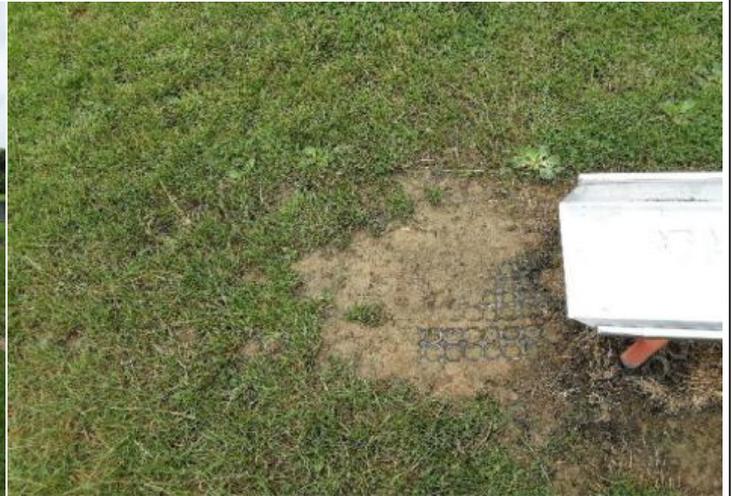
Finding: The grass mats are silted up and the soil is compacted; this may have an effect on the impact absorbing properties of the surface

Action: Consider HIC testing impact absorbing properties to ensure the correct surface qualities are maintained for the equipment and replace as required

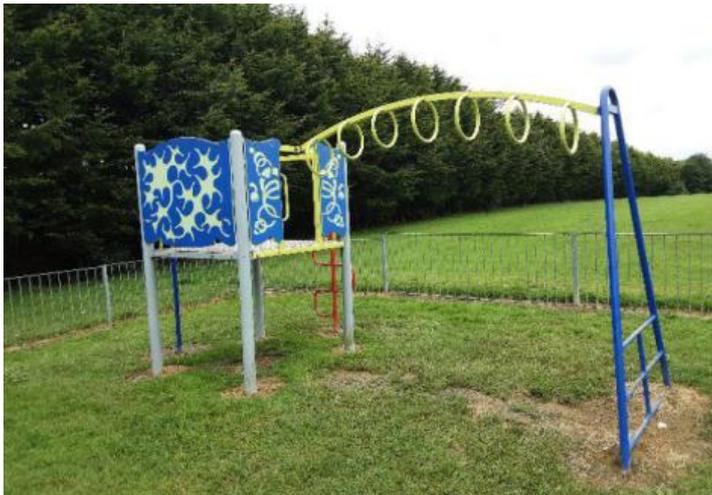
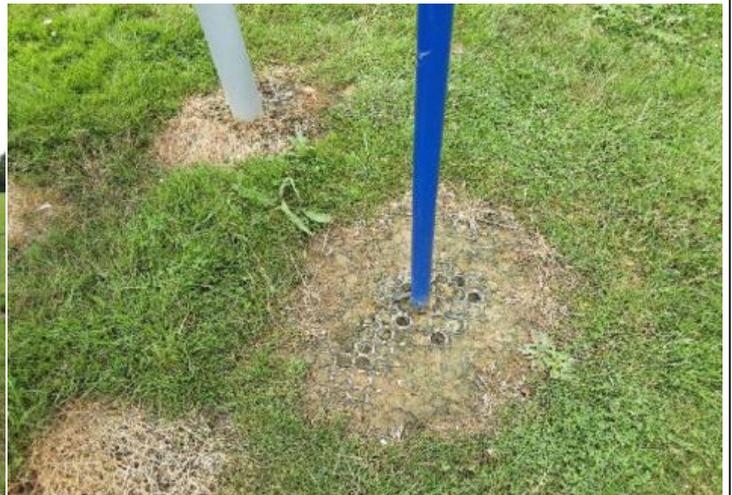
Finding: The grass mats are silted up and the soil is compacted; this may have an effect on the impact absorbing properties of the surface

Action: Consider HIC testing impact absorbing properties to ensure the correct surface qualities are maintained for the equipment and replace as required

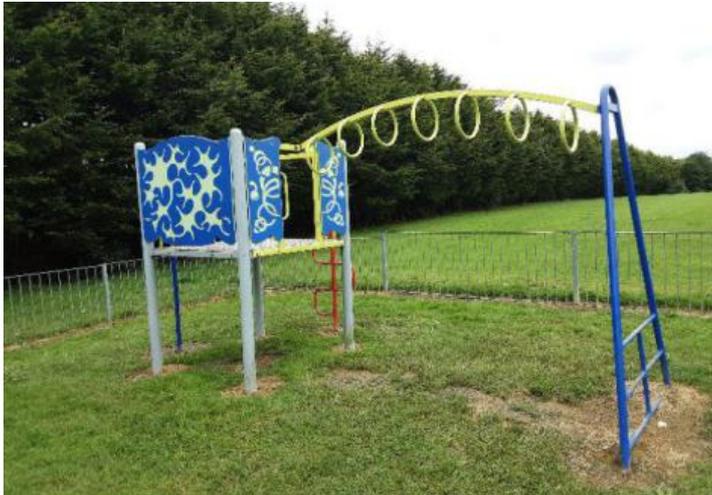
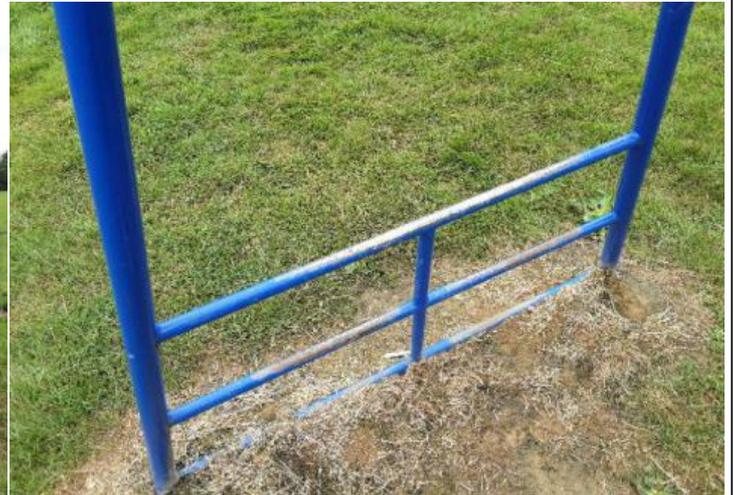
Finding: The paintwork on this item has been damaged or worn exposing the metal underneath which is rusting

Action: Treat any rusting components and repaint

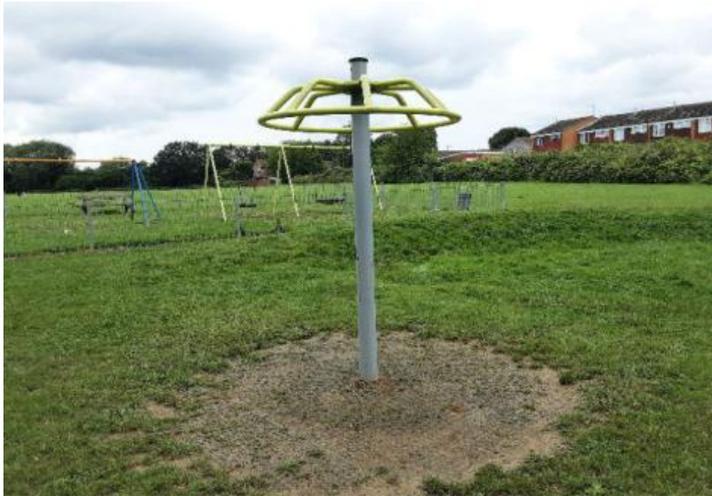
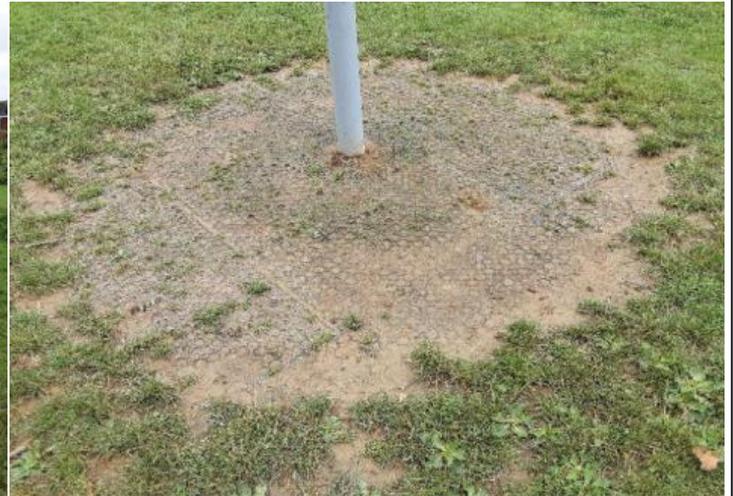
Finding: The grass mats are silted up and the soil is compacted; this may have an effect on the impact absorbing properties of the surface

Action: Consider HIC testing impact absorbing properties to ensure the correct surface qualities are maintained for the equipment and replace as required

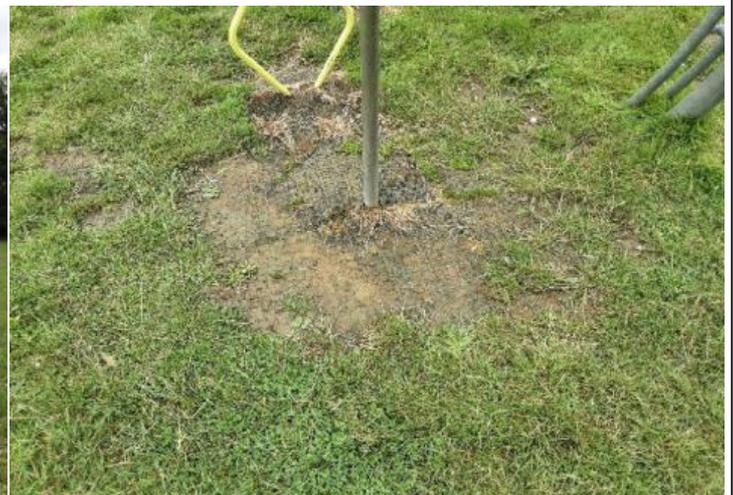
Finding: The grass mats are silted up and the soil is compacted; this may have an effect on the impact absorbing properties of the surface

Action: Consider HIC testing impact absorbing properties to ensure the correct surface qualities are maintained for the equipment and replace as required

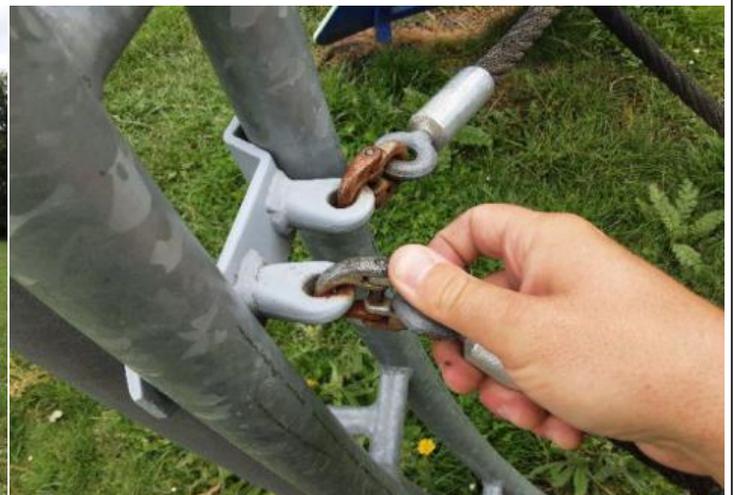
The connecting lugs are showing signs of wear - Monitor for any further deterioration and repair as required

Finding: The connecting lugs are showing signs of wear

Action: Monitor for any further deterioration and repair as required

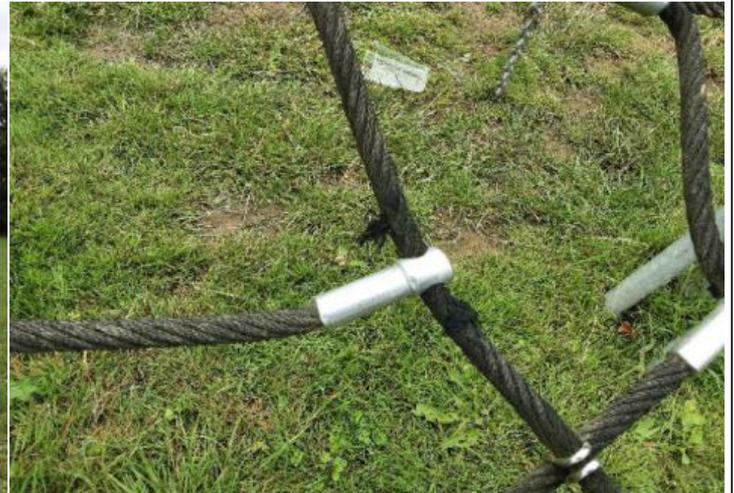
Finding: The ropes/nets are worn/damaged in places

Action: Monitor for any further deterioration and repair or replace as required

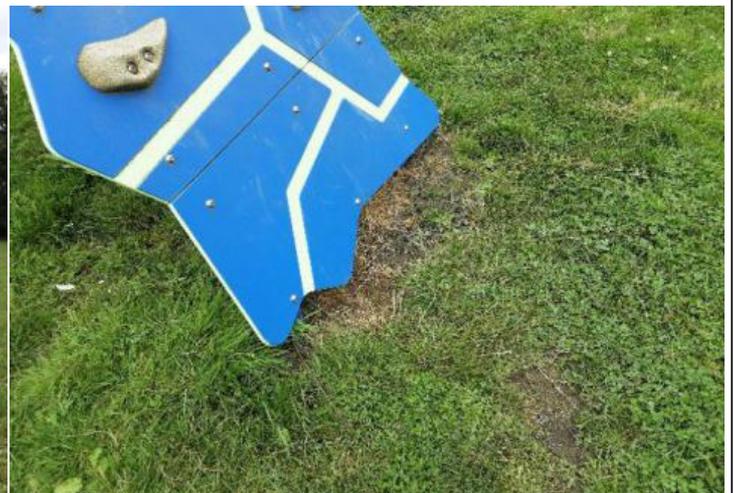
The surface has subsided in some areas - Monitor for any further deterioration and repair as required

Finding: The surface has subsided in some areas

Action: Monitor for any further deterioration and repair as required

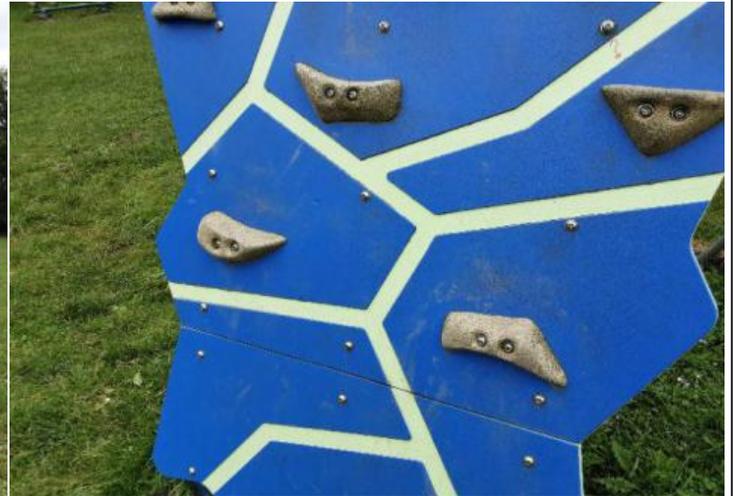
Finding: The item has been damaged

Action: Monitor for any further deterioration and replace as required
