the **play inspection** company

Annual Inspection

Broadbridge Heath Parish Council

Village Centre

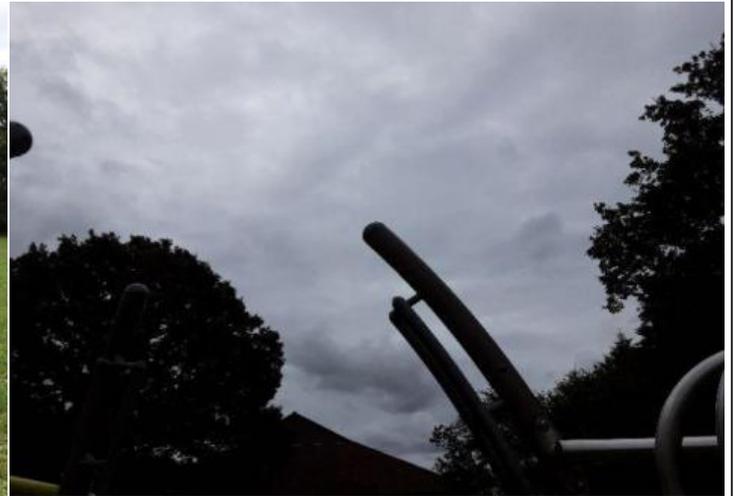
Finding: There is/are several inserts missing

Action: Replace missing inserts

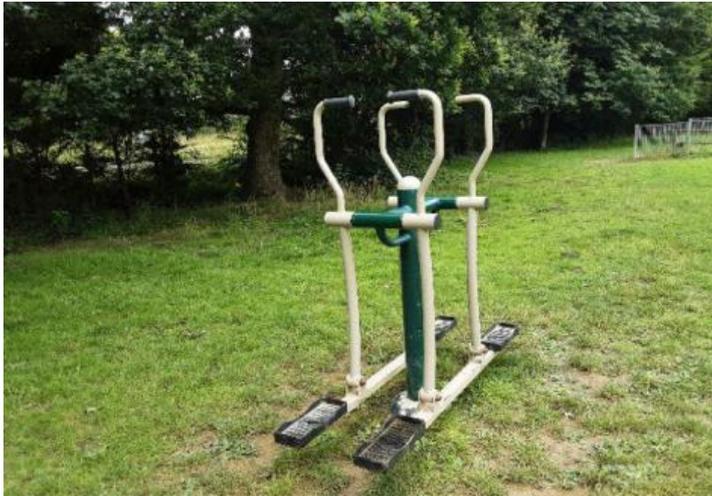
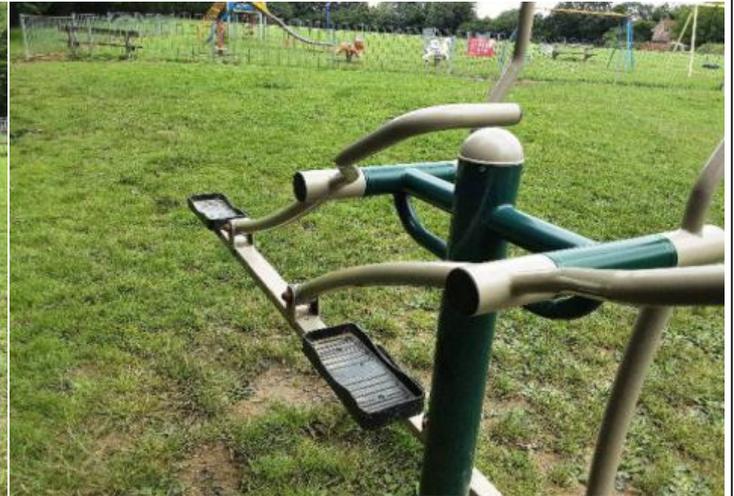
Finding: The swinging movement of the item exceeds the maximum 55 degrees from the vertical required by BS EN 16630

Action: Monitor - No remedial work recommended

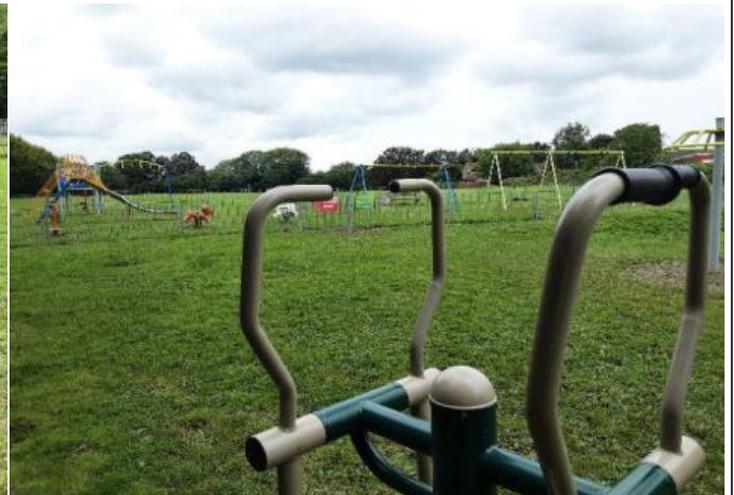
Finding: One or more handgrip(s) are damaged or missing.

Action: Replace missing or damaged handgrips

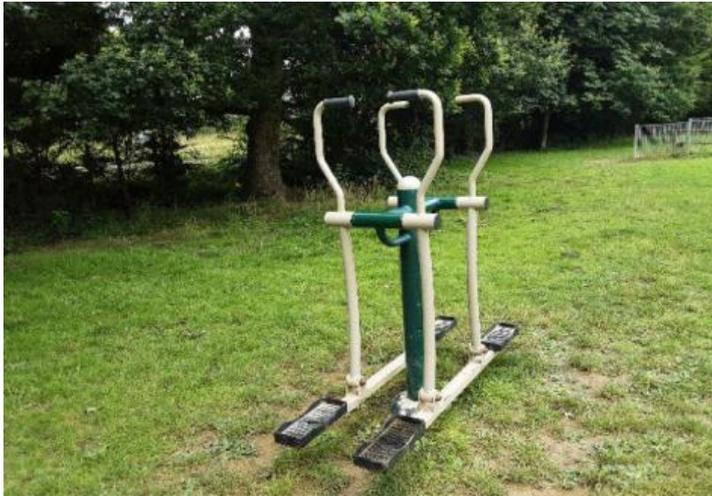
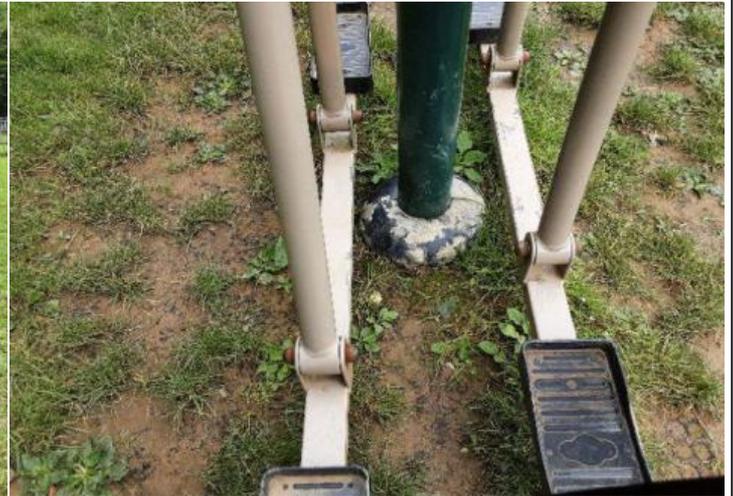
Finding: There is surface corrosion present on the item

Action: Consider treating the item

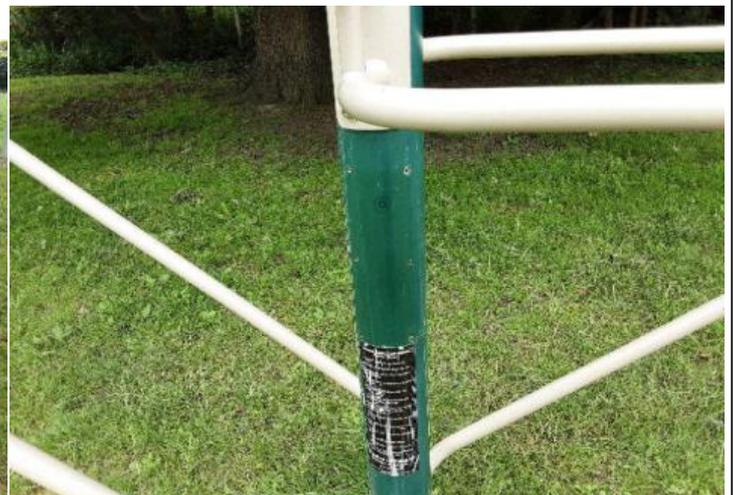
Finding: The information signage is missing

Action: Replace all missing components

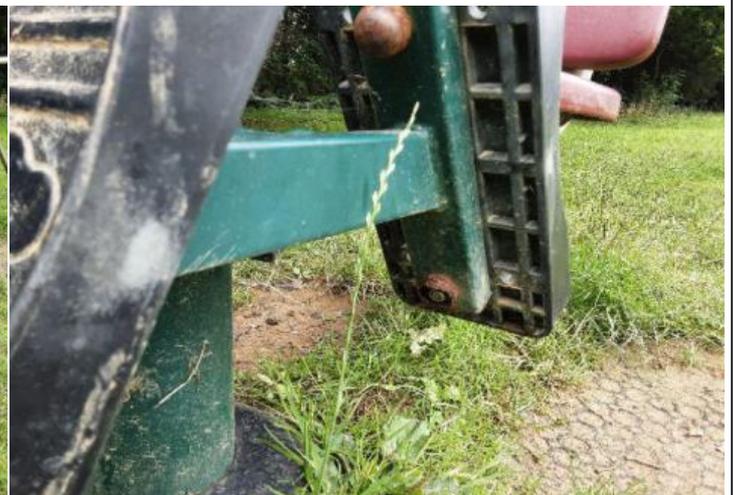
Finding: There is/are bolt cap covers missing or damaged on the item **Action:** Replace missing or damaged bolt cap covers

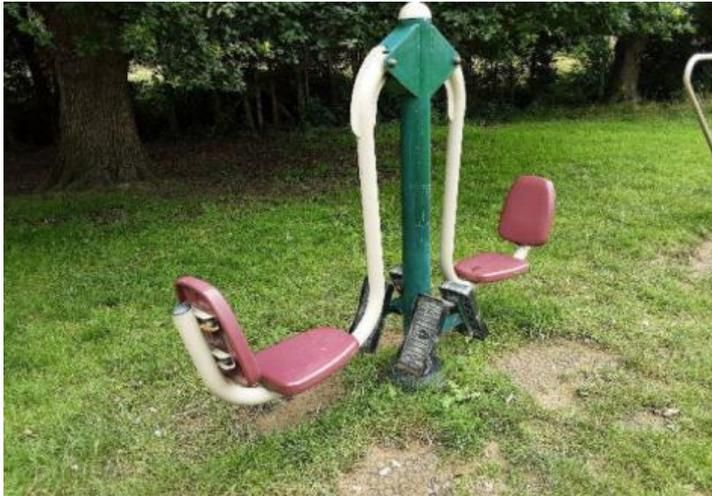
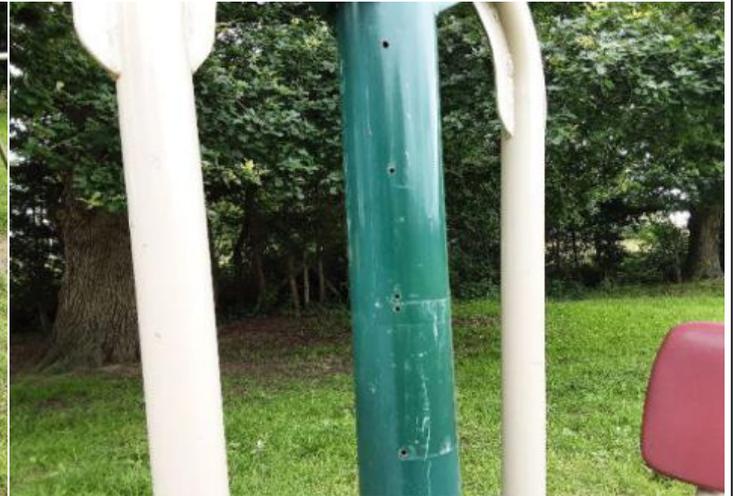
Finding: The information signage is missing

Action: Replace all missing components

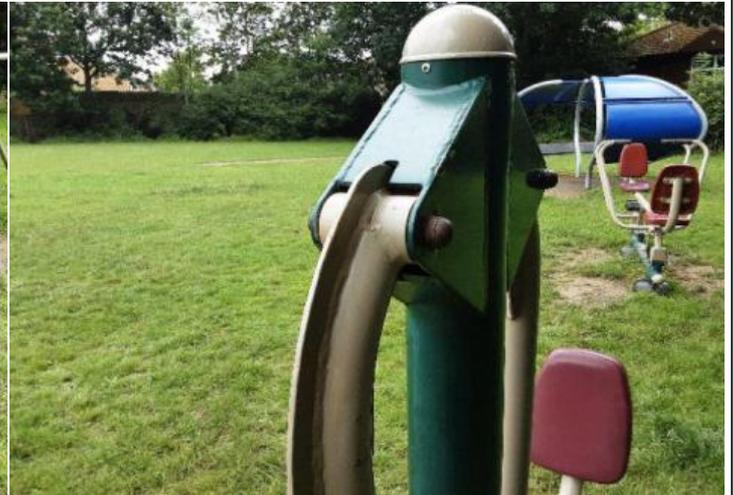
Finding: The bushes are showing signs of wear

Action: Monitor for any further deterioration and replace as required

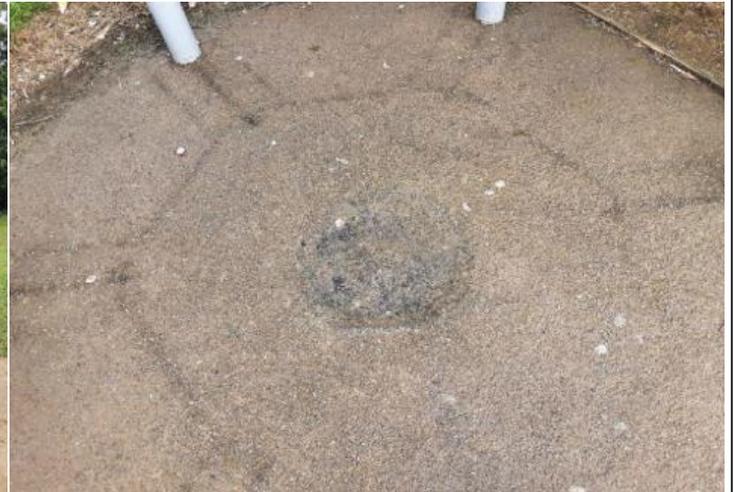
Finding: There is some evidence of fire damage to the surfacing

Action: Monitor for any further deterioration and repair as required

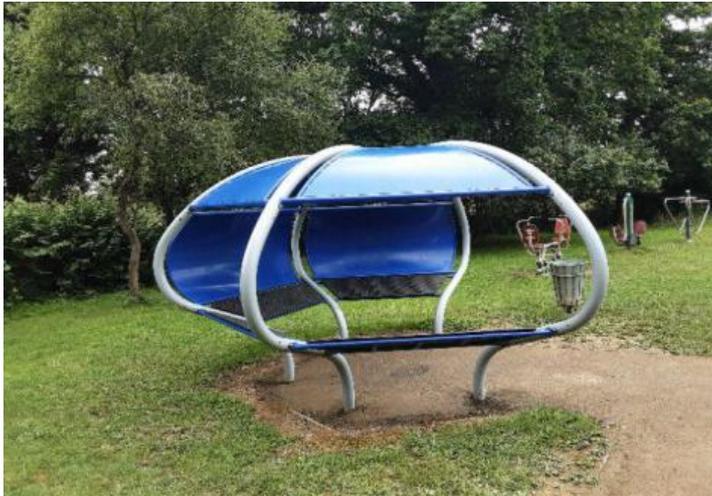
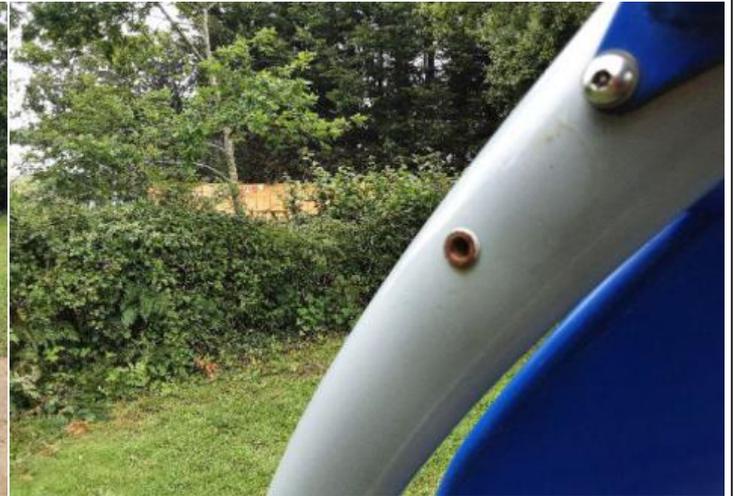
Finding: There is/are several inserts missing

Action: Replace missing inserts
