the **play inspection** company

Annual Inspection

Broadbridge Heath Parish Council

Charrington Way Play Area

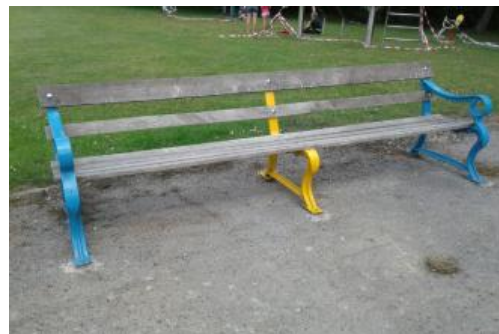
Finding 1

Item: Bench
Manufacturer: Owner/Operator
Surface Type: N/A
Item Quantity: 3
Equipment Compliance: N/A
Surface Area Compliance: N/A

This item is satisfactory - no work required -

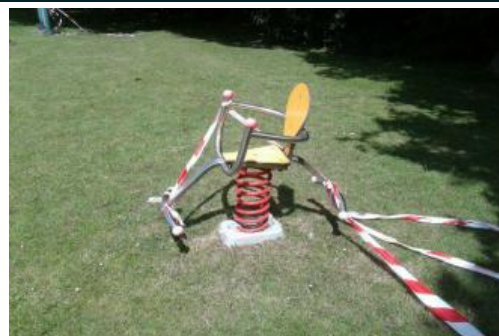
Finding 1

Item: Misc Springer
Manufacturer: Playdale Playgrounds Ltd
Surface Type: Grass Matrix Tiles
Item Quantity: 1
Equipment Compliance: Yes
Surface Area Compliance: Yes

This item is satisfactory - no work required -

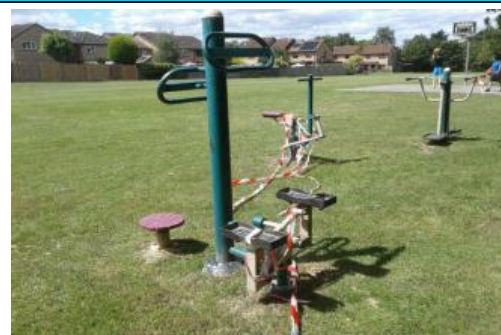
Finding 1

Item: Ski Stepper
Manufacturer: Fresh Air Fitness
Surface Type: Grass Matrix Tiles
Item Quantity: 1
Equipment Compliance: Yes
Surface Area Compliance: Yes

This item is satisfactory - no work required -
