the **play inspection** company

Annual Inspection

Broadbridge Heath Parish Council

Charrington Way Play Area

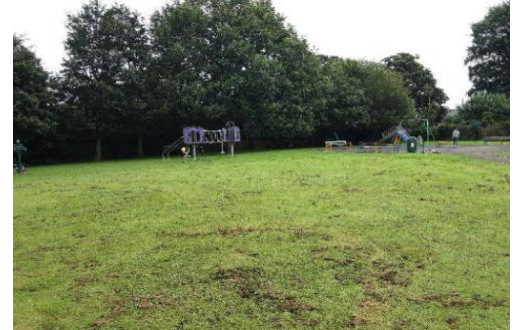
Item: Site General
Manufacturer: Owner/Operator
Surface Type: N/A
Item Quantity: 1
Equipment Compliance: N/A
Surface Area Compliance: N/A

The site is accessible to the public during the COVID 19 pandemic. The government have released guidelines for safely re-opening these types of facilities which is available on the government website. - Ensure there is an appropriate risk assessment in place and review regularly

There is moderate damage to the surface - Repair the damaged areas of surfacing

Finding: There is moderate damage to the surface

Action: Repair the damaged areas of surfacing

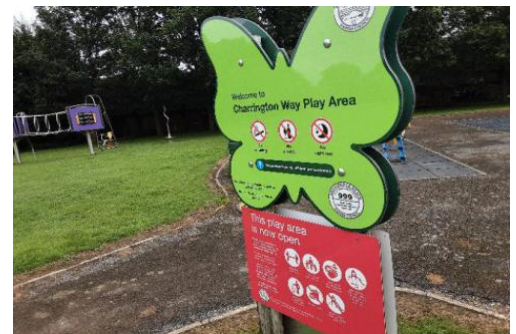
Item: Sign
Manufacturer: Owner/Operator
Surface Type: N/A
Item Quantity: 1
Equipment Compliance: N/A
Surface Area Compliance: N/A

The item is slightly loose in its foundations - Monitor for any further deterioration and repair as required

Finding: The item is slightly loose in its foundations

Action: Monitor for any further deterioration and repair as required

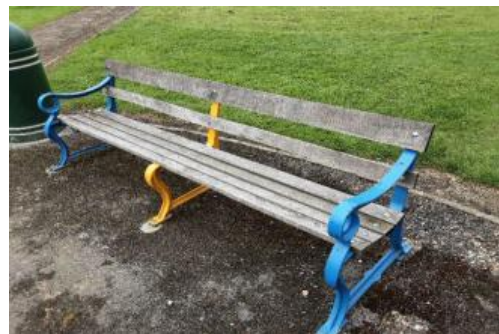
Item: Bench
Manufacturer: Owner/Operator
Surface Type: N/A
Item Quantity: 3
Equipment Compliance: N/A
Surface Area Compliance: N/A

This item is satisfactory - no work required -

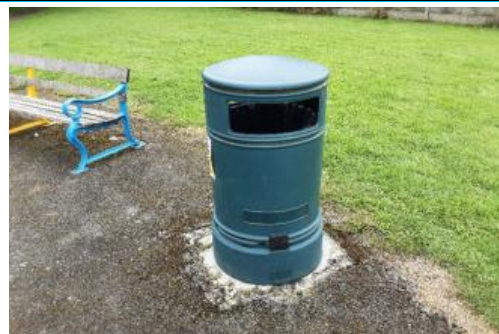
Item: Litter Bin
Manufacturer: Owner/Operator
Surface Type: N/A
Item Quantity: 2
Equipment Compliance: N/A
Surface Area Compliance: N/A

This item is satisfactory - no work required -

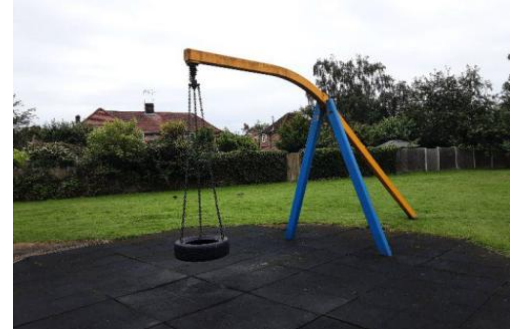
Item: Single Point Swing - Type 3
Manufacturer: Wicksteed Playgrounds
Surface Type: Rubber Tiles
Item Quantity: 1
Equipment Compliance: No
Surface Area Compliance: No

There are gaps opening in between the tiles - Monitor for any further deterioration and repair as required

There is some minor damage to the surface - Monitor for any further deterioration and repair as required

The surfacing dimensions are short and do not meet with the requirements of the current applicable standard - Monitor - no remedial action recommended

The gaiter is damaged - Replace all affected components

Finding: The gaiter is damaged

Action: Replace all affected components

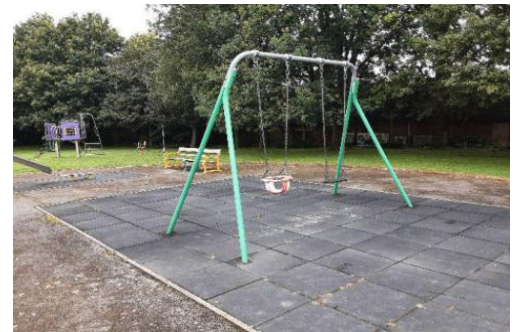
Item: 1 Bay 2 Seat (Cradle)
Manufacturer: Sutcliffe Play Limited
Surface Type: Rubber Tiles
Item Quantity: 1
Equipment Compliance: No
Surface Area Compliance: Yes

The shackles have been overtightened or seized transferring wear to the chain links below - Loosen shackles to ensure free movement at the pivot

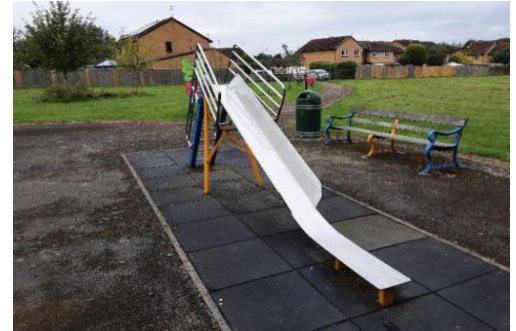
Item: Free Standing Slide
Manufacturer: Not Identified
Surface Type: Rubber Tiles
Item Quantity: 1
Equipment Compliance: No
Surface Area Compliance: No

There are gaps opening in between the tiles - Monitor for any further deterioration and repair as required

The item fails to meet the requirements of BS EN 1176 Part 1 4.2.7.2 head and neck entrapment in the barriers and/or steps - Monitor - No remedial work recommended

There is / are toggle entrapment/s present in contravention of the recommendations set out in BS EN 1176 Part 3 - Monitor - no remedial work recommended

The paintwork on this item has been damaged or worn exposing the metal underneath which is rusting - Treat any rusting components and repaint

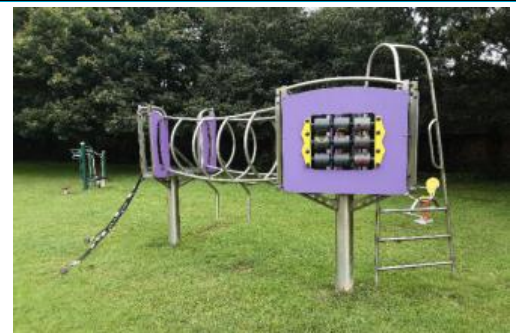
Item: Multi Play (Junior)
Manufacturer: Playdale Playgrounds Ltd
Surface Type: Grass Matrix Tiles
Item Quantity: 1
Equipment Compliance: Yes
Surface Area Compliance: Yes

This item is satisfactory - no work required -

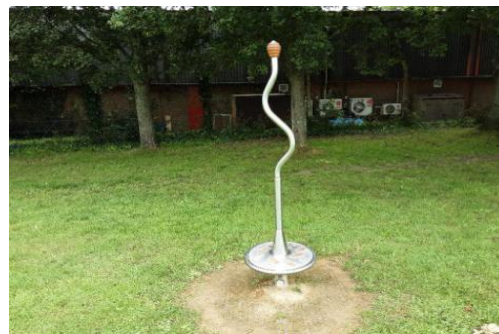
Item: Spinning Pole
Manufacturer: Playdale Playgrounds Ltd
Surface Type: Grass Matrix Tiles
Item Quantity: 1
Equipment Compliance: Yes
Surface Area Compliance: Yes

The grass mats are silted up and the soil is compacted; this may have an effect on the impact absorbing properties of the surface - Consider HIC testing impact absorbing properties to ensure the correct surface qualities are maintained for the equipment and replace as required

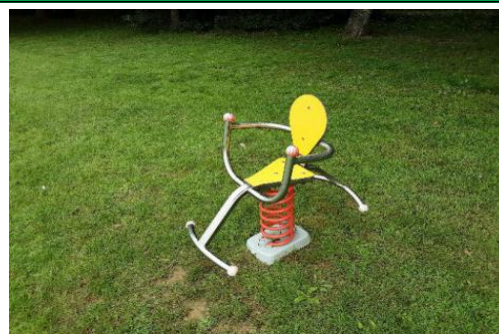
Item: Misc Springer
Manufacturer: Playdale Playgrounds Ltd
Surface Type: Grass Matrix Tiles
Item Quantity: 1
Equipment Compliance: Yes
Surface Area Compliance: Yes

There is some damage to the spring base - Repair or replace as required

There is/are bolt cap covers missing or damaged on the item - Replace missing or damaged bolt cap covers

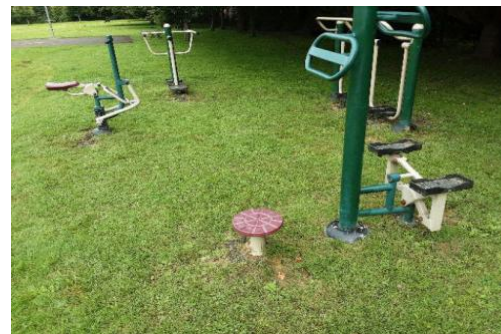
Item: Waist Twister
Manufacturer: Fresh Air Fitness
Surface Type: Grass Matrix Tiles
Item Quantity: 1
Equipment Compliance: No
Surface Area Compliance: Yes

The deflection of the rotating user station exceeds the maximum 105 degrees required by BS EN 16630 - Monitor - No remedial work recommended

The rotating user station is not appropriately marked with a guideline of user direction and/or the original position as required by BS EN 16630 - Monitor - No remedial work recommended

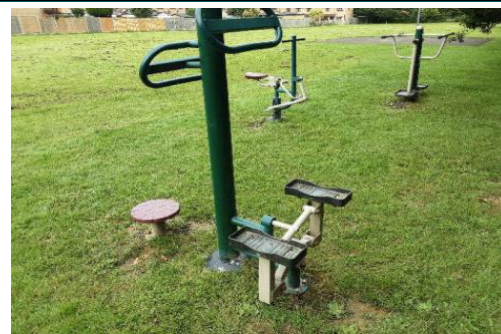
Item: Step Up Station
Manufacturer: Fresh Air Fitness
Surface Type: Grass Matrix Tiles
Item Quantity: 1
Equipment Compliance: Yes
Surface Area Compliance: Yes

The bushes are showing signs of wear - Monitor for any further deterioration and replace as required

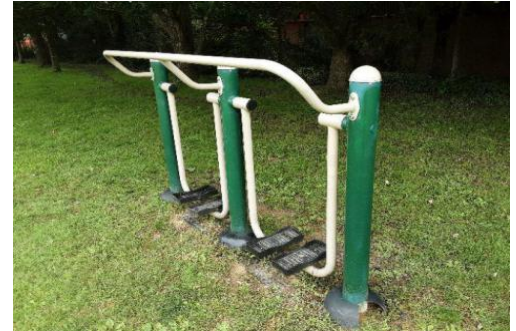
Item: Double Air Walker
Manufacturer: Fresh Air Fitness
Surface Type: Grass Matrix Tiles
Item Quantity: 1
Equipment Compliance: No
Surface Area Compliance: Yes

One of the post ground covers has been damaged -
Replace all affected components

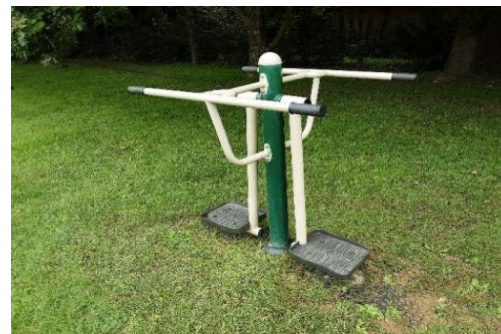
Item: Air Skier
Manufacturer: Fresh Air Fitness
Surface Type: Grass Matrix Tiles
Item Quantity: 1
Equipment Compliance: No
Surface Area Compliance: Yes

There are gaps between 8 and 60mm creating a potential crush/shear point in contravention of the requirements of BS EN 16630 - Monitor - No remedial work recommended

There is some minor damage to the surface - Monitor for any further deterioration and repair as required

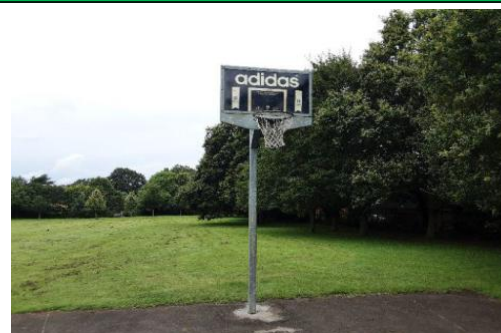
Item: Basket Ball Goal
Manufacturer: Not Identified
Surface Type: Tarmac
Item Quantity: 1
Equipment Compliance: Yes
Surface Area Compliance: N/A

There is some damage to the backboard - Replace all affected components
