Annual Inspection

Broadbridge Heath Parish Council

Singleton Road

Inspection Ref: 1140100

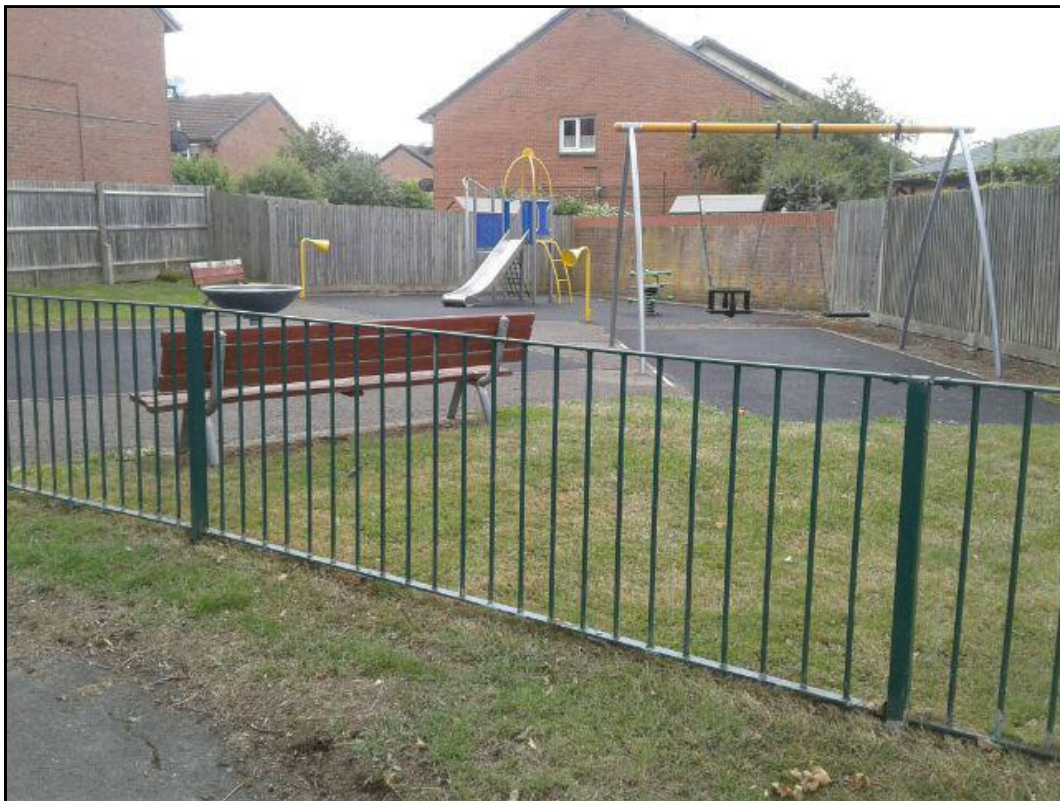
Risk Assessment: 8 Low Risk

Location:

The site is located in an area of public open space and is overlooked by a number of properties in the local community.
