the play inspection company

Annual Inspection

Broadbridge Heath Parish Council

Singleton Road

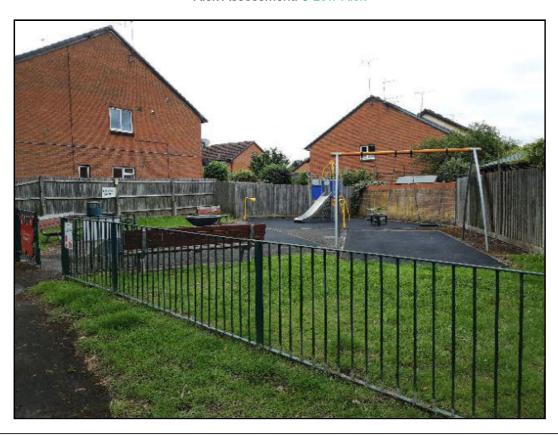
The site is located in an area of public open space and is overlooked by a number of properties in the local community. **Disabled Access:**
