the **play inspection** company

Annual Inspection

Broadbridge Heath Parish Council

Village Centre

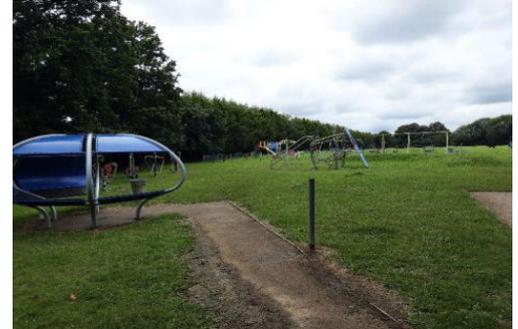
Item: Site General
Manufacturer: Owner/Operator
Surface Type: N/A
Item Quantity: 1
Equipment Compliance: N/A
Surface Area Compliance: N/A

The site is accessible to the public during the COVID 19 pandemic. The government have released guidelines for safely re-opening these types of facilities which is available on the government website. - Ensure there is an appropriate risk assessment in place and review regularly

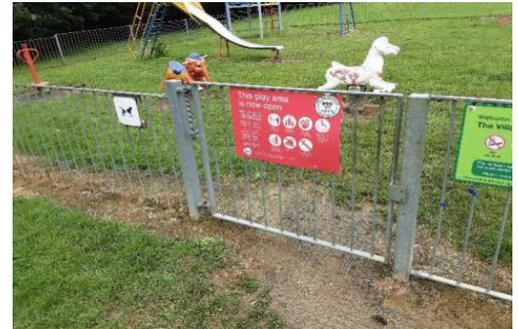
Item: Gate - Self Closing
Manufacturer: Owner/Operator
Surface Type: N/A
Item Quantity: 1
Equipment Compliance: N/A
Surface Area Compliance: N/A

The grass mats are silted up, the soil is compacted and the area will become very slippery when the soil is wet. - Reinstate as required

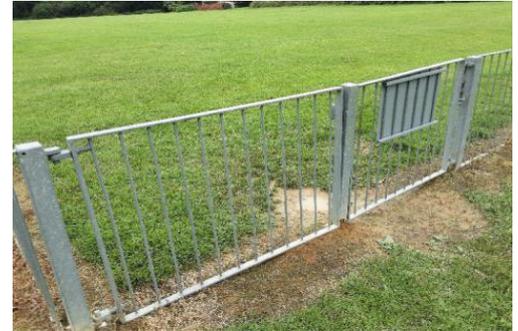
Item: Gate - Combination
Manufacturer: Owner/Operator
Surface Type: N/A
Item Quantity: 1
Equipment Compliance: N/A
Surface Area Compliance: N/A

The area under the gate has eroded leaving uneven areas, or the concrete foundations exposed, resulting in trip hazards at the entrance/exit to the playground - Reinstate to level with surrounding surfaces

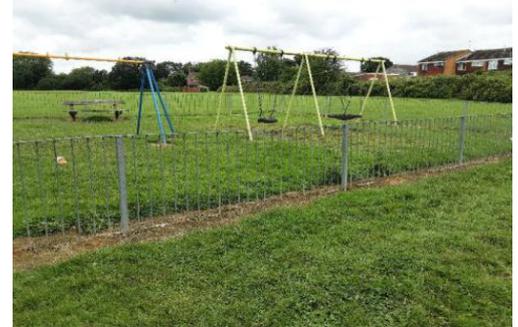
Item: Fencing - Flat Top
Manufacturer: Owner/Operator
Surface Type: N/A
Item Quantity: 1
Equipment Compliance: N/A
Surface Area Compliance: N/A

There is some damage to the fence sections - Monitor for any further deterioration and repair as required

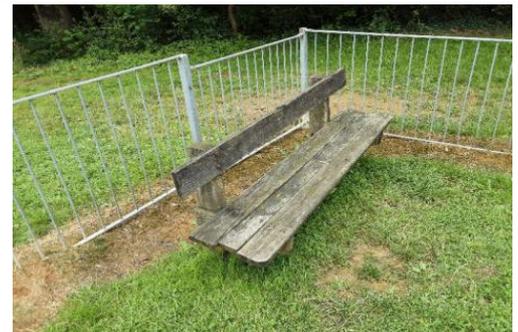
Item: Bench
Manufacturer: Owner/Operator
Surface Type: N/A
Item Quantity: 2
Equipment Compliance: N/A
Surface Area Compliance: N/A

There is some evidence of rot in the timber - Monitor for any further deterioration and replace as required

There is some strimmer / machinery damage apparent on the posts, this can penetrate the preservative applied to the timber and accelerate the rotting process - Monitor for any deterioration (rot) and replace as required

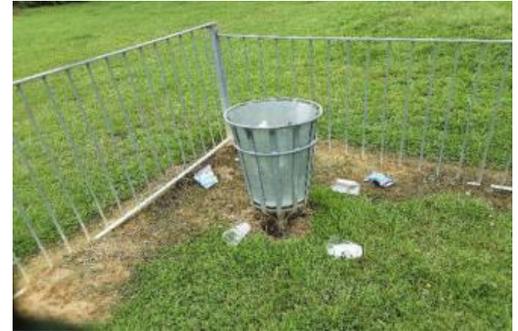
Item: Litter Bin
Manufacturer: Owner/Operator
Surface Type: N/A
Item Quantity: 2
Equipment Compliance: N/A
Surface Area Compliance: N/A

This item is satisfactory - no work required -

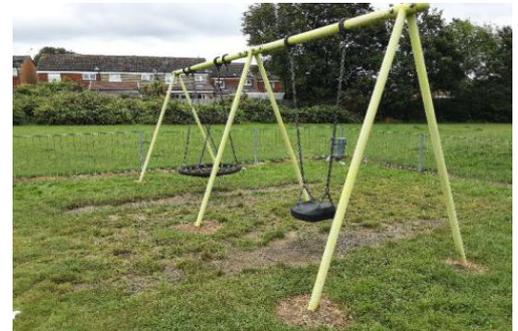
Item: 2 Bay Swing
Manufacturer: S M P (Playgrounds Ltd)
Surface Type: Grass Matrix Tiles
Item Quantity: 1
Equipment Compliance: No
Surface Area Compliance: Yes

The grass mats are silted up and the soil is compacted; this may have an effect on the impact absorbing properties of the surface - Consider HIC testing impact absorbing properties to ensure the correct surface qualities are maintained for the equipment and replace as required

The swing seat connectors have some wear present - Monitor for further deterioration and replace when 40% worn

There is some notable evidence of chain wear - Monitor for any further deterioration and replace when 40% worn

There is some wear to the shackles. - Monitor for any further deterioration and replace when 40% worn

The bushes are showing signs of wear - Monitor for any further deterioration and replace as required

The chain links are worn in excess of 40% and require renewing on the basket seat - Replace worn chains

The Anti Wrap bearings are dry and not moving freely - Lubricate bearings in accordance with the manufacturers recommendations

The chain openings are in excess of the 8.6mm as recommended by BS EN 1176 - Monitor - No remedial work recommended

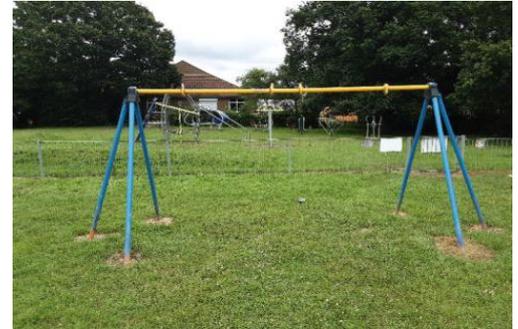
Item: 1 Bay 2 Seat (Cradle)
Manufacturer: Wicksteed Playgrounds
Surface Type: Grass Matrix Tiles
Item Quantity: 1
Equipment Compliance: N/A
Surface Area Compliance: N/A

The seat(s) and suspension were missing at the time of inspection and the inspector was unable to make a full compliance assessment - Replace missing seat(s) and suspension

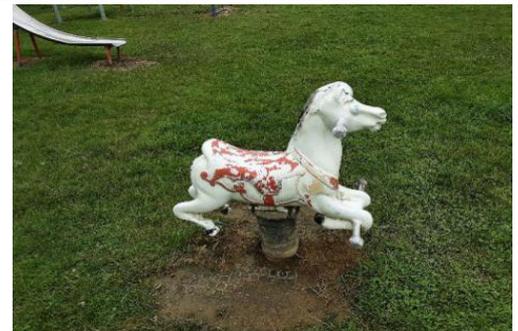
Item: Spring Horse
Manufacturer: Wicksteed Playgrounds
Surface Type: Grass Matrix Tiles
Item Quantity: 1
Equipment Compliance: Yes
Surface Area Compliance: Yes

The grass mats are silted up and the soil is compacted; this may have an effect on the impact absorbing properties of the surface - Consider HIC testing impact absorbing properties to ensure the correct surface qualities are maintained for the equipment and replace as required

The paintwork on the spring has been damaged or worn exposing the metal underneath which is rusting - Treat any rusting components and repaint

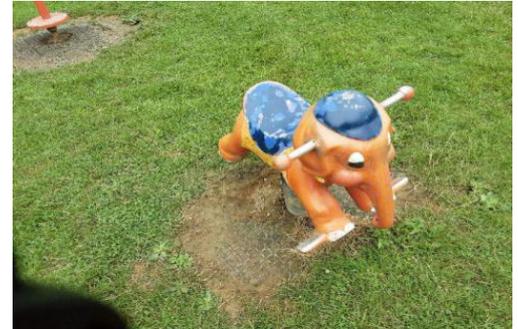
Item: Spring Elephant
Manufacturer: Wicksteed Playgrounds
Surface Type: Grass Matrix Tiles
Item Quantity: 1
Equipment Compliance: Yes
Surface Area Compliance: Yes

The grass mats are silted up and the soil is compacted; this may have an effect on the impact absorbing properties of the surface - Consider HIC testing impact absorbing properties to ensure the correct surface qualities are maintained for the equipment and replace as required

The spring cover is damaged, split or missing - Monitor for any further deterioration and replace as required

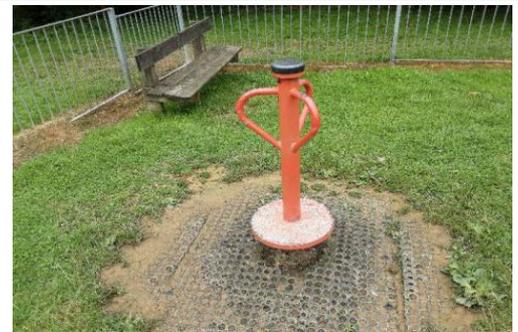
Item: Spinning Pole
Manufacturer: Wicksteed Playgrounds
Surface Type: Grass Matrix Tiles
Item Quantity: 1
Equipment Compliance: Yes
Surface Area Compliance: Yes

The grass mats are silted up and the soil is compacted; this may have an effect on the impact absorbing properties of the surface - Consider HIC testing impact absorbing properties to ensure the correct surface qualities are maintained for the equipment and replace as required

There are gaps opening between the grass mat tiles creating trip hazards - Reinstate surface

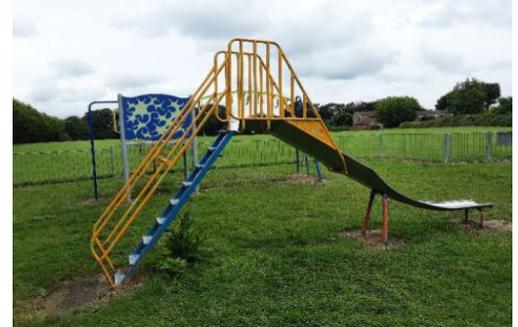
Item: Free Standing Slide
Manufacturer: Wicksteed Playgrounds
Surface Type: Grass Matrix Tiles
Item Quantity: 1
Equipment Compliance: No
Surface Area Compliance: Yes

There is weed / vegetation growth on, between, or around the edges of the surfacing - Remove weed / vegetation growth

There is / are toggle entrapment/s present in contravention of the recommendations set out in BS EN 1176 Part 3 - Monitor - no remedial work recommended

There are a number of dents in the slide surface - Monitor for any further deterioration and repair as required

The item fails to meet the requirements of BS EN 1176 Part 1 4.2.7.2 head and neck entrapment in the barriers and/or steps - Monitor - No remedial work recommended

The paintwork on this item has been damaged or worn exposing the metal underneath which is rusting - Treat any rusting components and repaint

The grass mats are silted up and the soil is compacted; this may have an effect on the impact absorbing properties of the surface - Consider HIC testing impact absorbing properties to ensure the correct surface qualities are maintained for the equipment and replace as required

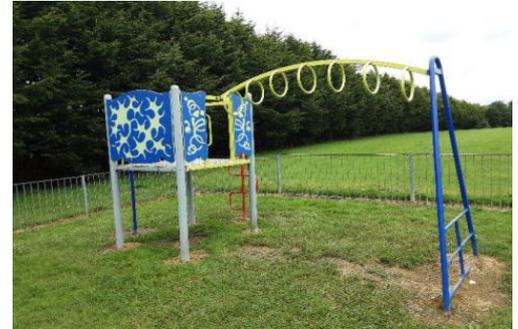
Item: Multi Play (Junior)
Manufacturer: S M P (Playgrounds Ltd)
Surface Type: Grass Matrix Tiles
Item Quantity: 1
Equipment Compliance: Yes
Surface Area Compliance: Yes

The grass mats are silted up and the soil is compacted; this may have an effect on the impact absorbing properties of the surface - Consider HIC testing impact absorbing properties to ensure the correct surface qualities are maintained for the equipment and replace as required

The paintwork on this item has been damaged or worn exposing the metal underneath which is rusting - Treat any rusting components and repaint

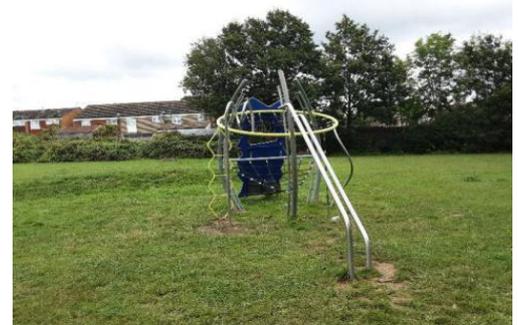
Item: Climbing Frame
Manufacturer: S M P (Playgrounds Ltd)
Surface Type: Grass Matrix Tiles
Item Quantity: 1
Equipment Compliance: Yes
Surface Area Compliance: Yes

The connecting lugs are showing signs of wear - Monitor for any further deterioration and repair as required

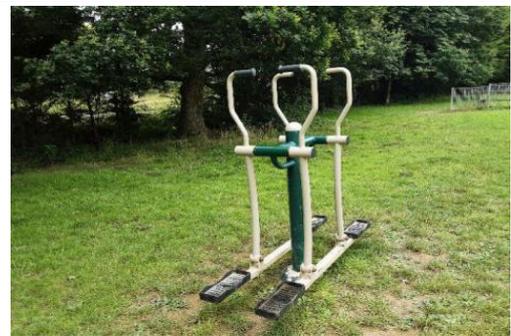
Item: Skier
Manufacturer: Fresh Air Fitness
Surface Type: Grass Matrix Tiles
Item Quantity: 1
Equipment Compliance: No
Surface Area Compliance: Yes

Finding 1
 The grass mats are silted up, the soil is compacted and the area will become very slippery when the soil is wet. - Reinstate as required

Finding 2
 The swinging movement of the item exceeds the maximum 55 degrees from the vertical required by BS EN 16630 - Monitor - No remedial work recommended

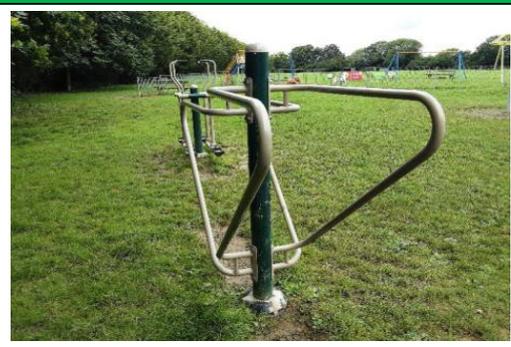
Item: Push Up / Dip Station
Manufacturer: Fresh Air Fitness
Surface Type: Grass Matrix Tiles
Item Quantity: 1
Equipment Compliance: No
Surface Area Compliance: Yes

Finding 1
 The information signage is missing - Replace all missing components

Finding 2
 The grass mats are silted up, the soil is compacted and the area will become very slippery when the soil is wet. - Reinstate as required

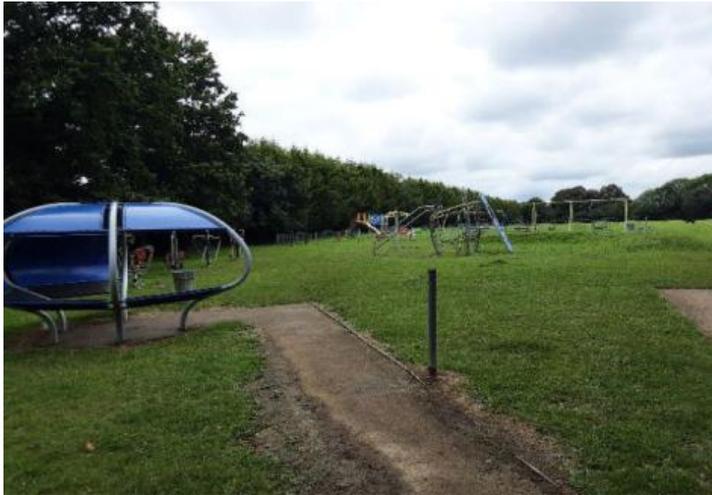
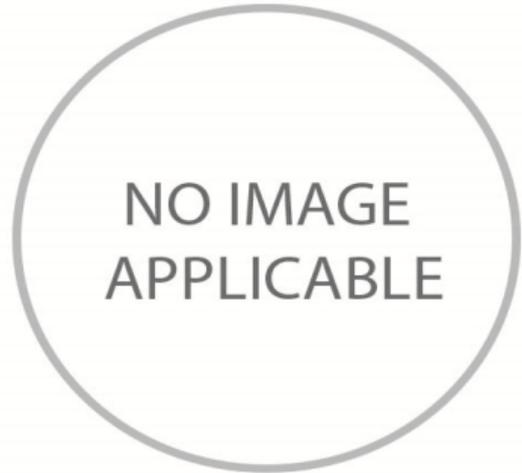
Item: Ancillary Items - Site General
Manufacturer: Owner/Operator

Finding: The site is accessible to the public during the COVID 19 pandemic. The government have released guidelines for safely re-opening these types of facilities which is available on the government website.

Action: Ensure there is an appropriate risk assessment in place and review regularly

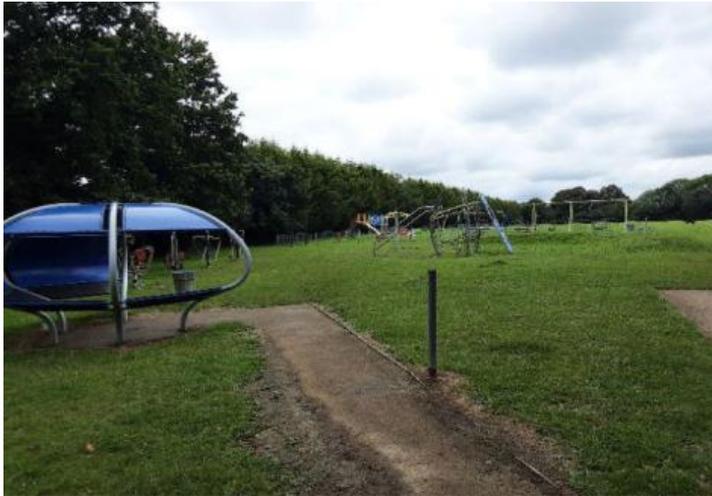
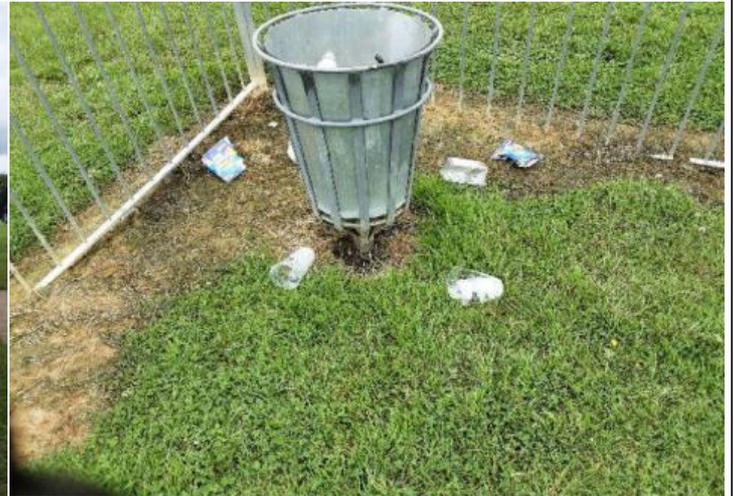
Item: Ancillary Items - Site General
Manufacturer: Owner/Operator

Finding: There is litter/debris in the area

Action: Remove litter/debris from the area and maintain

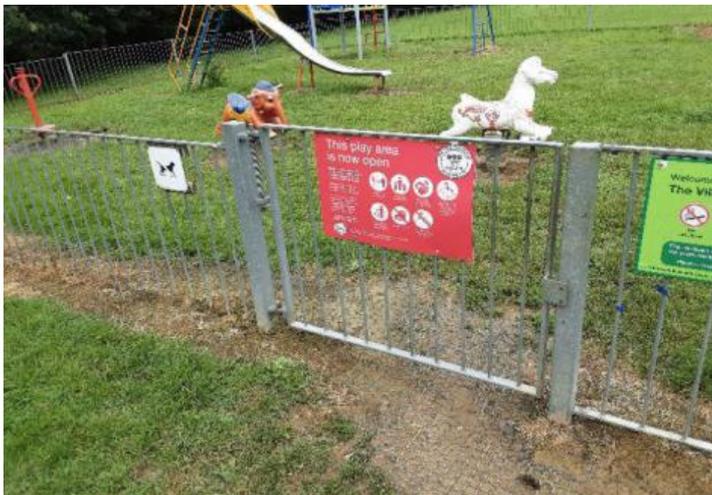
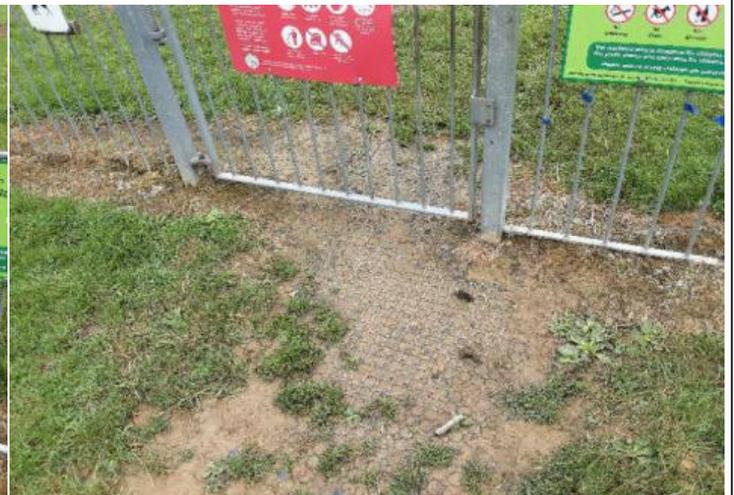
Item: Gates - Gate - Self Closing
Manufacturer: Owner/Operator

Finding: The grass mats are silted up, the soil is compacted and the area will become very slippery when the soil is wet.

Action: Reinstate as required

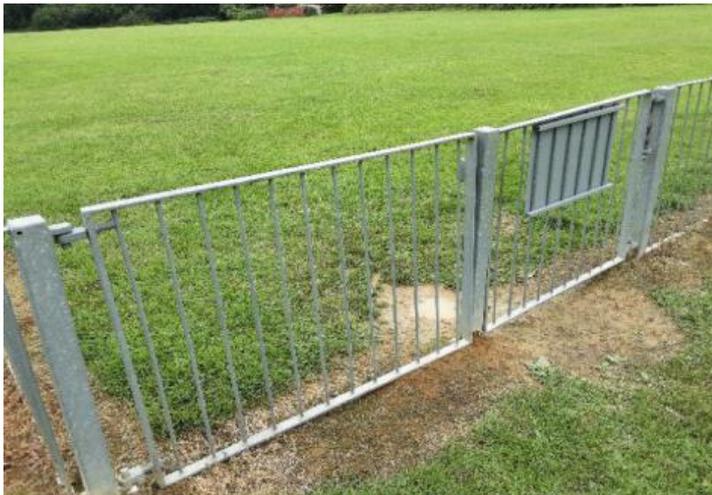
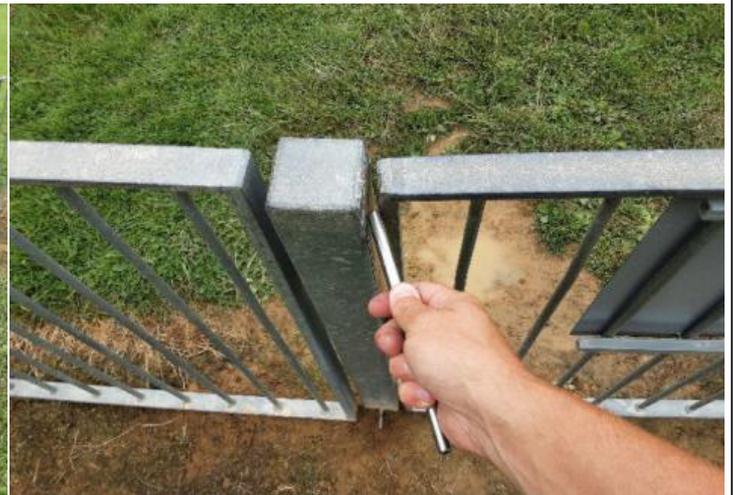
Item: Gates - Gate - Combination
Manufacturer: Owner/Operator

Finding: There are openings that are less than 12mm that could trap or crush fingers

Action: Where possible a 12mm gap should be maintained on both sides or between the gate leaves

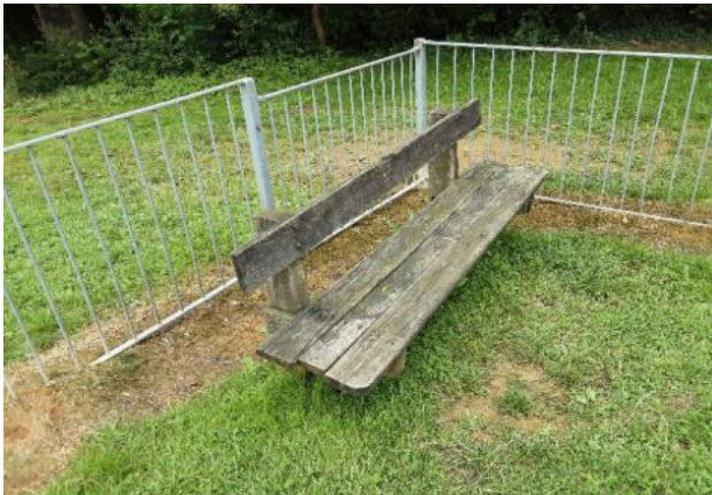
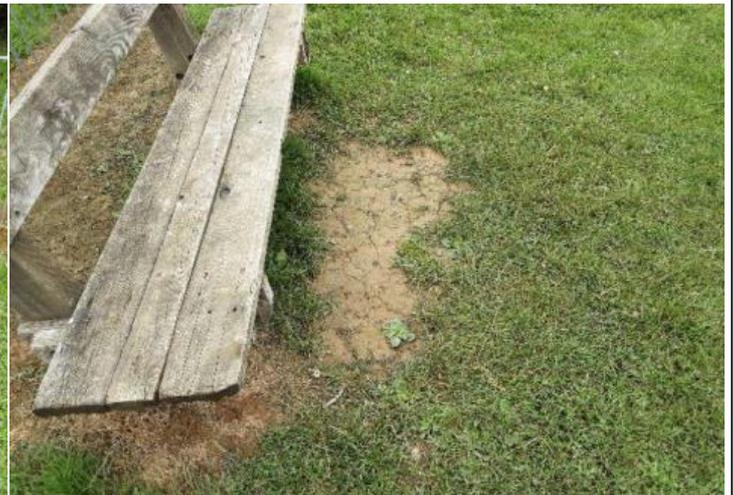
Item: Ancillary Items - Bench
Manufacturer: Owner/Operator

Finding: The area around the item has eroded and may become slippery

Action: Reinstate eroded area

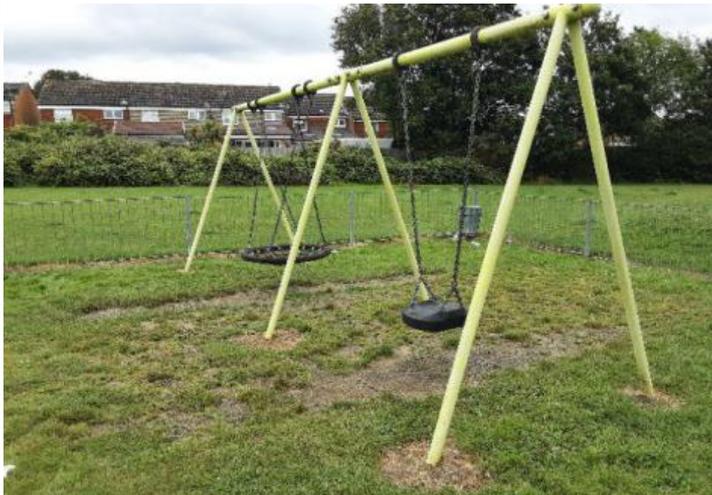
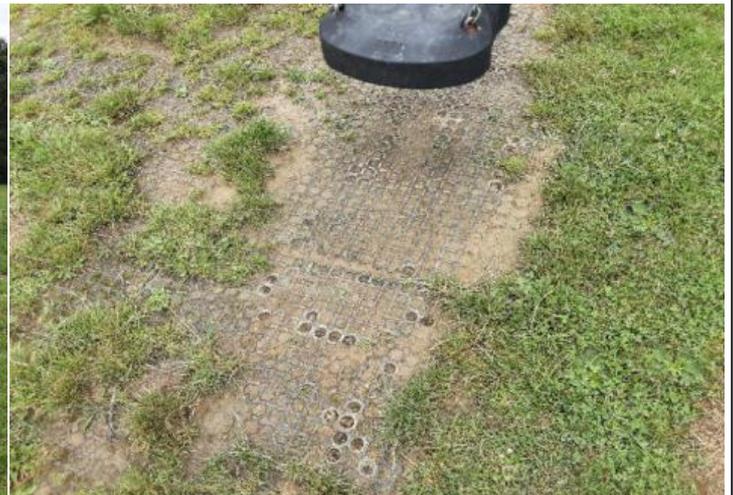
Item: Swings - 2 Bay Swing
Manufacturer: S M P (Playgrounds Ltd)

Finding: There are gaps opening between the grass mat tiles

Action: Reinstate surface

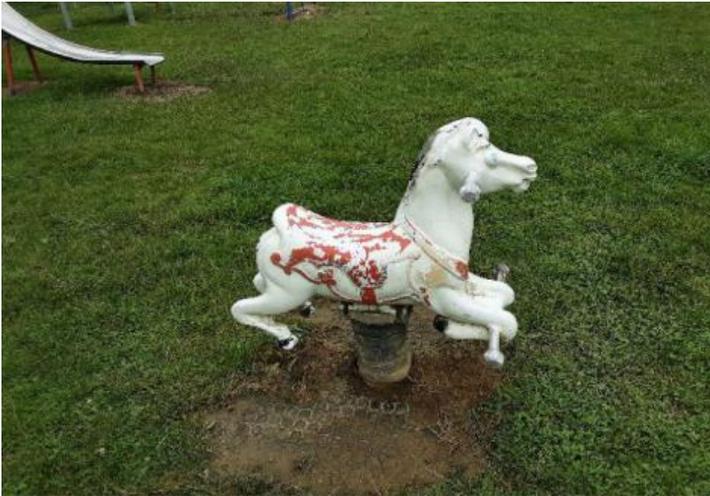
Item: Rocking Equipment - Spring Horse
Manufacturer: Wicksteed Playgrounds

Finding: The paintwork on the spring has been damaged or worn exposing the metal underneath which is rusting
Action: Treat any rusting components and repaint

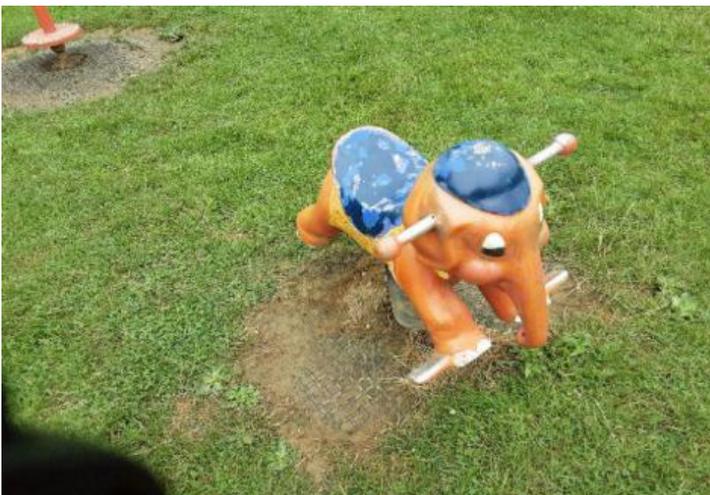
Item: Rocking Equipment - Spring Elephant
Manufacturer: Wicksteed Playgrounds

Finding: The grass mats are silted up and the soil is compacted; this may have an effect on the impact absorbing properties of the surface
Action: Consider HIC testing impact absorbing properties to ensure the correct surface qualities are maintained for the equipment and replace as required

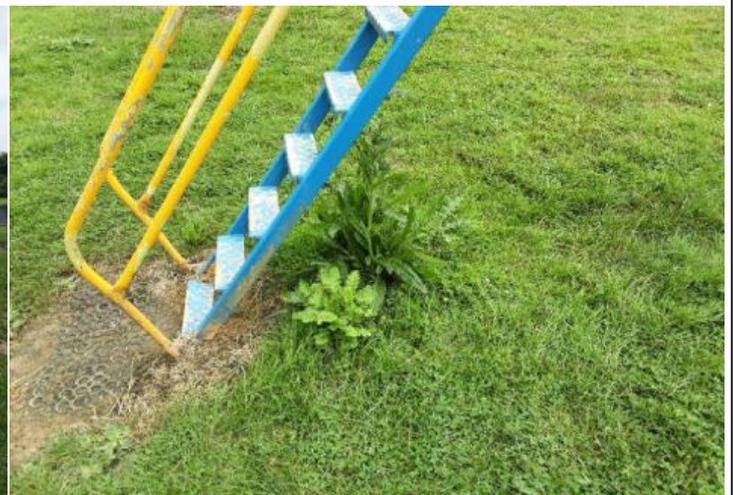
Item: Other - Free Standing Slide
Manufacturer: Wicksteed Playgrounds

Finding: There is weed / vegetation growth on, between, or around the edges of the surfacing

Action: Remove weed / vegetation growth

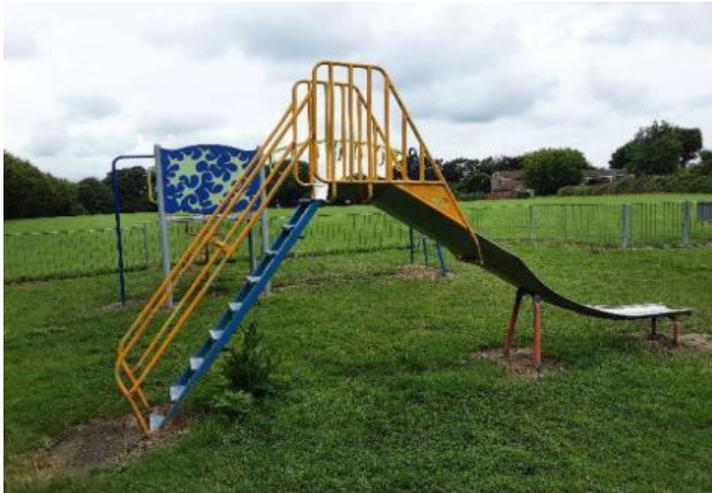
Item: Other - Free Standing Slide
Manufacturer: Wicksteed Playgrounds

Finding: The item fails to meet the requirements of BS EN 1176 Part 1 4.2.7.2 head and neck entrapment in the barriers and/or steps

Action: Monitor - No remedial work recommended

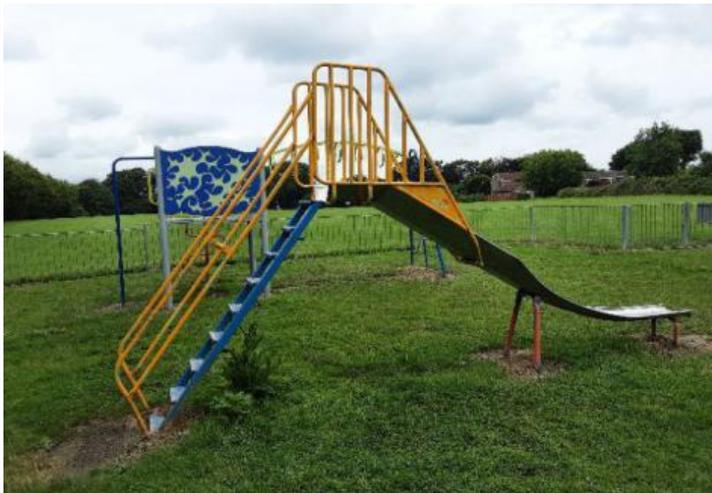
Item: Other - Free Standing Slide
Manufacturer: Wicksteed Playgrounds

Finding: There is / are toggle entrapment/s present in contravention of the recommendations set out in BS EN 1176 Part 3

Action: Monitor - no remedial work recommended

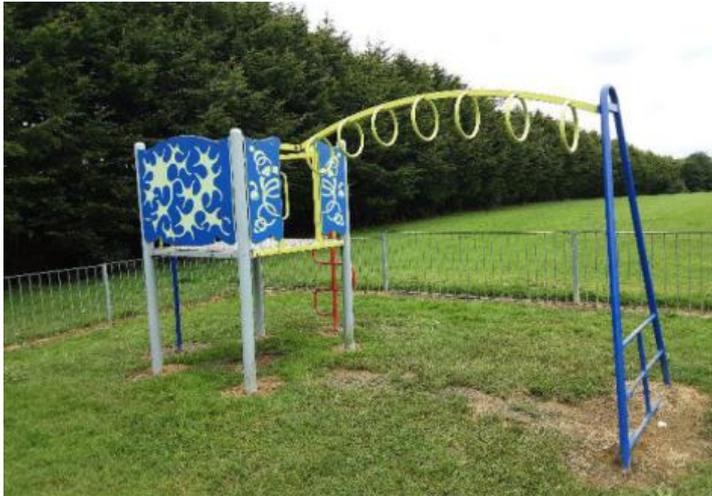
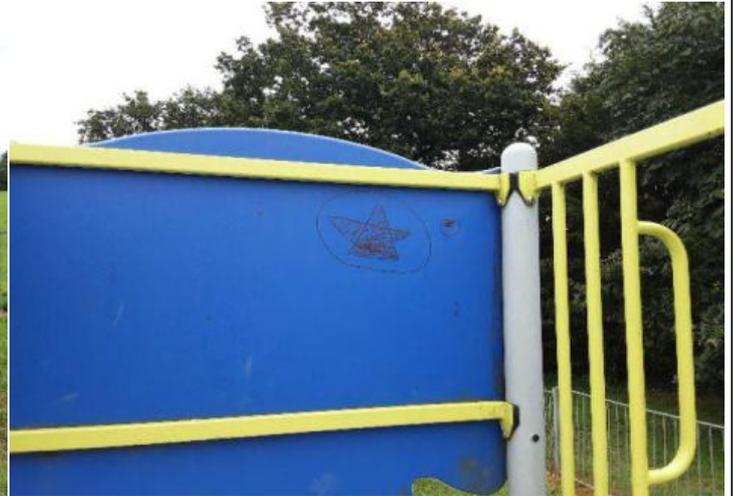
Item: Activity Equipment - Multi Play (Junior)
Manufacturer: S M P (Playgrounds Ltd)

Finding: There is some graffiti present

Action: Remove the graffiti

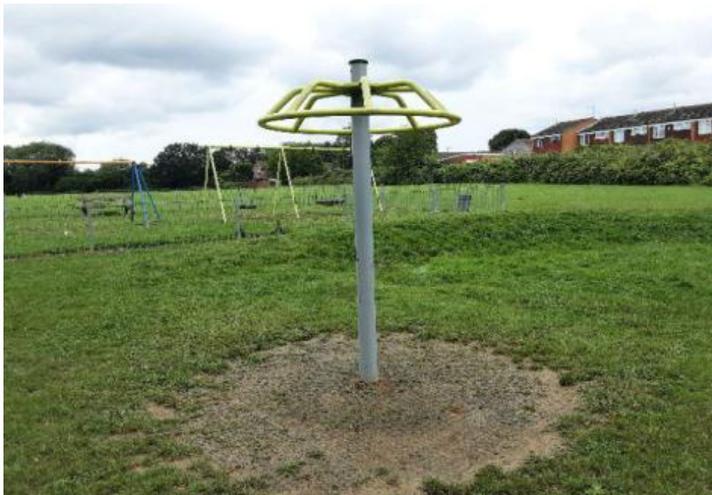
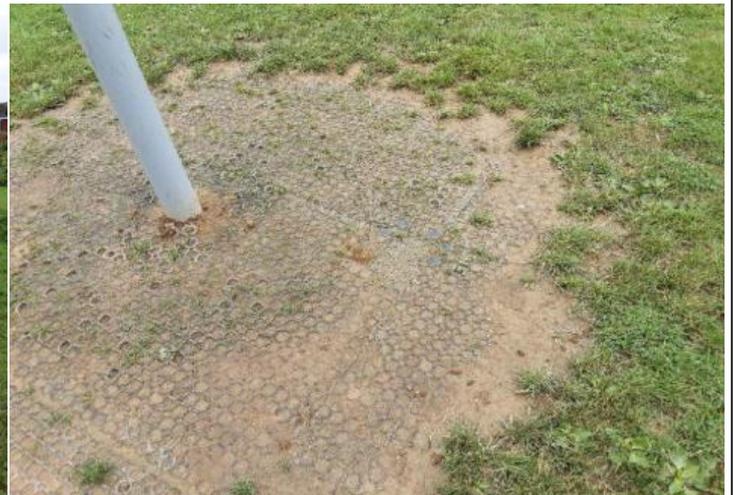
Item: Rotor Play - Overhead Rotator
Manufacturer: S M P (Playgrounds Ltd)

Finding: Fixing Pins have been installed in the impact areas of the grass mats

Action: Remove pins from impact areas

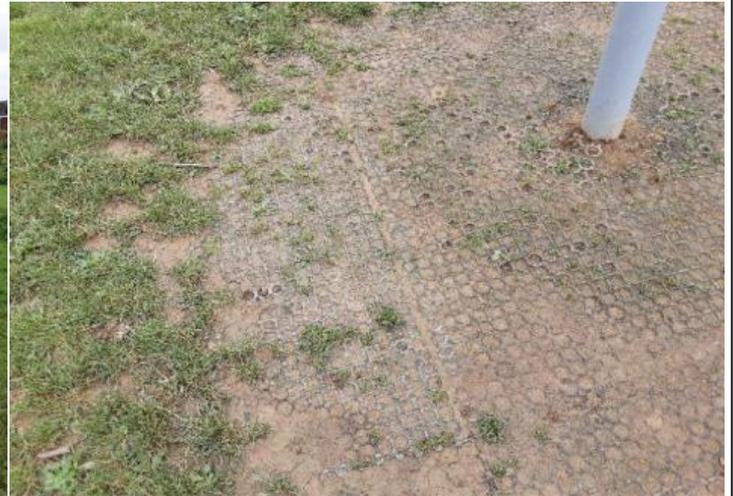
Item: Rotor Play - Overhead Rotator
Manufacturer: S M P (Playgrounds Ltd)

Finding: There are gaps opening between the grass mat tiles

Action: Reinstate surface

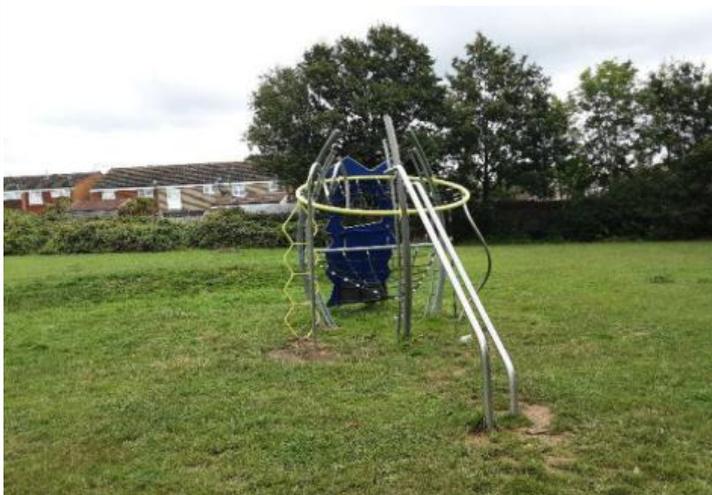
Item: Activity Equipment - Climbing Frame
Manufacturer: S M P (Playgrounds Ltd)

Finding: The grass mats are silted up and the soil is compacted; this may have an effect on the impact absorbing properties of the surface

Action: Consider HIC testing impact absorbing properties to ensure the correct surface qualities are maintained for the equipment and replace as required

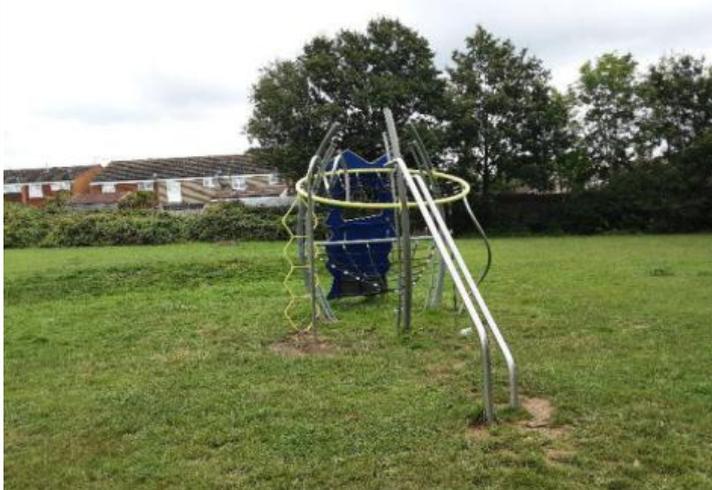
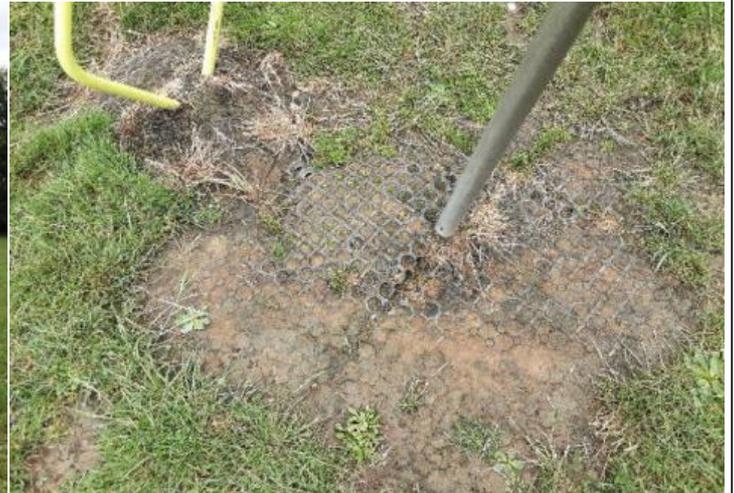
Item: Activity Equipment - Climbing Frame
Manufacturer: S M P (Playgrounds Ltd)

Finding: There are gaps opening between the grass mat tiles

Action: Reinstate surface

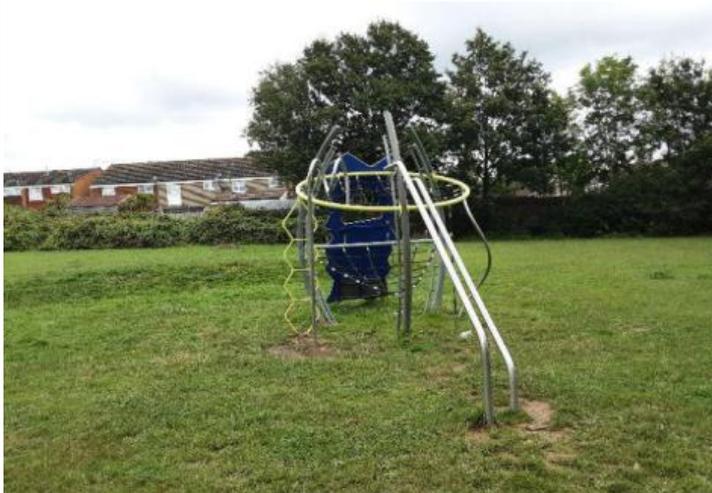
Item: Activity Equipment - Climbing Frame
Manufacturer: S M P (Playgrounds Ltd)

Finding: The ropes/nets are worn/damaged in places

Action: Monitor for any further deterioration and repair or replace as required

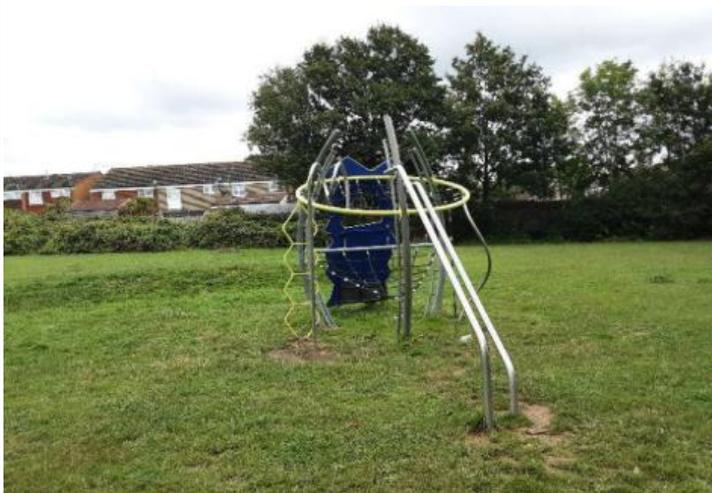
Item: Activity Equipment - Climbing Frame
Manufacturer: S M P (Playgrounds Ltd)

Finding: The surface has subsided in some areas

Action: Monitor for any further deterioration and repair as required

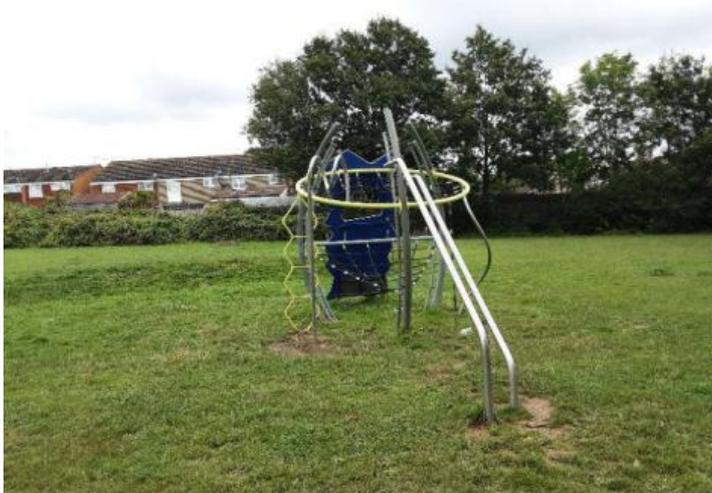
Item: Activity Equipment - Climbing Frame
Manufacturer: S M P (Playgrounds Ltd)

Finding: The item has been damaged

Action: Monitor for any further deterioration and replace as required

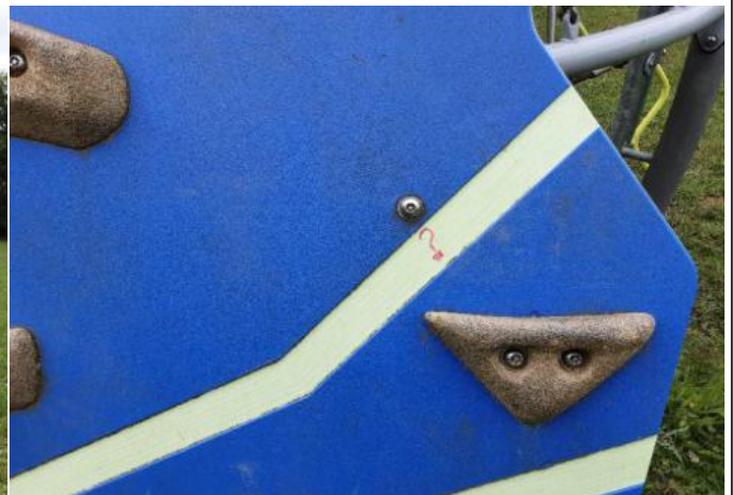
Item: Activity Equipment - Climbing Frame
Manufacturer: S M P (Playgrounds Ltd)

Finding: There is some graffiti present

Action: Remove the graffiti

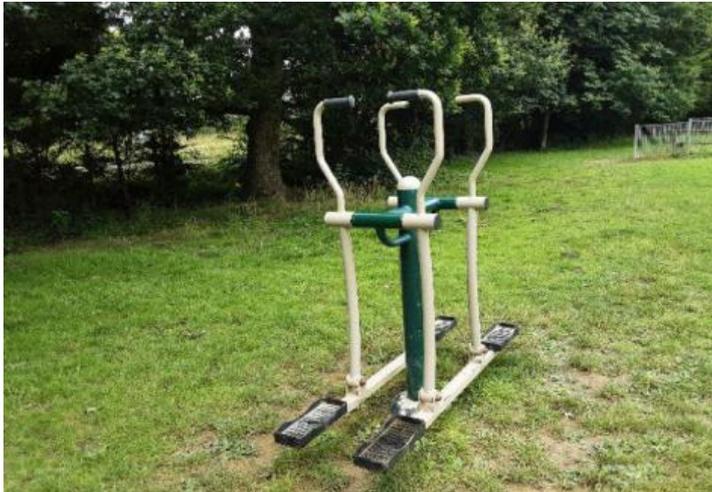
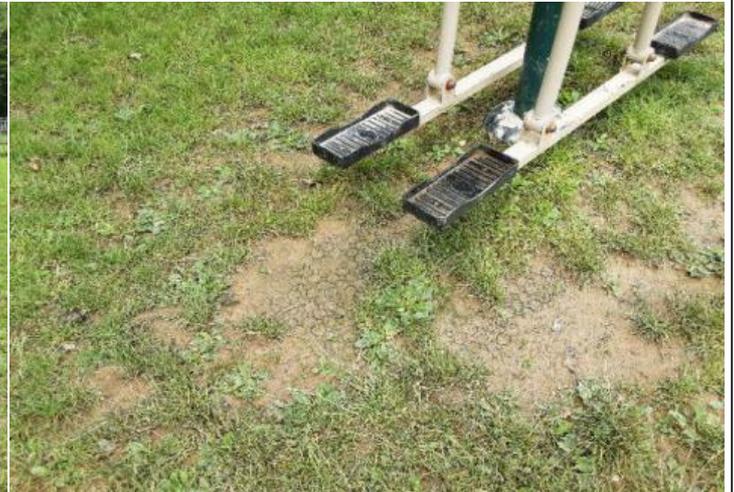
Item: Outdoor Fitness Equipment - Skier
Manufacturer: Fresh Air Fitness

Finding: The grass mats are silted up, the soil is compacted and the area will become very slippery when the soil is wet.

Action: Reinstate as required

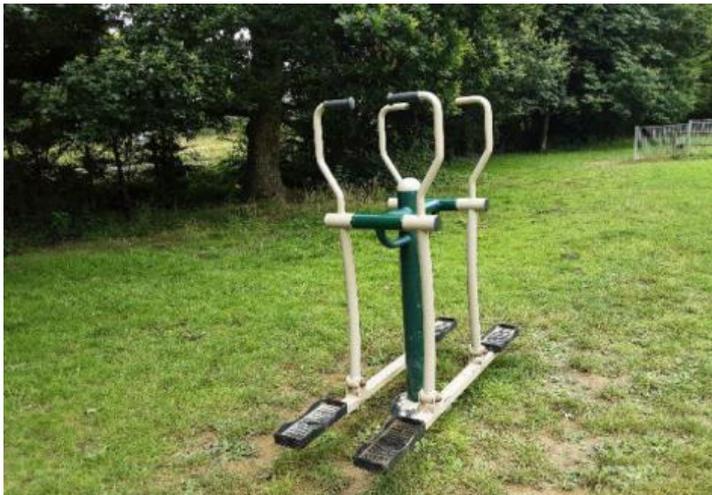
Item: Outdoor Fitness Equipment - Skier
Manufacturer: Fresh Air Fitness

Finding: One or more handgrip(s) are damaged or missing.

Action: Replace missing or damaged handgrips

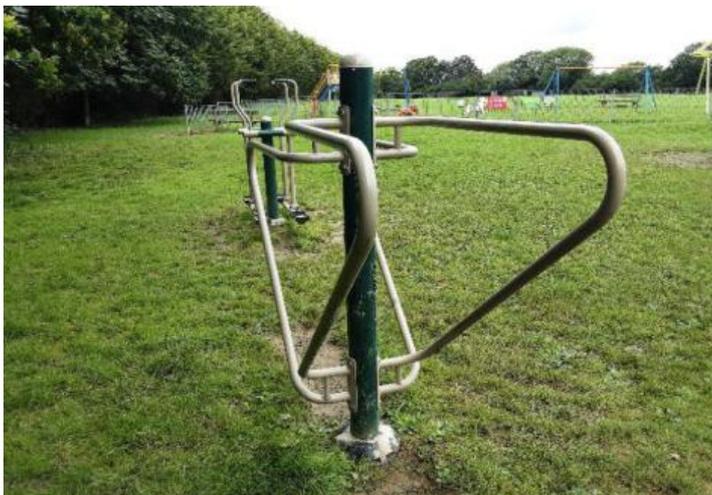
Item: Outdoor Fitness Equipment - Push Up / Dip Station
Manufacturer: Fresh Air Fitness

Finding: The information signage is missing

Action: Replace all missing components

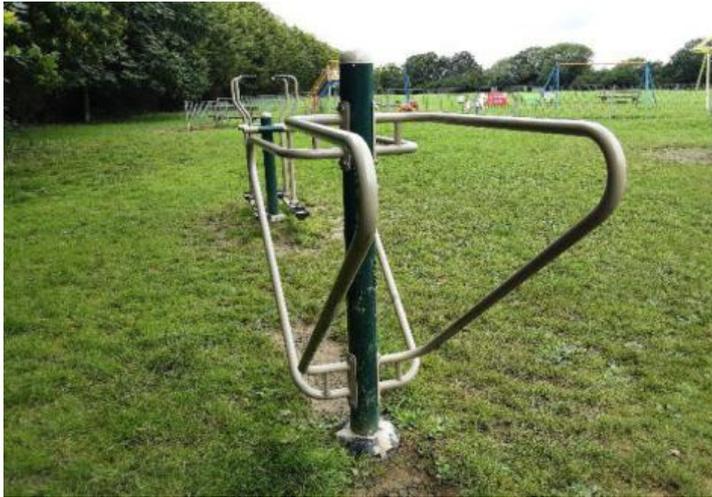
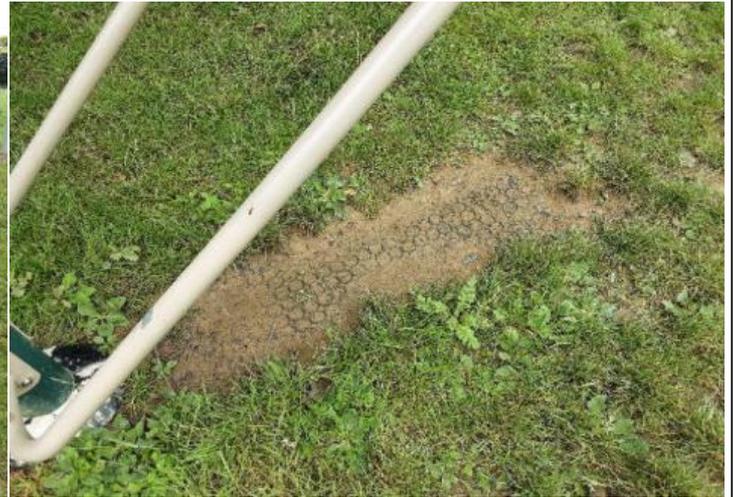
Item: Outdoor Fitness Equipment - Push Up / Dip Station
Manufacturer: Fresh Air Fitness

Finding: The grass mats are silted up, the soil is compacted and the area will become very slippery when the soil is wet. **Action:** Reinstate as required

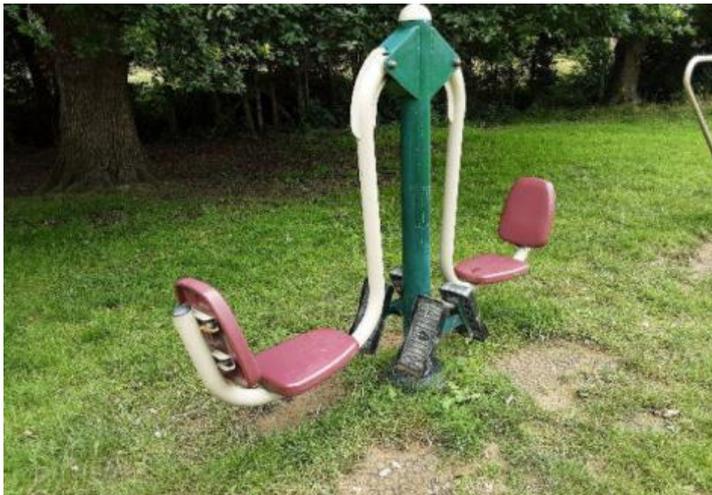
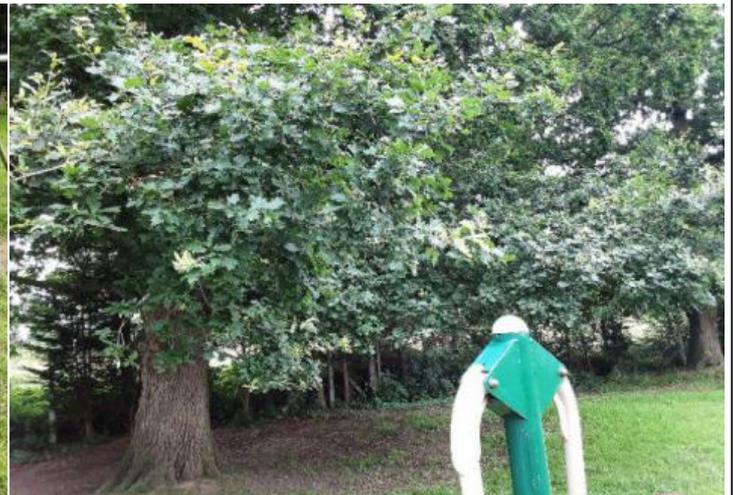
Item: Outdoor Fitness Equipment - Leg Press
Manufacturer: Fresh Air Fitness

Finding: The tree canopy overhangs the equipment and is less than 2.0m away **Action:** Lift tree canopy to ensure a minimum clearance of 2.0m from the equipment

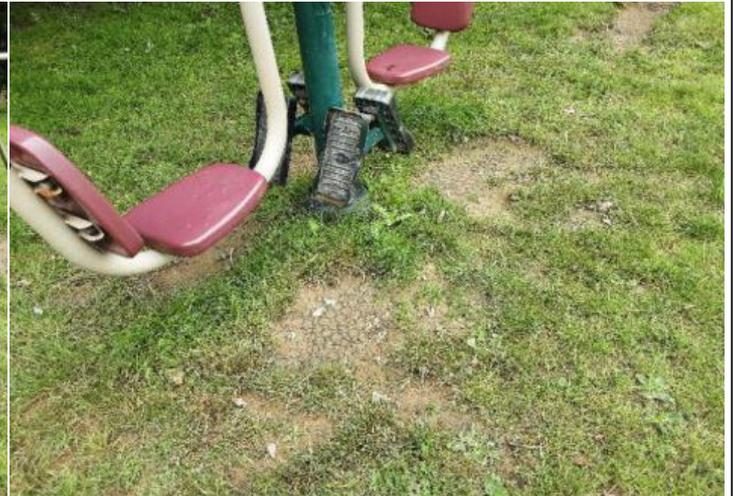
Item: Outdoor Fitness Equipment - Leg Press
Manufacturer: Fresh Air Fitness

Finding: The grass mats are silted up, the soil is compacted and the area will become very slippery when the soil is wet. **Action:** Reinstate as required

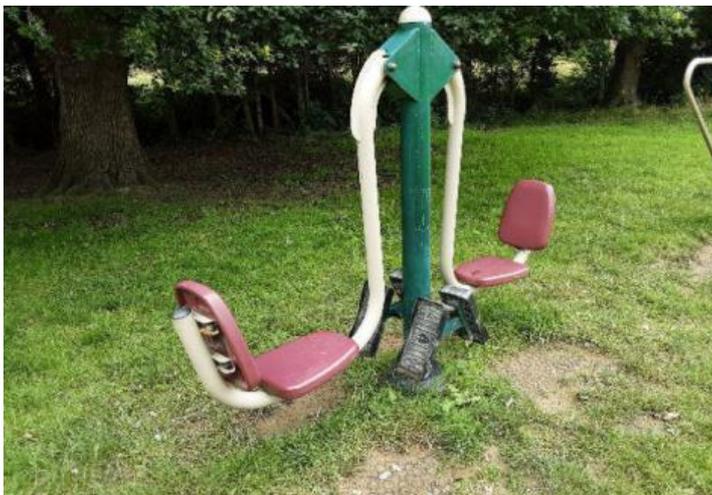
Item: Outdoor Fitness Equipment - Leg Press
Manufacturer: Fresh Air Fitness

Finding: There is/are bolt cap covers missing or damaged on the item **Action:** Replace missing or damaged bolt cap covers

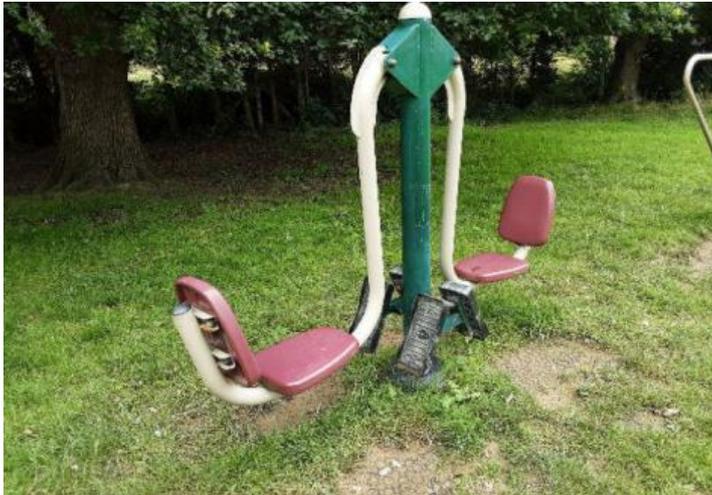
Item: Outdoor Fitness Equipment - Leg Press
Manufacturer: Fresh Air Fitness

Finding: The bushes are showing signs of wear

Action: Monitor for any further deterioration and replace as required

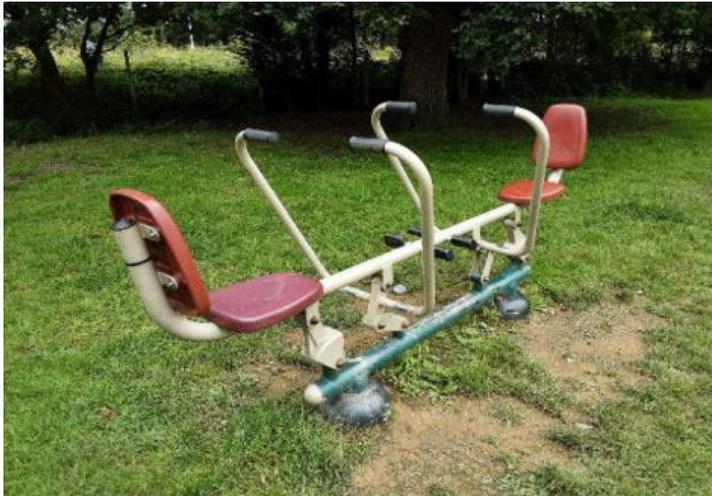
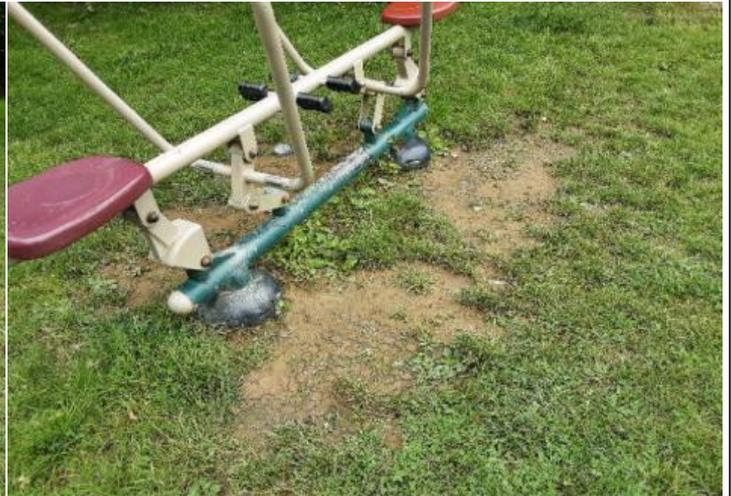
Item: Outdoor Fitness Equipment - Rower
Manufacturer: Fresh Air Fitness

Finding: The grass mats are silted up, the soil is compacted and the area will become very slippery when the soil is wet. **Action:** Reinstate as required

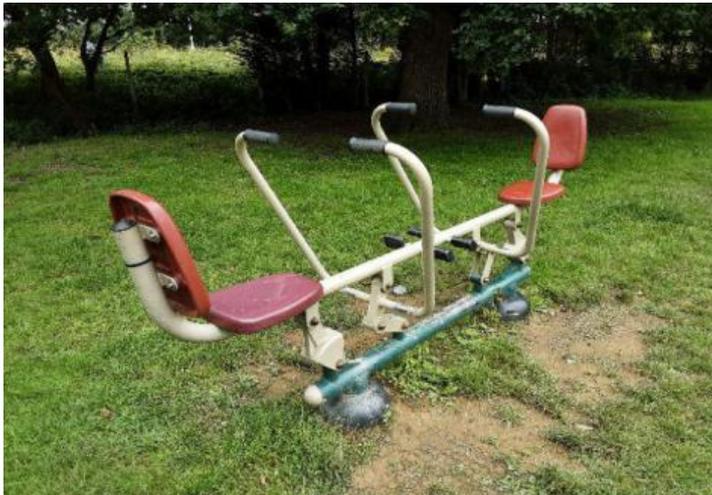
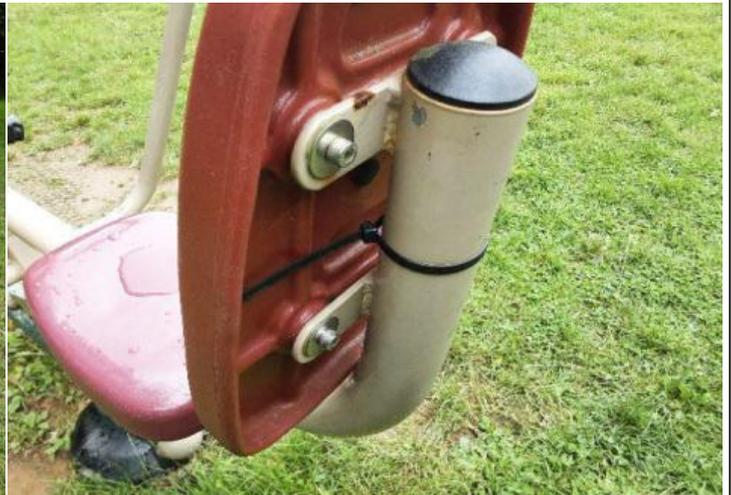
Item: Outdoor Fitness Equipment - Rower
Manufacturer: Fresh Air Fitness

Finding: There are a number of redundant cable ties attached to the equipment **Action:** Remove

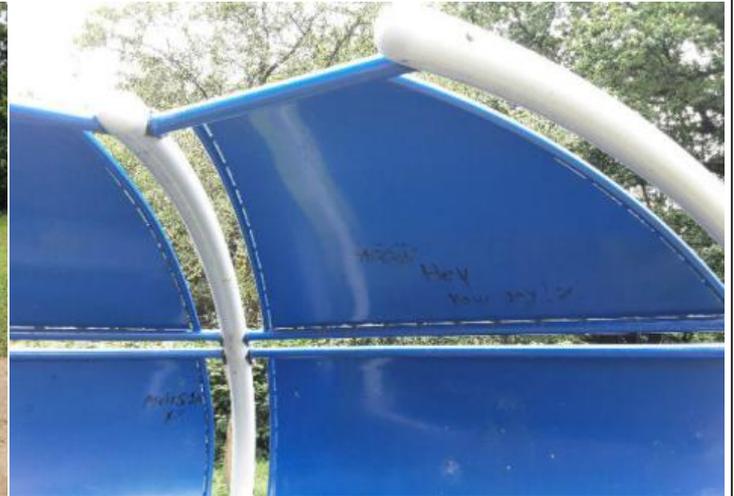
Item: Ancillary Items - Teenage Shelter
Manufacturer: S M P (Playgrounds Ltd)

Finding: There is offensive graffiti present

Action: Remove as soon as practicable
