the **play inspection** company

Annual Inspection

Broadbridge Heath Parish Council

Village Centre

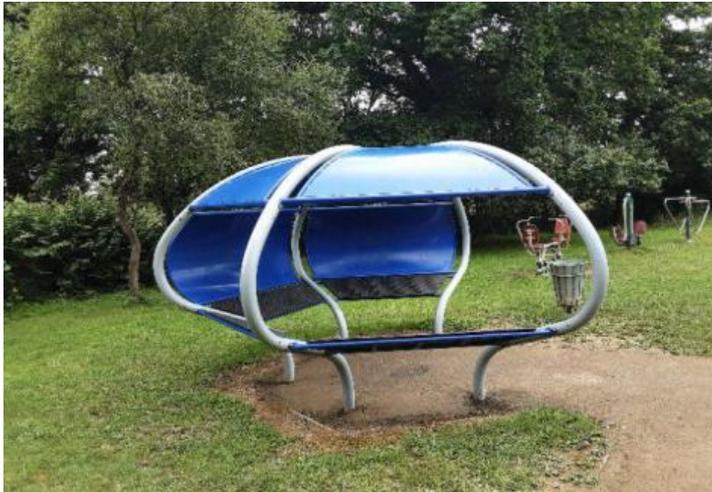
Item: Ancillary Items - Teenage Shelter
Manufacturer: S M P (Playgrounds Ltd)

Finding: There is some evidence of fire damage to the surfacing

Action: Monitor for any further deterioration and repair as required
